Report 08-101, express freight train 923, level crossing collision and  
resultant derailment, Orari, 14 March 2008

**Final report 08-101**  
**express freight Train 923**  
**level crossing collision and resultant derailment**  
**Orari**  
**14 March 2008**

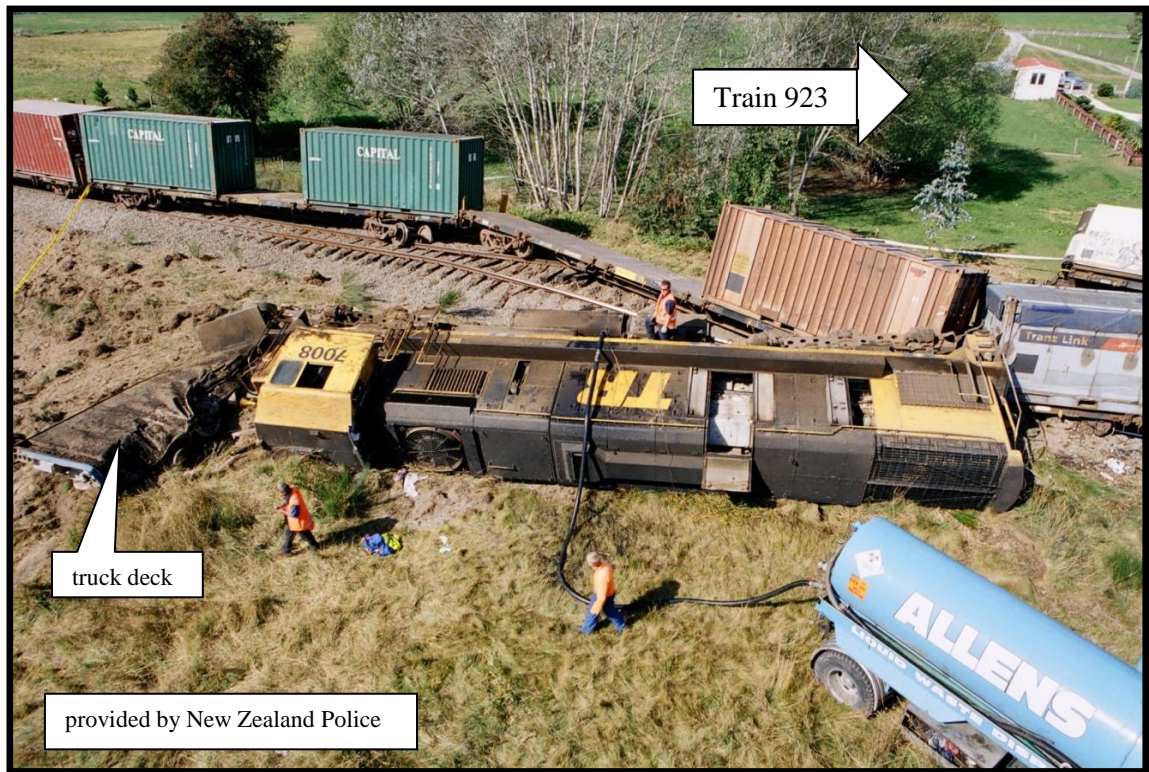
- 1.1.6 Following the collision, the locomotive and the leading 12 wagons derailed. During the derailment sequence the locomotive turned through 180 degrees to face the direction from which it had come and rolled through 90 degrees onto its side, coming to rest some 171 m past the level crossing (see Figure 1). The locomotive engineer remained conscious while the locomotive rotated and the cab filled with dirt and dust. The locomotive cab became separated from the chassis mounting brackets during the derailment sequence and the cab dislocated forward and to the right. However, the cab integrity was maintained.

**Figure 1**  
DFT 7008 after the collision

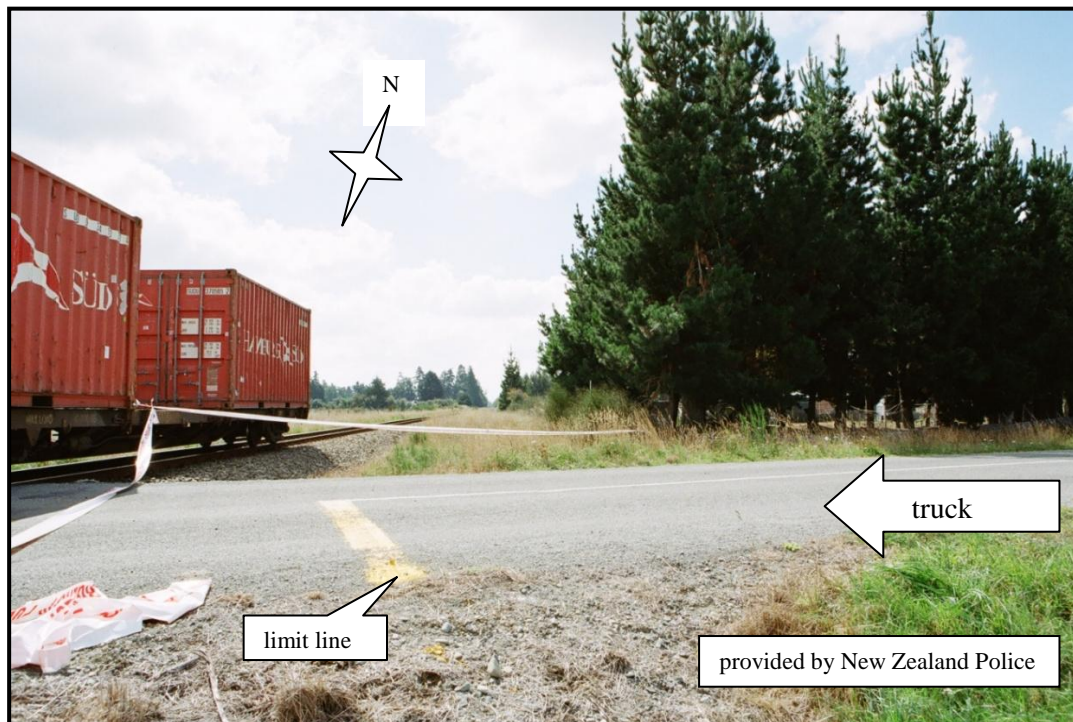
- 1.2.3 The road from State Highway 1 to the level crossing was on a slight rising gradient of 1 in 175. The road surface on the approach to the level crossing was slightly crowned to allow water to run off to the side of the road.
- 1.2.4 The railway track on the north side of Hawke Road level crossing, from where Train 923 approached, was straight for about 5 km and on a down gradient averaging about 1 in 200.
- 1.2.5 The view line looking north when approaching the level crossing from State Highway 1 was restricted by a plantation of mature trees (see Figure 3). The effect of this was that when standing 7 m behind the limit line or 14 m from the track, a southbound train could not be seen until it was 73 m from the level crossing. Once stopped at the limit line, there was an unrestricted view along both directions of the railway.

**Figure 3**  
**View from Hawke Road level crossing looking north**

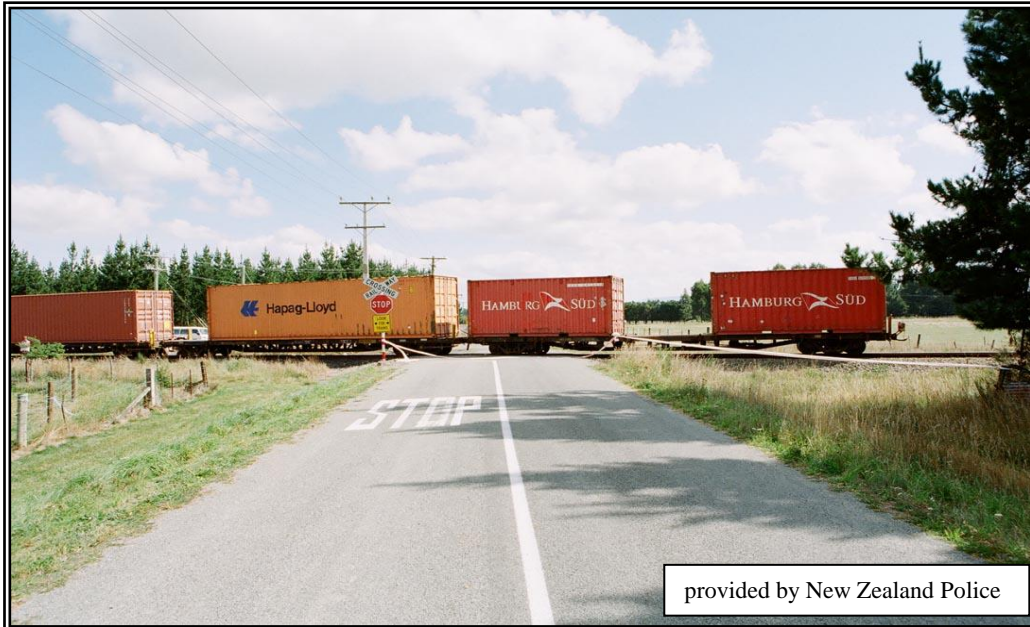
- 1.2.7 The approach to the level crossing had the signs and markings that were required by Land Transport New Zealand<sup>3</sup> (Land Transport Safety Authority, 2000). This was an advanced level crossing ahead warning sign (PW-57), which was an outline of a train on a yellow background, on the left side of the road about 91 m before the level crossing. A “STOP” was painted with white lettering on the road ahead of the yellow limit line (see Figure 4). The limit line, which indicated the safe position for vehicles to stop, was 5 m from the nearest rail.

**Figure 4**  
**The approach to Hawke Road level crossing from State Highway 1**

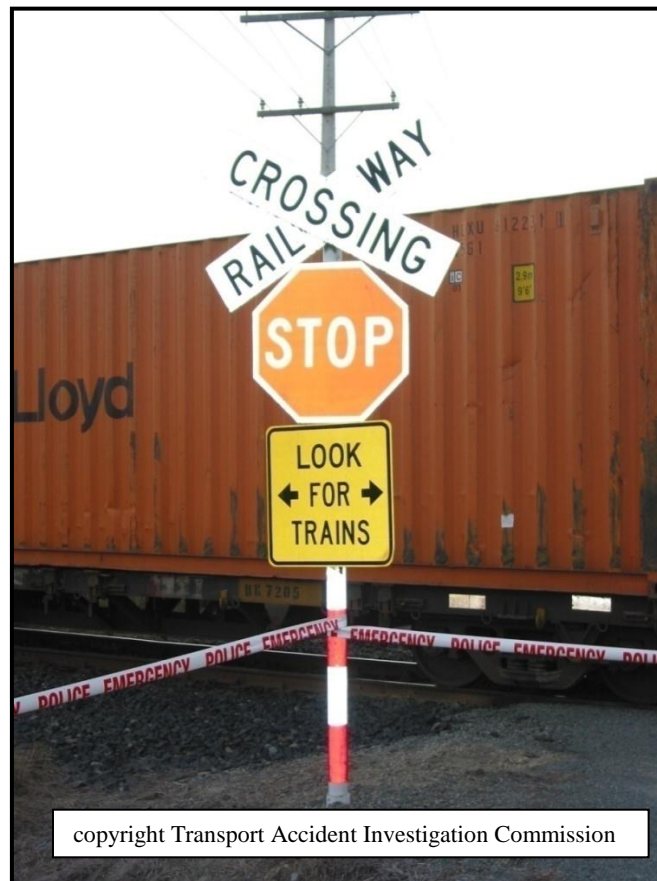
- 1.2.8 The railway level crossing “Stop” assembly (RG-32), consisting of a “Railway Crossing” sign, a “Stop” sign and a “Look for Trains” sign, was in place (see Figure 5).

- 1.2.9 All signage and road markings were in good condition.

**Figure 5**  
**The warning signs in place at Hawke Road level crossing**

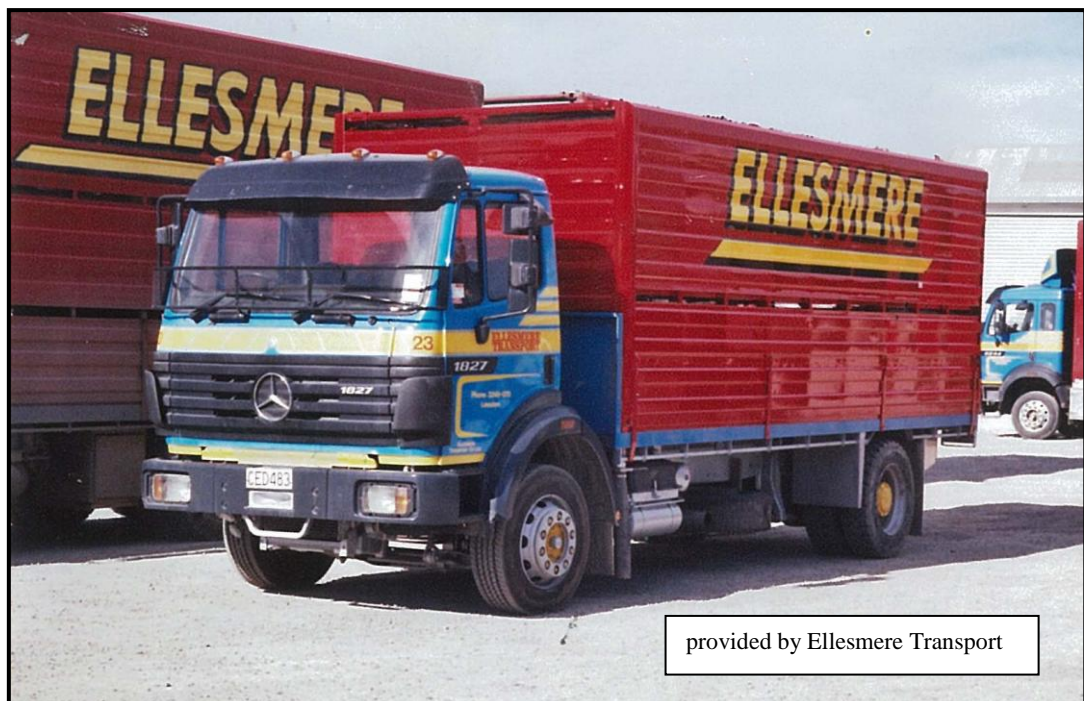
1.6.1 The vehicle, a 2-axle Mercedes-Benz model 1827, registration CED483, had a tare weight of 7140 kilograms (kg) and was manufactured in 1995 (see Figure 7). The truck had a current Certificate of Fitness, issued on 7 February 2008. The check included a full brake test. Although the vehicle was rated as having a gross vehicle mass of 19 000 kg, New Zealand's legislation (Land Transport New Zealand, 2002) restricted the maximum legal gross weight of a 2-axle truck to 14 200 kg. The vehicle was not fitted with safety belts or airbags nor were they required to be fitted.

**Figure 7**  
**The Mercedes-Benz truck**

1.6.3 Five days after the collision, a vehicle standards advisor approved by Land Transport New Zealand conducted a vehicle examination for the Commission. Because of the condition of the truck, it was not possible for the advisor to carry out any mobile tests. His visual inspection of the truck included the steering components, the suspension, the entire braking system, the engine and the drive train. The advisor found no condition with the truck that could have compromised its normal functioning. He concluded that the truck would have been up to the standard of a Certificate of Fitness before the collision.
