Report 08-102

Rail Inquiry 08-102

Metro passenger train derailment,
Sylvia Park, 14 April 2008

Diesel motor fires on board metro passenger trains,
3 June 2008 and 25 July 2008

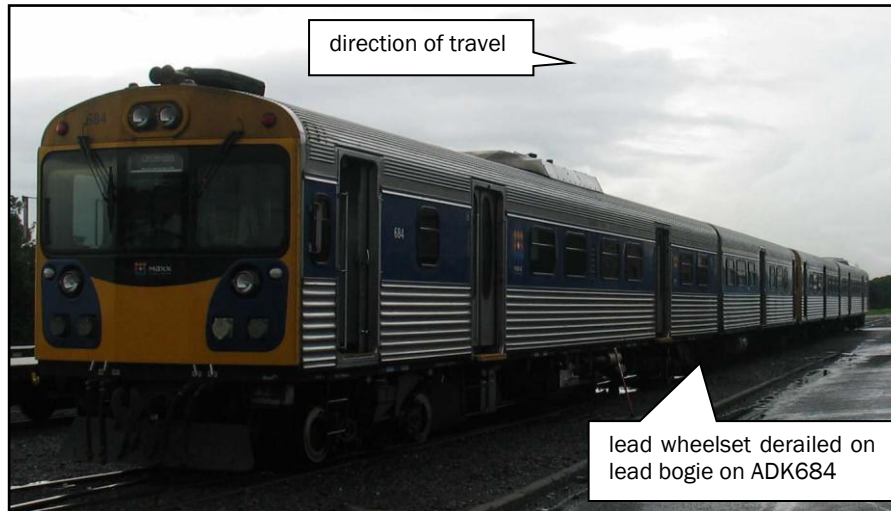
Figure 1
The ADK 4-car set that derailed at Sylvia Park

- 3.1.1. On Monday 14 April 2008, Train 2215 was the scheduled 0812 Veolia passenger service from Britomart to Papakura. The train was a 4-car DMU set consisting of ADK682 (leading), ADB772, ADB774 and ADK684 (see Figure 1).

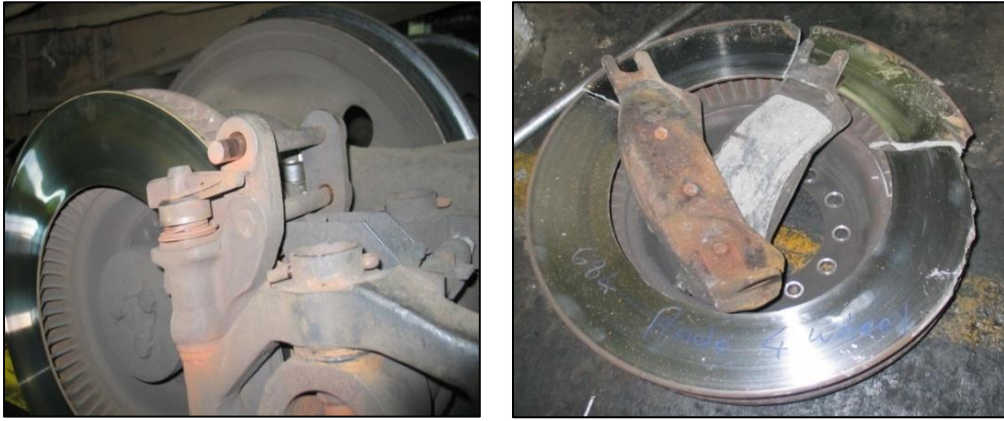
Figure 2
 Photograph of serviceable ADK braking system (left),
 and damaged brake disc and callipers from ADK684 (right)

- 3.1.7. Initially it was not understood what had occurred at Sylvia Park. Some hours later when the brake disc was examined, it was found to have been damaged and 2 brake callipers were missing (see Figure 2). Two other brake callipers from the same bogie were damaged as well.

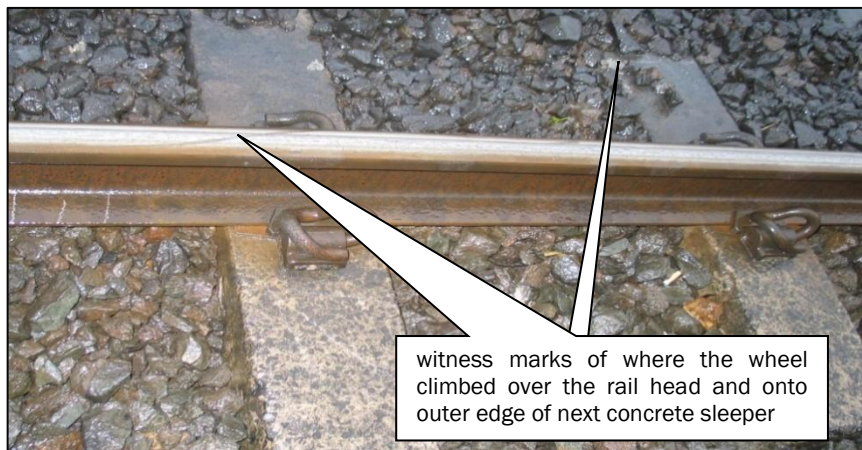
Figure 3
 Witness marks on the track at Sylvia Park

3.1.8. An inspection at the derailment site revealed witness marks on the rail and the missing calliper was found nearby. A shallow gouge mark was seen where the left-hand wheel flange had climbed over the rail head then struck a concrete sleeper (see Figure 3).

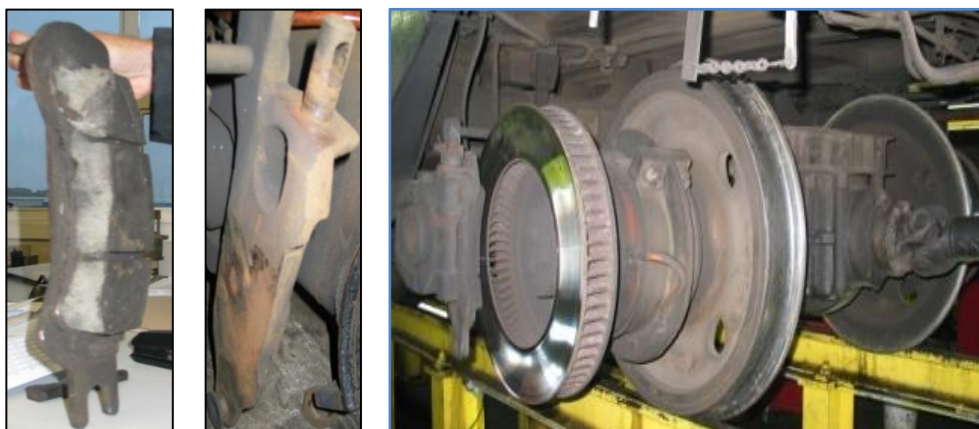
Figure 4
 From left to right, brake calliper,
 backing plate and disc brake arrangement on outside of wheel

3.1.9. The brake calliper had become disconnected from its mounting backing-plate located on the outside of the brake disc (see Figure 4).

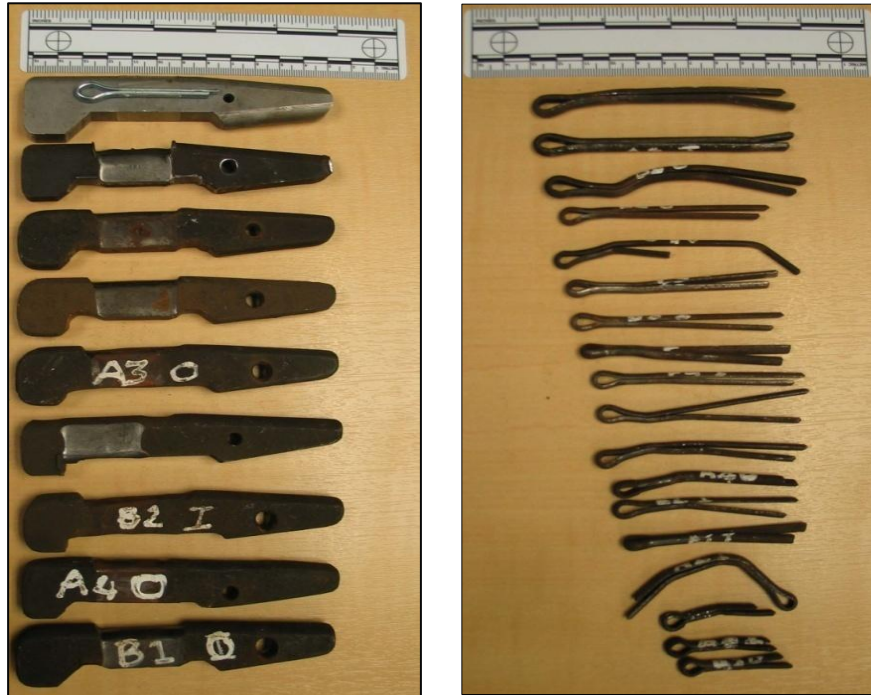
Figure 5
 Photographs showing a selection of worn keys and split pins recovered from other ADK vehicles (top left shows a new key and split pin for comparison)

- 3.1.10. An investigation into the failure mechanism that had resulted in the brake calliper disconnecting from its backing plate on ADK684 concluded that the securing key had either fractured or had worked out from its slot at the top of the backing plate following the failure or loss of the split pin. The key and its associated cap, spring and split pin were also ejected, but despite an area search at the point of derailment, the 3 items were not found. The calliper showed damage that indicated a wheel may have ridden over it.
- 3.1.11. An examination of the other 8 ADK 2-car sets after the incident showed that the condition of the keys and split pins varied (see Figure 5).

The report noted that some of the keys on the bogie were fitted with split pins that appeared not suitable for service which was consistent with the description of the keys and split pins recovered from the ADK sets (refer Figure 5).

- 3.1.12. In a matter of days following this incident, KiwiRail changed the process for replacing keys and split pins (refer to the “Safety actions” section of the report for detail).

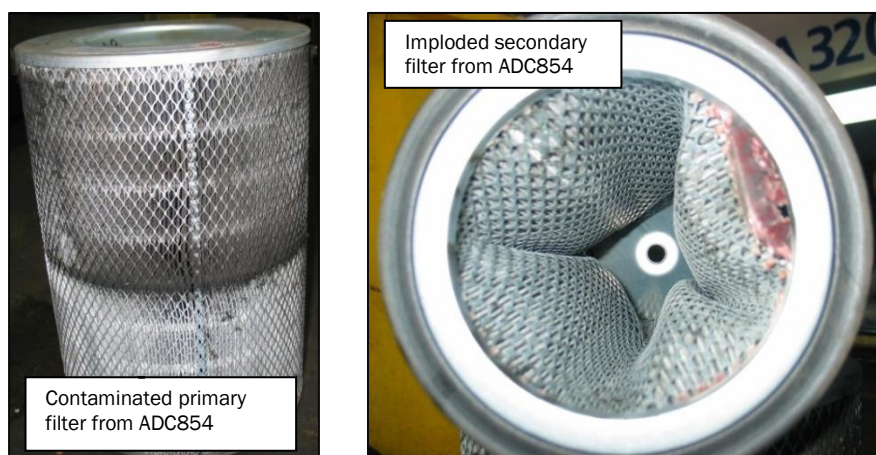
Figure 6
The damaged air filters

3.2.11. The auxiliary motors drew air through vents near the top of the carriage and through a set of primary and secondary air filters in an integral cylindrical unit. An inspection of these air filters and associated air ducting revealed deformation of both, with the secondary (finer) filter on one having imploded (see Figure 6).

- 3.2.12. The air filters from ADC854 were sent to an independent laboratory for analysis. The following conclusions were drawn from this analysis:
- the primary filter was blocked with predominantly iron-bearing particles, about 50% of which were smaller than 53 μm^2 in a liquid medium (the contaminant)

- the contaminant contained a high proportion of solid particles in a liquid medium that may have been oil but this could not be confirmed
 - the contamination may have originated from a source likely to contain concentrations of iron-bearing minerals such as metallic dust. Possible sources included steel mills, iron foundries and the braking system on the DMU sets

- the secondary air filter probably collapsed due to an appreciable pressure drop across it caused by the blockage of the primary filter.
- 3.2.13. Discussions with KiwiRail staff were inconclusive as to the source of the contamination. Steel particles (dust) were a by-product of wearing on the cast iron brake blocks fitted to some rail vehicles, and the trains were stabled close to a steel processing plant. Some trains were stabled alongside the train washing facility, which could have resulted in the ingestion of water/debris from the washing process. The auxiliary motors were left running during these periods.
