**Report 08-103, passenger Train 6294, electrical fire and collapse of overhead traction line, Mana station, Wellington, 18 April 2008**

**Report 08-103**

**electrical fire and collapse of overhead traction line**

**Mana station, Wellington**

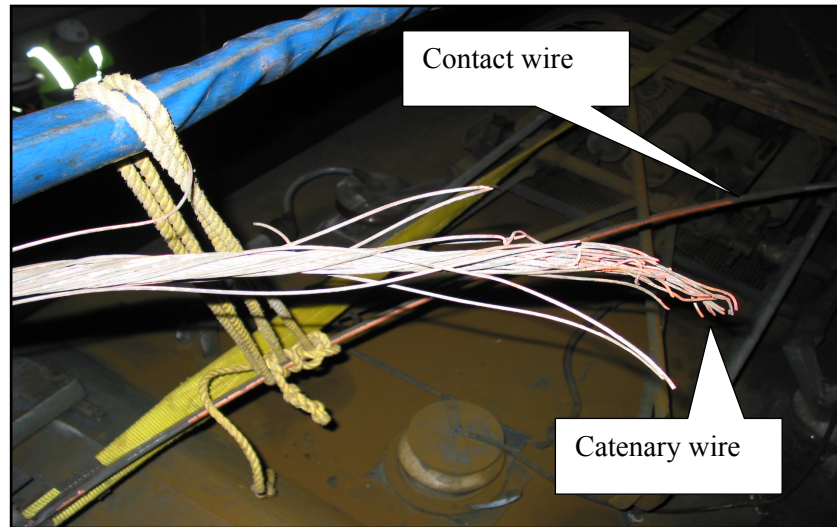
**Figure 6**  
**Broken overhead line at Mana**  
Photo provided by Tranz Metro for use by the Commission.

- 1.7.1 The remnants of the overhead line and the dropper cable connection from around Switch 46 were examined. The overhead line contact wire and the supporting catenary wire had been completely melted through at the point where the EM pantograph had been in contact with them while the train was stationary at Mana platform (see Figures 6 and 7). The loose ends of the overhead line dropped onto the train and the platform.

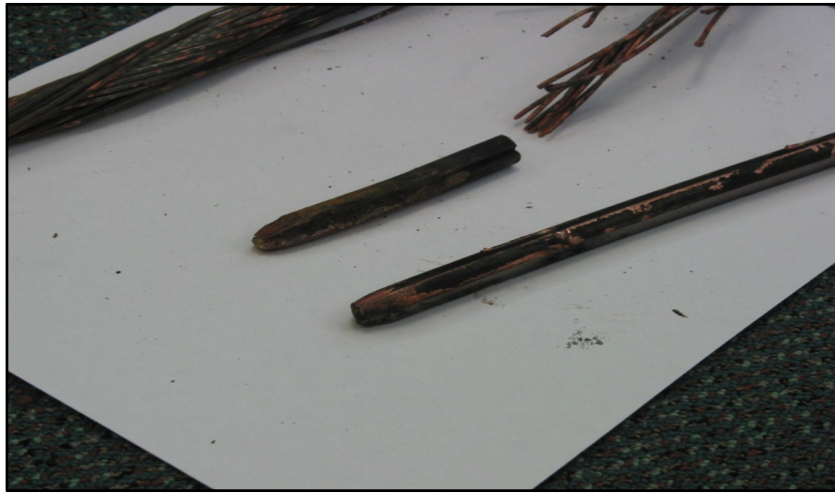
**Figure 7**  
**Parted overhead contact wire**  
 © Transport Accident Investigation Commission

- 1.7.2 The contact wire was ‘necked’ at the break (see Figure 7), which was a sign that the material had stretched under tension before parting. A break of this nature would be consistent with the line heating up under high electrical current, becoming ductile and stretching under normal installation tension and failing.

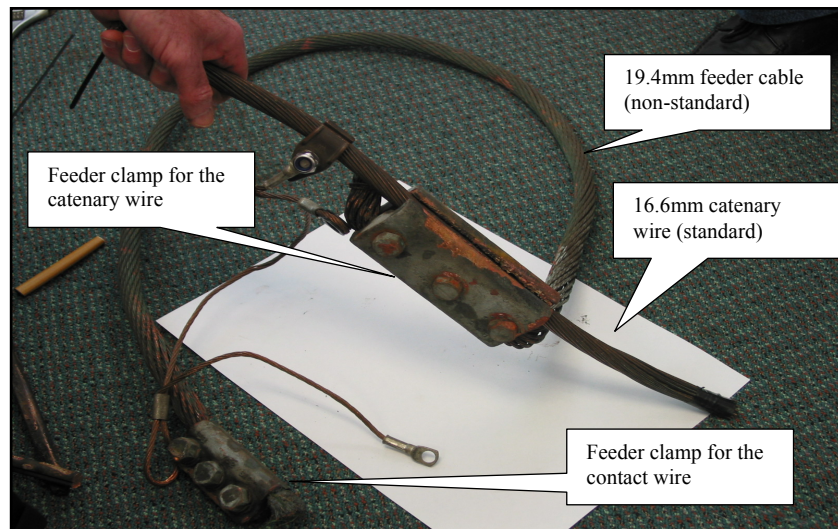
**Figure 8**  
**Feeder cable and clamp at switch 46**  
 © Transport Accident Investigation Commission

- 1.7.6 The feeder cable was a larger diameter cable than usual but the connection of this feeder onto the contact wire was made with a clamp intended for the smaller standard cable size. The clamp consisted of 2 half shells that should have fitted snugly around both the feeder cable and the contact wire, which were then bolted together with 3 compression bolts positioned midway between the 2 conductors. The design of the 2 shells forced them to mate with the contact faces parallel. As the feeder wire had a greater diameter than that for which the clamp was designed for, the resulting clamp contact pressure on the contact wire at the bottom side of the clamped shells would have been reduced. This joint would have had a much higher electrical resistance than if it had been made with the correct-size feeder cable.

- 3.2 The overhead traction wires parted in 3 places causing the lines to fall to the ground. The reason for their parting was the excessive current heating the wire above its melting point where it contacted the train pantograph, and through a high-resistance joint caused by incorrect assembly.

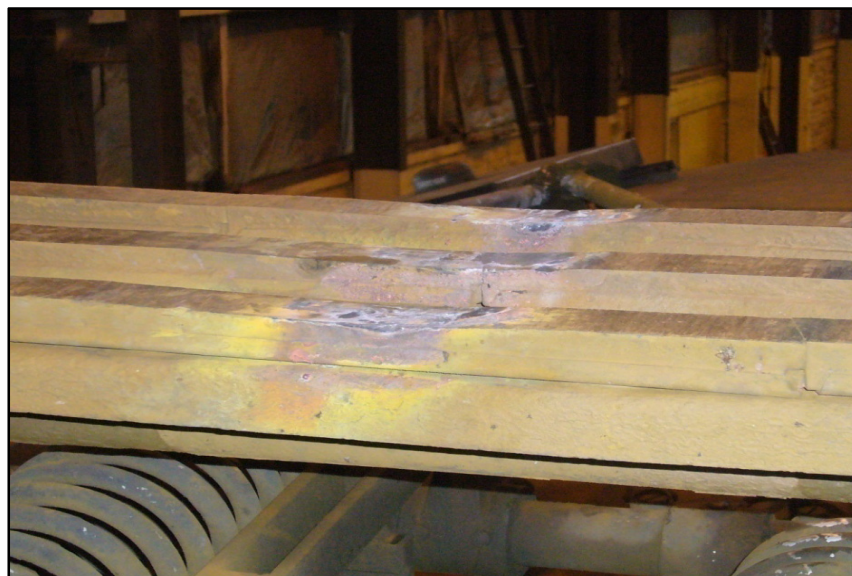
**Figure 9**  
**Pantograph damage: Arc damage on contact surface**  
 © Transport Accident Investigation Commission

- 1.8.1 An examination of the train revealed that the sliding carbon contact surface on the pantograph had been damaged by severe arcing, with pitting, grooves and splatters of molten copper present (see Figure 9). The support arms and joints of the pantograph showed obvious signs of excessive current conduction. At the point where the pantograph arm joined to a half height pivot bearing, the aluminium tube had melted and created a hole. (see Figure 11)

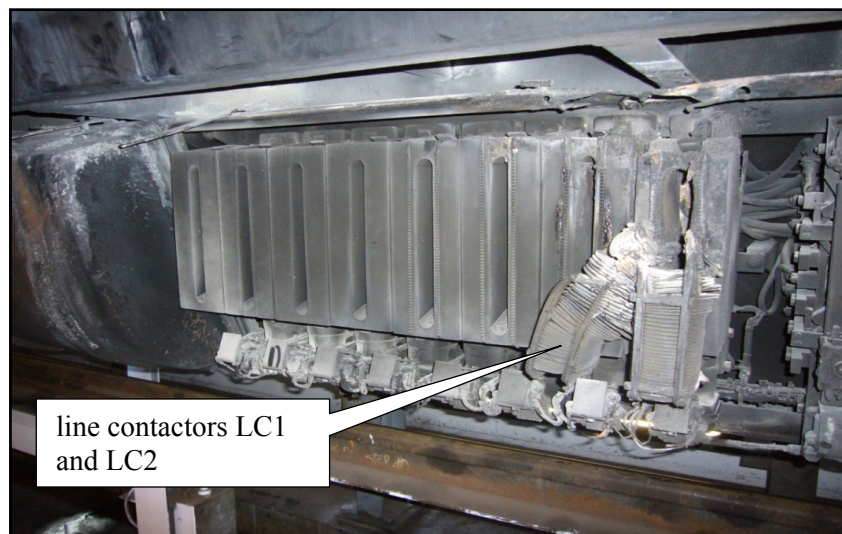
**Figure 10**  
**Main equipment case**

- 1.8.2 The No.1 motor on EM1373 was examined through the floor inspection hatch just outside the driver's cab. Soot deposits indicated that severe arcing had been occurring near the armature. The circuit breaker was inspected in situ and the circuit breaker arc chute showed signs of recent arc suppression but appeared to be intact. The equipment cabinet at the source of the fire was opened and examined. The 2 line contactors, LC1 and LC2, had been destroyed by the electrical fault current with much of the physical structure of these devices missing. Adjacent contactors were covered in carbon soot (see Figure 10).

- traction motors 1 and 4 had low insulation test readings. (Comment: These motors are installed in separate bogies).
- motor cut out switch contacts were welded closed
- line contactors LC 1 and LC 2 in the main equipment case were destroyed from severe arcing
- high-speed breaker contacts were welded closed
- the main equipment case was holed and all items inside were smoke damaged.
- the pantograph structure was damaged from arcing
