Report 08-110, train control operating irregularity, leading to potential low-speed, head-on collision, Amokura, 23 September 2008

Report 08-110

train control operating irregularity

leading to potential low-speed, head-on collision

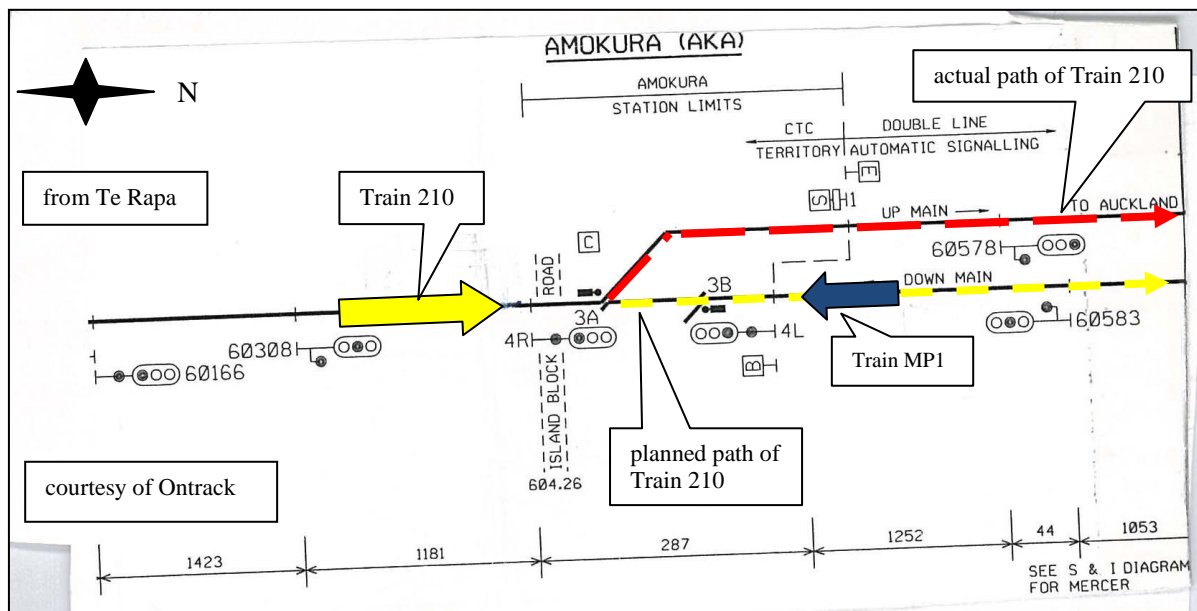
Figure 2
Track/Signalling layout at Amokura (not to scale)

- 1.1.2 The train controller had just started his shift and was not aware that a Down train (MP1) was standing stationary on the Down main line at Amokura just ahead of Train 210 (see Figure 2). A signal maintainer working on the failure of the local signalling system at Amokura contacted the train controller and told him that he had partially resolved the signalling problem. The train controller abandoned the wrong-line-running arrangements he had initiated and routed Train 210 along the normal Up main line instead.

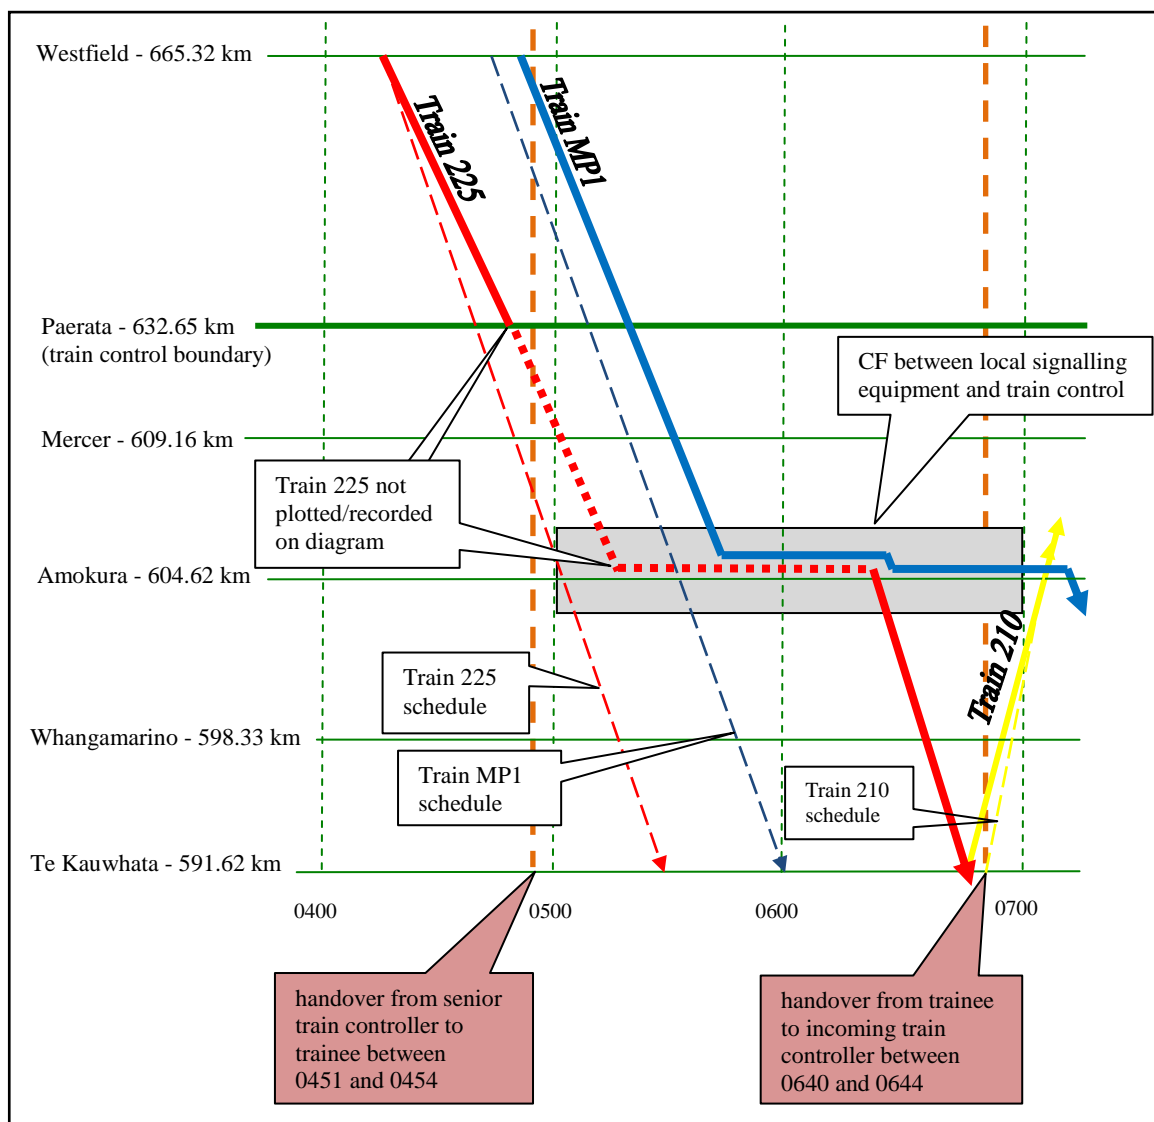
Figure 3
Recorded train journeys between Westfield and Te Kauwhata (not to scale)

- 1.3.8 At 0520, a Down train approached Paerata. The senior train controller commented that it was a suburban service to Pukekohe, but the trainee, who had previously cleared Signal 8L, said that he thought it was Train 225 and recorded its passage at 0524 with that identity. This movement was actually Train MP1 (a southbound Auckland-Tauranga express freight service). The senior train controller was heard to say on the voice recording system that he had recalled hearing about Train 225 earlier and not drawing it down on the train control diagram (see Figure 3).

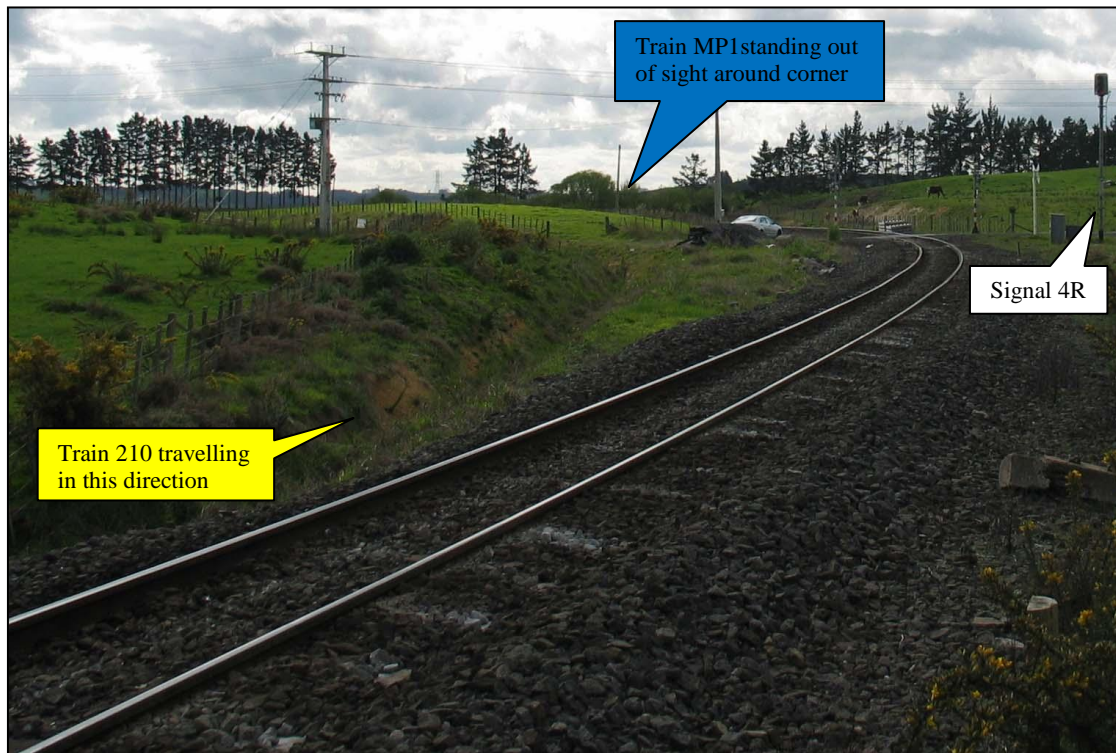
Figure 4
The approach to Amokura from the south

- 1.3.19 At 0708, Train 210 passed Signal 4R at Amokura and the locomotive engineer said that he “got a hell of a shock” when he saw Train MP1 standing on the Down main line where, if the Mis.60 had been issued and executed, he would have driven his train (see Figure 4).

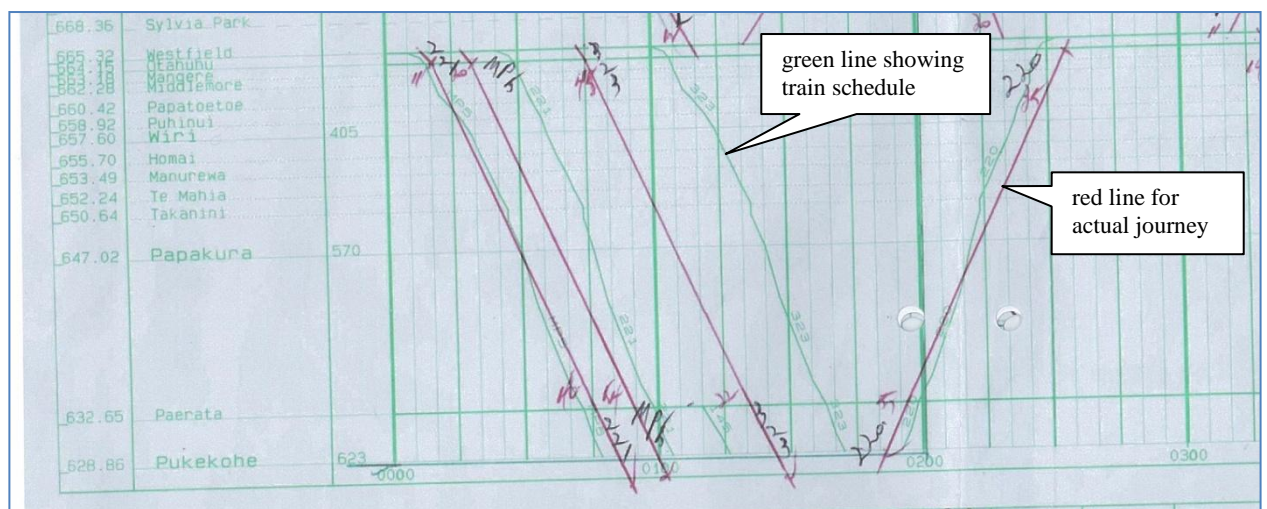
Figure 6
Train control diagram

- 1.7.2 A principal and long standing feature of the NTCC operation was the paper-based train control diagram (see Figure 6). The diagram showed the timetable linear (in green) of all scheduled Up and Down trains with their running numbers that were scheduled to run within a 24-hour (midnight to midnight) period. Before accepting a train into their area, the train controller was responsible for creating a safe path. There were procedures in place to notify train controllers of additional trains and train cancellations.

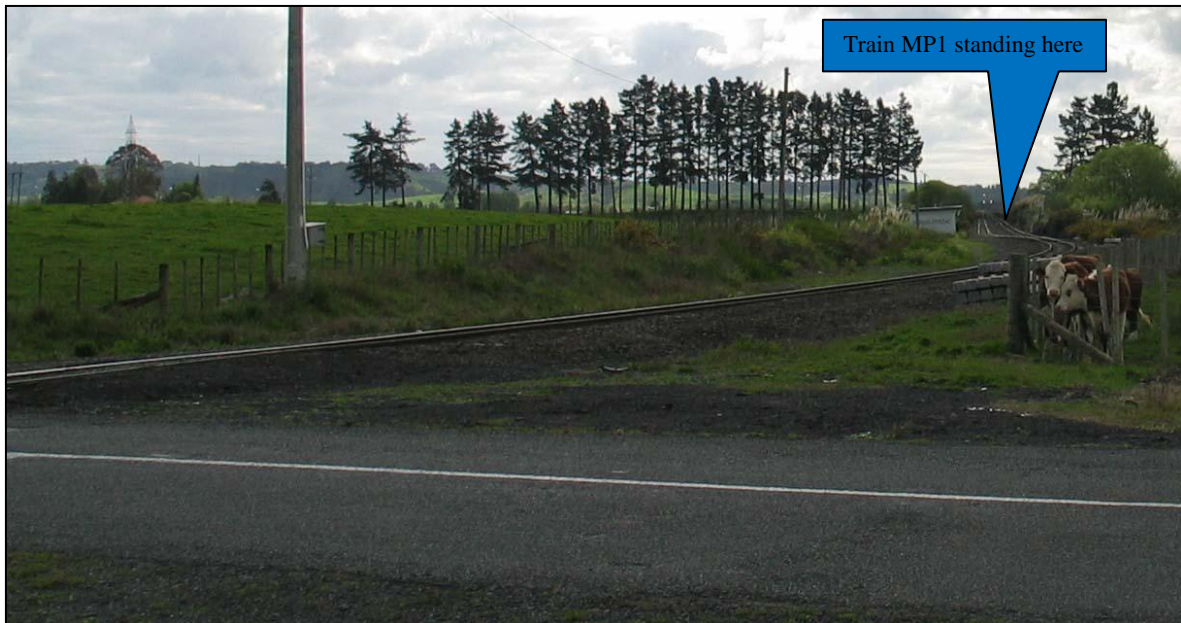
Figure 8
Amokura looking north

- 2.5 If the decision to send Train 210 wrong-line-running along the Down main line where Train MP1 was standing had been followed through, the only remaining defence that could have prevented a low-speed head-on collision was the reaction of the locomotive engineer and the braking capability of Train 210, unless the locomotive engineer of Train MP1 had contacted the train controller.
