Report 08-111: Express freight Train 524, derailment, near Puketutu,
North Island Main Trunk, 3 October 2008

Final Report

Rail inquiry 08-111

Express freight Train 524, Derailment
near Puketutu, North Island Main Trunk, 3 October 2008

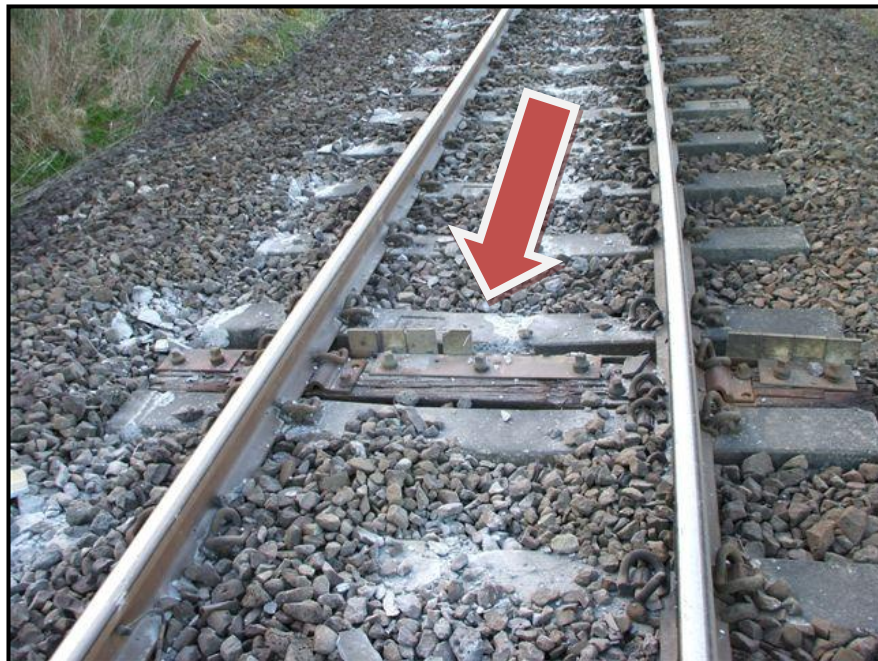
Figure 1
Damaged dragging equipment detector

- 3.1.5. At 0223:04 the derailed bogie was detected by a dragging equipment detector unit located at 469.140 km (see Figure 1). The dragging equipment detector sent an alert to train control and broadcast an alert on the local channel 1 radio. At 0223:15 the locomotive engineer initiated a full service brake application in response to the alert, and while the train was slowing the train controller radioed the locomotive engineer to advise him of the alert received at train control.

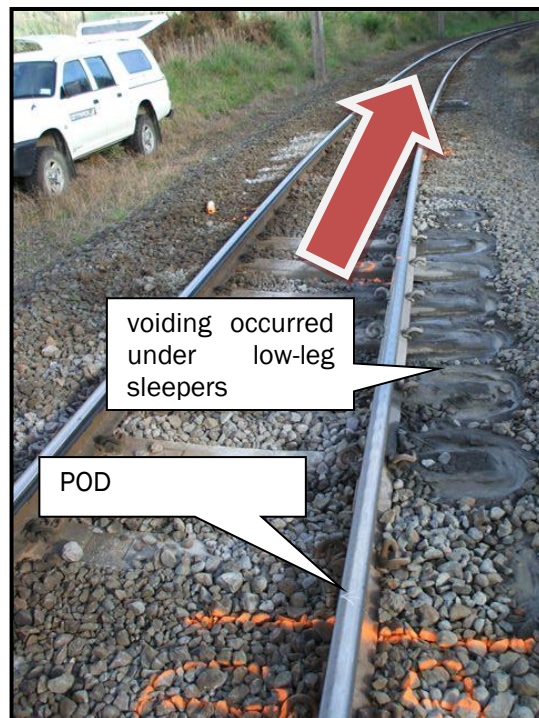
Figure 3
Soft spot near the POD

- 3.2.8. The post-derailment measure-up of the track geometry was carried out manually under static loading conditions³. At the time of the measure-up, there was a 5 m long soft spot under the right rail (low-leg) from the POD (see Figure 3) to the drop-off point. A void meter was not used to measure the extent of vertical displacement, but it was estimated to be between 10 and 15 mm.

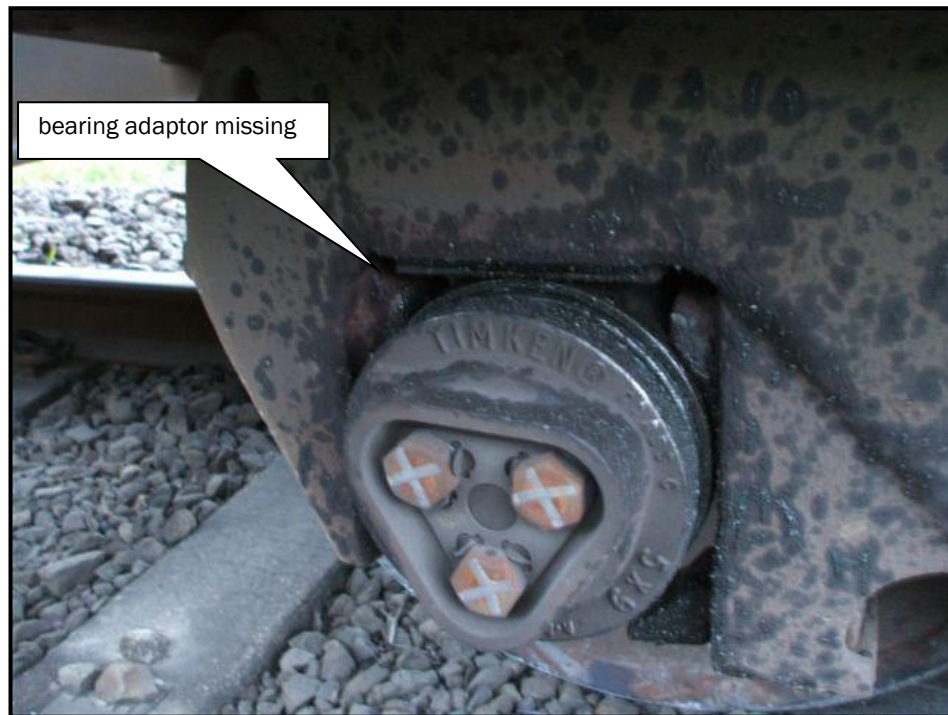
Figure 7
Journal bearing arrangement on A2 wheel-set

- 3.5.9. The derailed wagon was dragged about 1.2 km before the train stopped. The bearing adapter from the left side of the leading axle on the trailing bogie (first wheel-set to derail) was missing, the bearing had been leaking and grease was observed on the field side of the bearing and splattered on the side-frame horn (see Figure 7).

- 3.5.10. The bearing adaptor had failed through a region that included the thinnest section of material. The MLD1 Report⁴ showed that one section of the bearing adapter was found on the vehicle access road at 468.570 km, 10 m before the POD. KiwiRail contended that this section of the bearing adaptor was found 10 m past the POD. In discussion, 2 years later, with the KiwiRail Network employee who had recovered the failed section, he could not recall whether it had been picked up 10 m before or after the POD. Nevertheless, the diagram accompanying the MLD1 showed that it was recovered 10 m before the POD. The other section was recovered 94 m past the POD and 6 m from the left rail. These recovered bearing adapter sections were taken to an independent metallurgy laboratory for analysis. The laboratory report is summarised in Appendix 1.

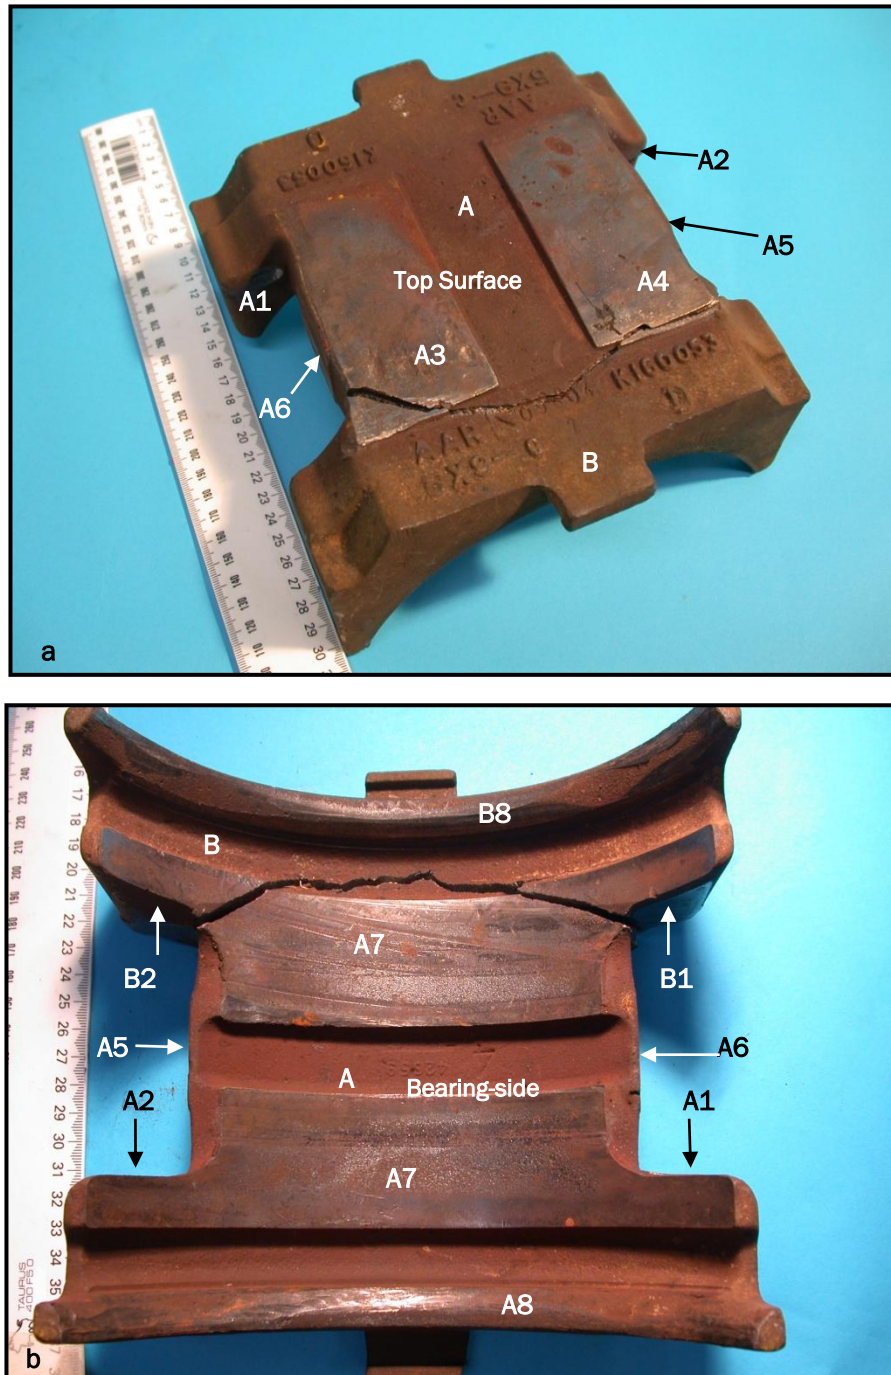
Figure 8
Failed bearing adapter

1.1.1. The bearing adapter (see Figure 8) was visually examined and the following noted:

1.1.2. The bearing adapter had fractured at one end (see Figure 8), through a region that included the thinnest section of material (see Figure 9).

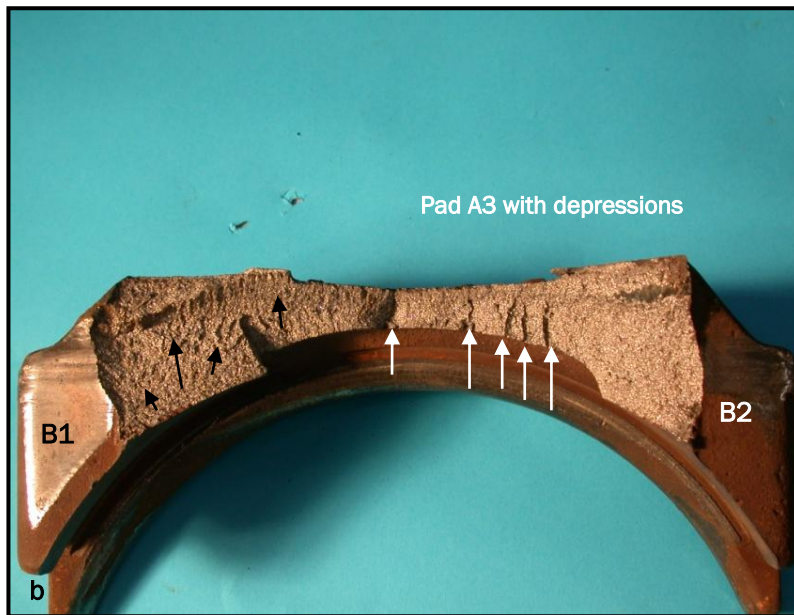
Figure 9
Fracture face on portion B

- 1.1.3. The fracture was generally fairly coarse, brittle and mostly reflective but with a slight grey tinge (see Figure 9). White arrows indicate steps and black arrows indicate the apparent direction of fracture. The grains tended to become coarser from the curved edge to the relatively flat edge (see Figure 10).

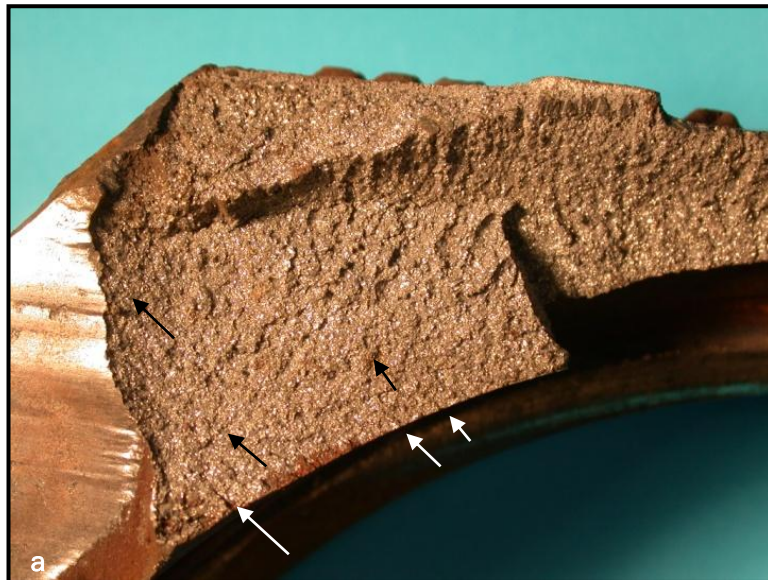
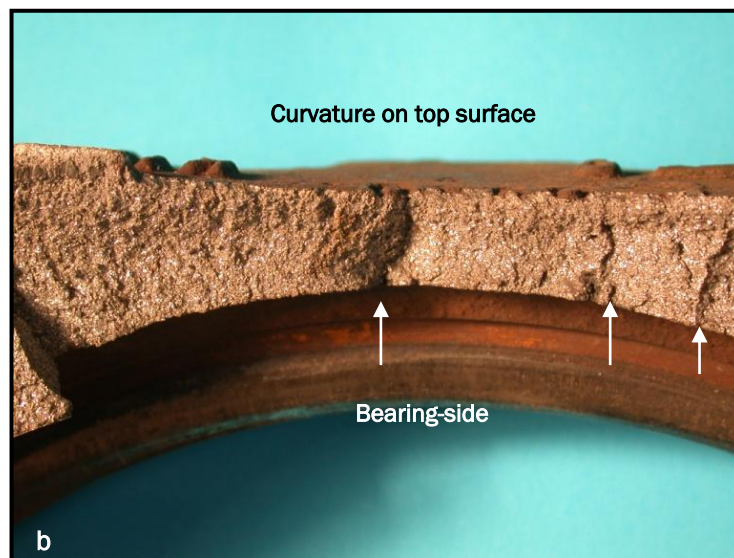
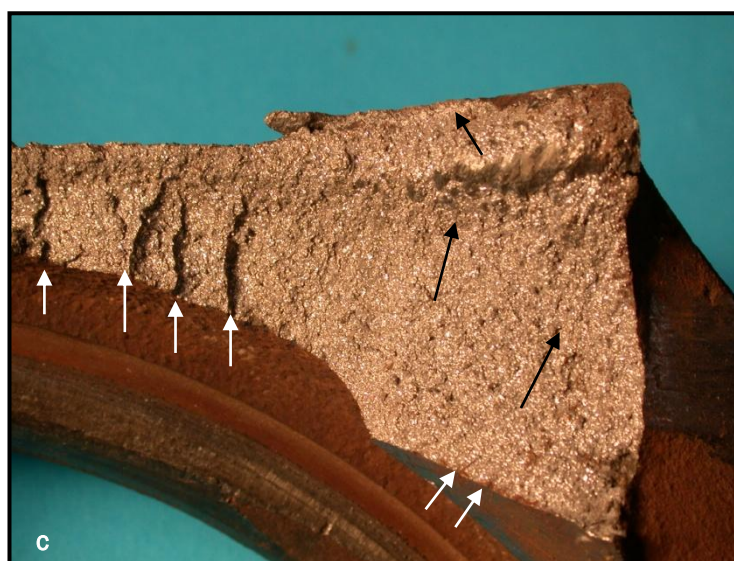
Figure 10
Close-up of the fracture face on portion B

- 4.4 The morphology of the fracture in the bearing adaptor indicated that it started at the underside curved section and broke from the bearing side towards the top surface. The largest castellations were close to the thinnest material section where stresses would be expected to be higher. No material imperfection was detected that might have initiated fatigue cracking. However, there were indications that a fatigue failure had occurred: the presence of numerous castellations, from large ones at the thin region to smaller ones towards the sides in the thicker sections; and the gradually coarser appearance of the grains towards the top surface.

- 1.1.4. The fracture face had a series of steps that met the curved edge but not the relatively flat edge. Faint ridges could also be seen on the fracture on a macro scale. These and the steps, or castellations, indicated that the fracture initiated at the curved surface. The castellations were largest close to the thinnest section, Figure 10b. Smaller castellations were present on the curved edge at the thicker sections, also indicated by white arrows in Figures 10a and 10c.

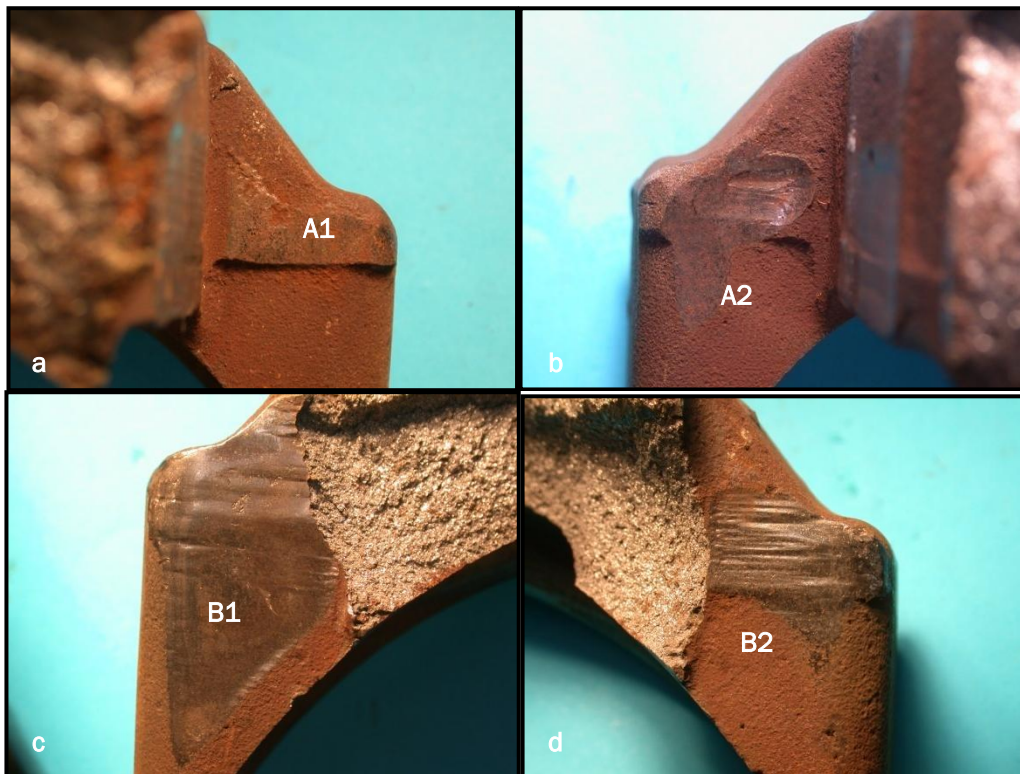
Figure 11
Regions A1, A2, B1 and B2 from Figure 8

- 1.1.10. Severe wear, including loss of material had taken place on regions A1, A2, B1 and B2, Figure 11. All of the severe wear included deep scoring with distinct material loss and polishing. The light-moderate wear was mostly polishing wear with slight pitting.

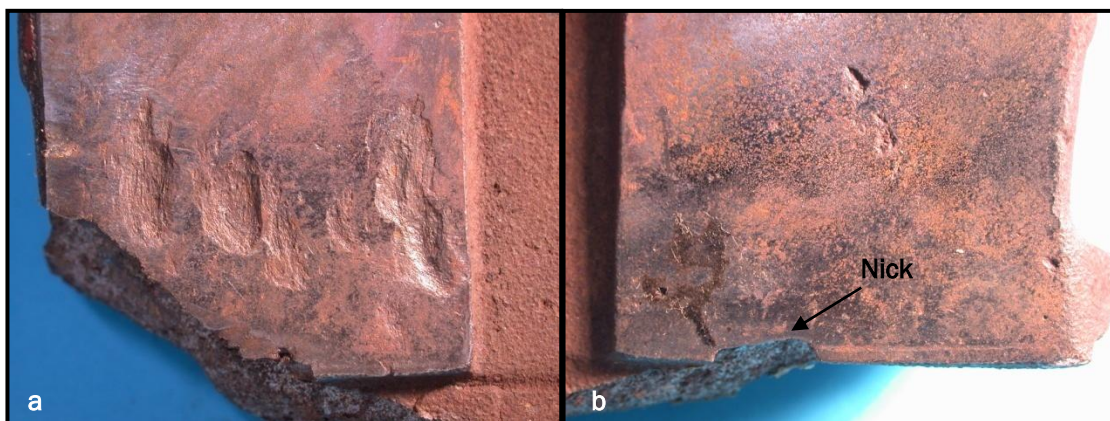
Figure 12
Regions A3 and A4 from Figure 8

- 4.9 The proximity of the indentations to the fracture and the largest castellations suggests that the entrapment of foreign material and repeated loading and unloading may have influenced the initiation of fatigue cracking within the bearing adaptor.

- 1.1.11. Wear on A3 included repeated, fairly deep deformation of a similar shape, Figure 12 that appeared to have been made by an entrapped foreign object. This may have also removed some material. These depressions were close to the fracture and on the same side of the fracture as the most severe castellations, seen in Figures 10b and 10c. Wear on A4 was much less severe but included much smaller and occasional, fairly deep depressions. Both pads had lost material; in A3 this was lost due to fracturing, in A4 a nick was present at the end of the pad.

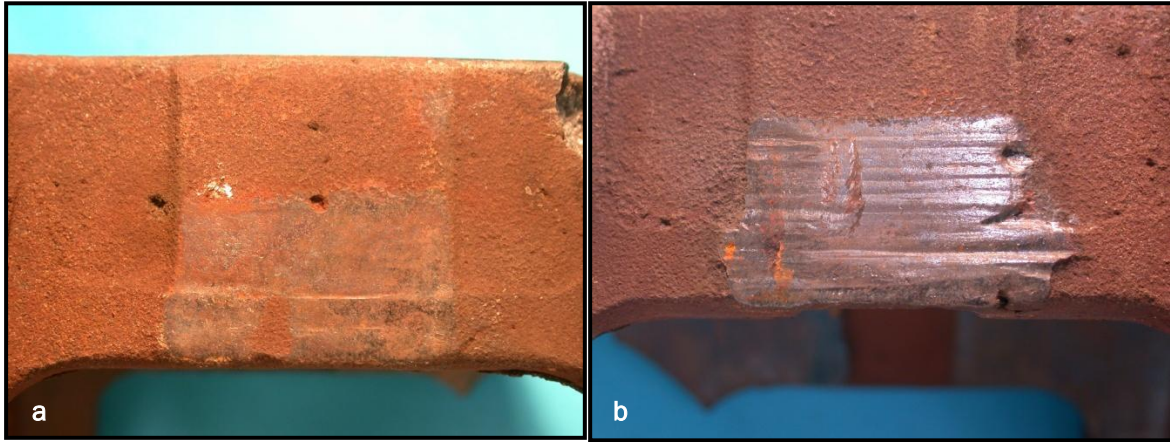
Figure 13
Regions A5 and A6 from Figure 8

- 1.1.12. Light to moderate wear had occurred on A5. Severe wear, similar to that described for regions A1, A2, B1 and B2 was present on A6, Figure 13.

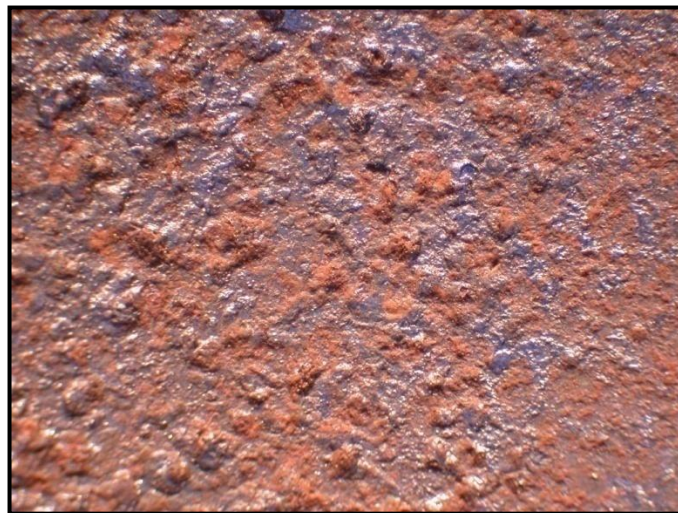
Figure 14
Surface A5 from Figure 8

- 1.1.13. The bearing surface, A7, exhibited numerous shallow pits with light corrosion product, Figure 14. In the area nearest portion B, there were angled scratches, Figure 8b. These did not extend on to portion B and are considered to have been made after the block broke.

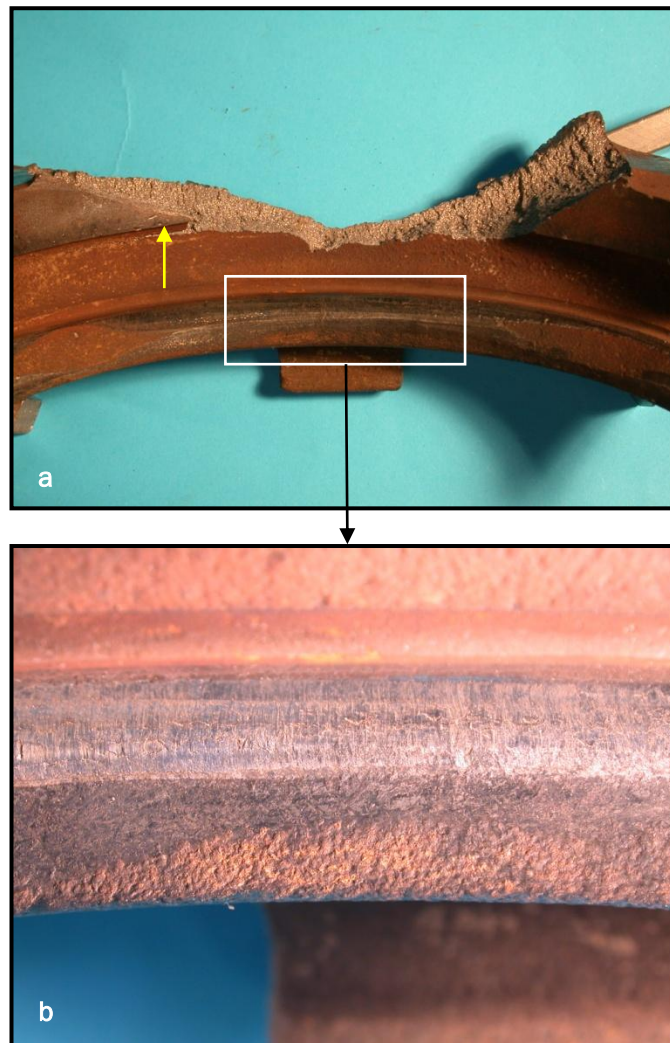
Figure 15
Worn region of the outer rim on portion B

- 1.1.14. A crack was associated with the main fracture, indicated by the yellow arrow in Figure 15a. This would have occurred at the time of fracture.
- 1.1.15. Wear, causing material loss was evident on shoulders, A8 and B8, Figures 8 and 15b.

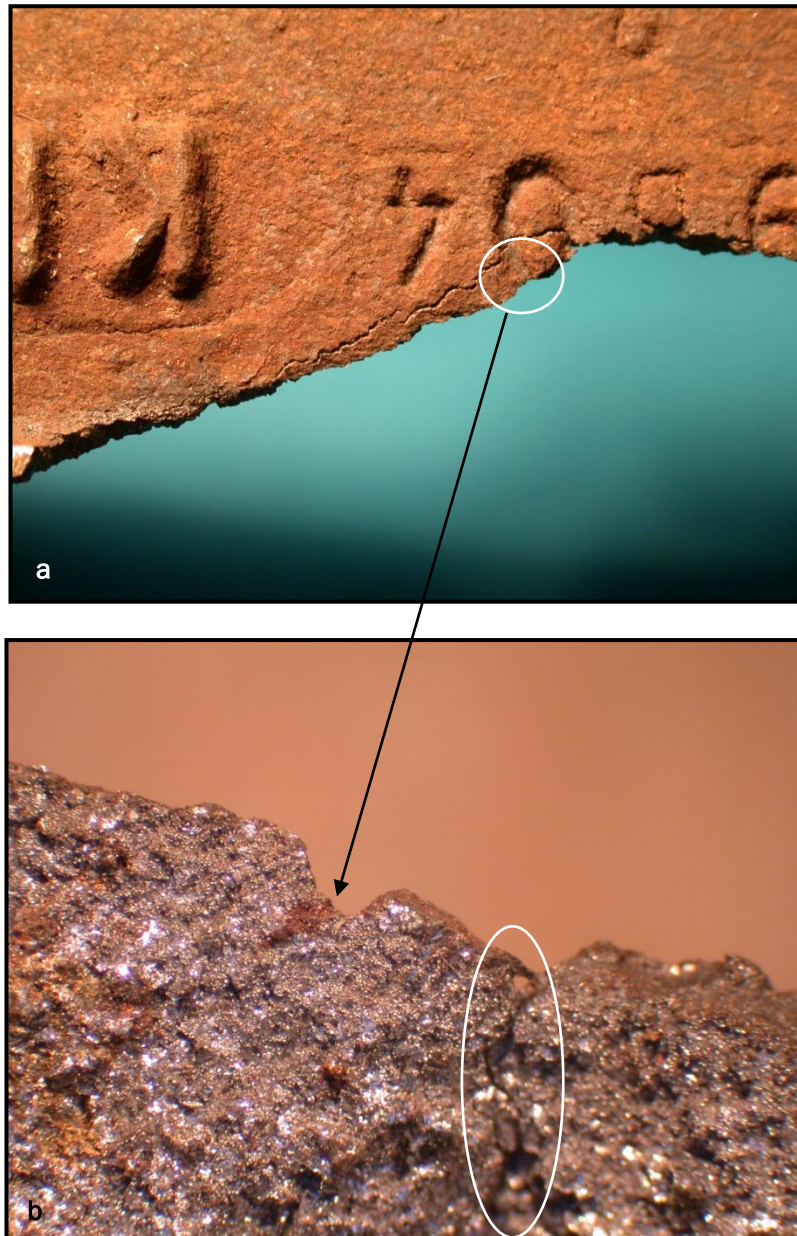
Figure 16
Corrosion at the base of "0" and crack to the right of it

- 4.11 The secondary cracking observed in the centre relief near the end relief, associated with the character "O" in Figure 16 a, was considered to have been additional cracking due to the final overload failure and not indicative of a load applied to the top surface of the bearing adaptor. Because the crack was fairly open, there was probably mainly tensile force present at the time of the overload fracture.

- 1.1.16. Secondary cracking was present close to the edge of the fracture on portion B, Figure 16a.
- 1.1.17. On the adjacent fracture surface, there was a small region of relatively old corrosion product, Figure 16b. The fracture was observed to coincide with the trough of the character that resembled the number '0' in what appeared to be an identifier on the casting.

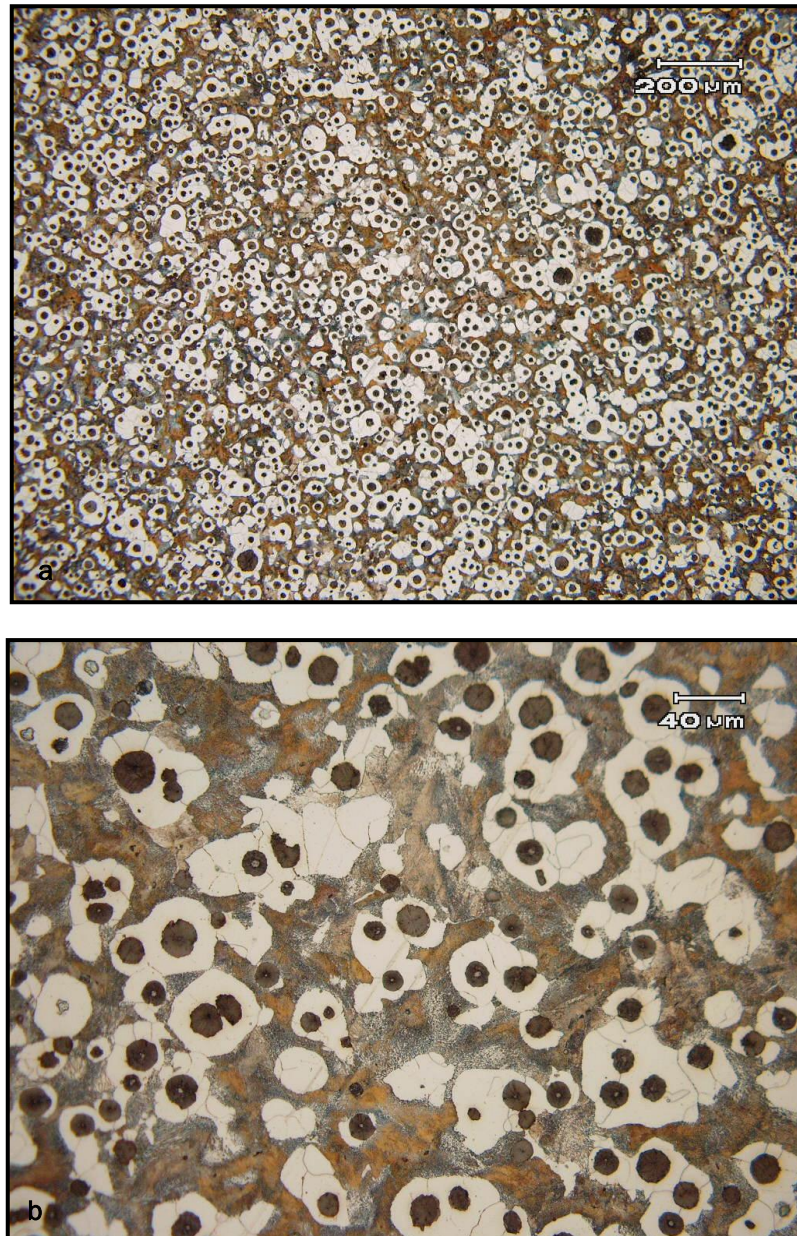
Figure 17
Microstructure of the bearing adaptor

- 1.2.1. A piece of material was taken from the end of one of the arms and prepared metallographically for examination under the optical microscope. The structure was consistent with a nodular (spheroidal graphite) cast iron, Figure 17. There was a high but normal density of graphite nodules, Figure 17a. The graphite nodules were predominantly surrounded by ferrite; however, several nodules were associated with pearlite, Figure 17b. The pearlite was generally fairly dense. The structure was consistent with as-cast material.
