**Report 08-113, empty push/pull passenger Train 5250, collision with platform-end stop block,
Britomart station, Auckland, 19 December 2008**

empty push/pull passenger Train 5250

collision with platform-end stop block

Britomart station, Auckland

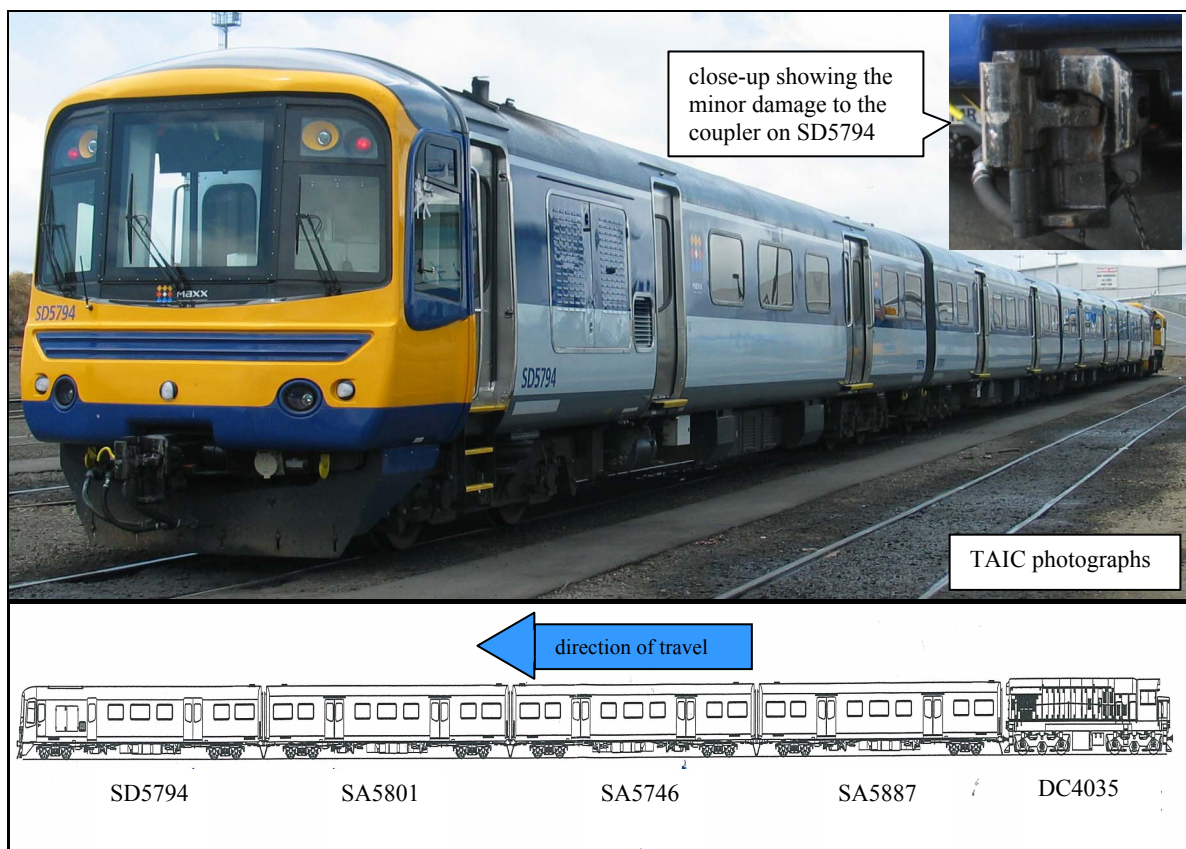
Figure 2
Image and drawing of Train 5250

- 1.1.10 In this instance and when the driver felt the train was not slowing sufficiently, he made a full service brake application followed by an emergency brake application, but Train 5250 collided with the stop block at the end of platform 2 at a speed of about 2 km/h. The coupler on SD5794 sustained minor damage. The stop block was also damaged.

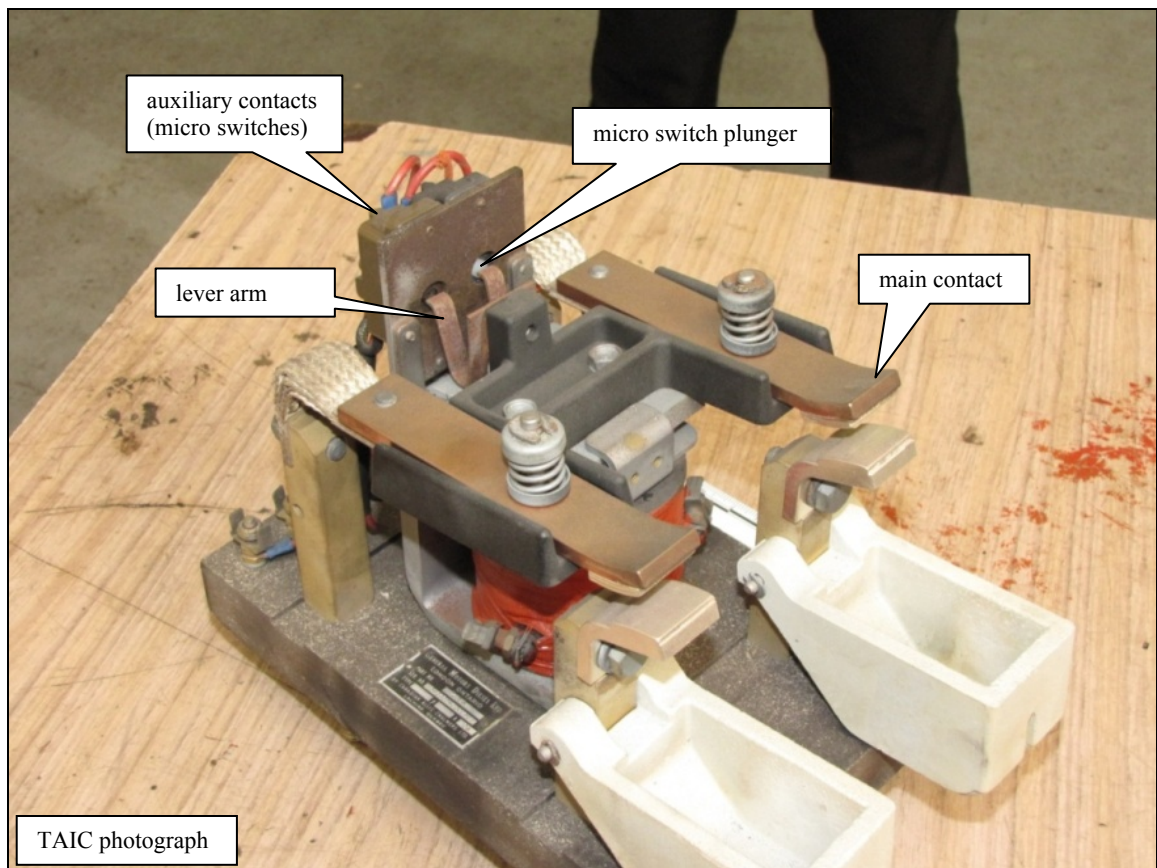
Figure 3
BK contactor

1.2.7 On 23 December 2008, KiwiRail mechanical engineers found that the train brake application in the locomotive had been disabled by an incorrect operation of an auxiliary contact fitted to a “braking contactor” (BK contactor) within the electrical circuitry/air brake system of DC4035. The auxiliary contact had an interlock function that under normal operation would have prevented the automatic air brakes applying on the locomotive when dynamic braking was selected. This would have been achieved by the auxiliary contact activating an air dump valve on the locomotive’s brake system.

1.2.9 Two auxiliary contacts were physically connected to the BK contactor so that the normal movement of the BK contactor closing would actuate 2 micro switches. The micro switches were enclosed devices screwed to a mounting plate on the body of the BK contactor. The micro switch actuating plungers passed through the mounting plate and made physical contact with a lever arm on the moving part of the BK contactor (see Figure 3).

- 1.2.10 The nature of the fault was a mechanical clearance error that resulted in one auxiliary contact jamming in the “closed” position instead of opening when the BK contactor de-energised. This had the effect of “tricking” the system into thinking the dynamic braking had been engaged when the locomotive throttle was advanced to notch one or above, activating the air dump valve through an electrical back-feed that prevented the locomotive’s air brakes applying.

- 4.4 Because the failure of an auxiliary contactor was a single point of failure affecting a safety-critical system, the circuit was redesigned to include a blocking diode that would prevent a back-feed in the event of failure. This will considerably lower the risk (2 components would need to fail) of this failure adversely affecting the braking system.
