**Report 08-202, coastal bulk carrier *Anatoki* and bulk carrier *Lodestar Forest*,  
collision, Tauranga Harbour roads, 28 April 2008**

**Report 08-202**

**coastal bulk carrier *Anatoki* and bulk carrier *Lodestar Forest*  
collision**

**28 April 2008**

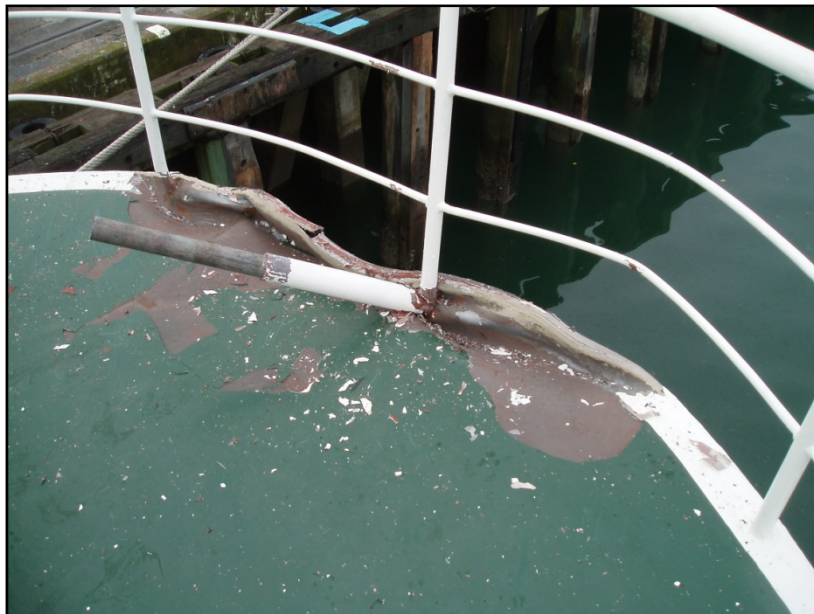
**Figure 5**  
**Damage sustained by the *Anatoki***

- 1.6.1 The *Anatoki* sustained damage to the bow consisting of the jack staff being bent, the shell plating on the centreline was deformed and indented to a depth of approximately 200 millimetres (mm).

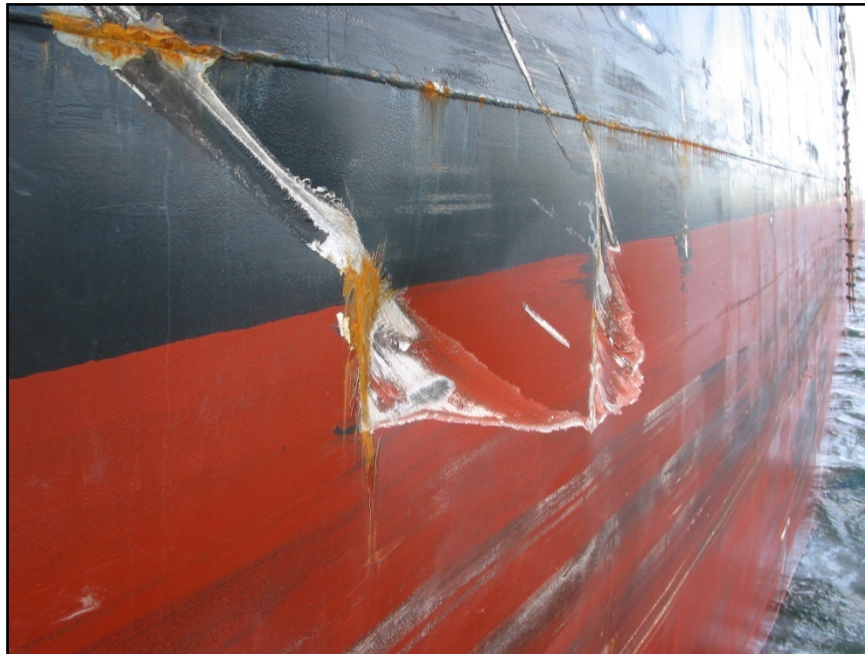
**Figure 6**  
**Damage sustained by the *Lodestar Forest***

- 1.6.2 The *Lodestar Forest* sustained damage to the starboard side shell plating in way of number 5 hatch where the plating was indented about 30 mm between frames 42 and 45.
