**Report 08-203**

**Passenger Ferry  
*Monte Stello***

**Loss of Power**

**2 May 2008**

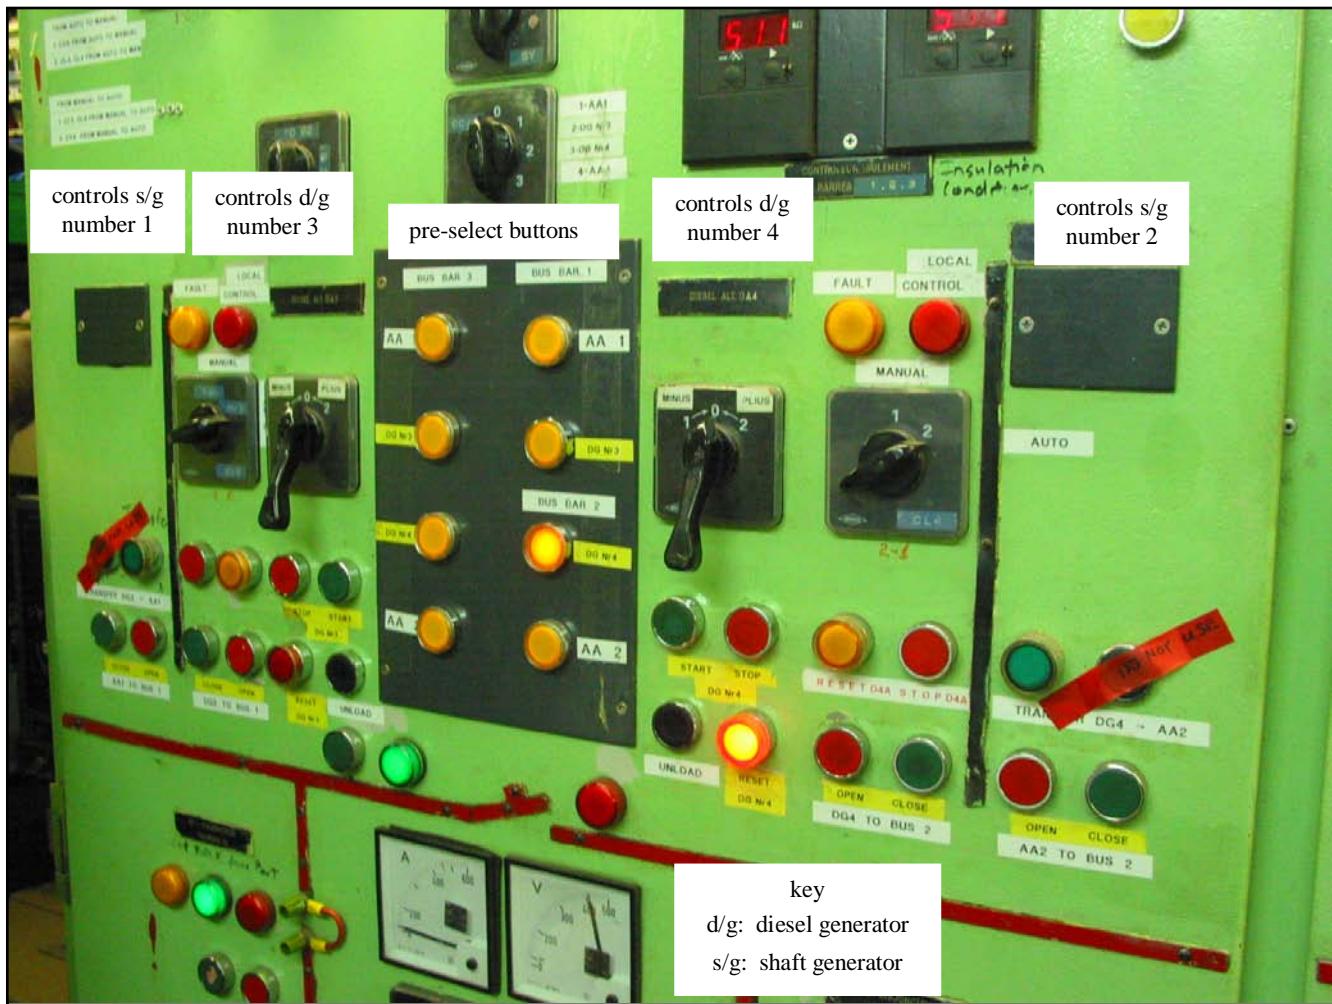
**Figure 3**  
**Main switchboard generator controls**

- 1.3.16 The photograph in Figure 3 was taken after the incident and before repairs were made to the alarm PLC. At the time diesel generator number 4 was connected to bus-bar number 2 and feeding bus-bar number 1 through the bus tie CB1 (see Figure 2). The reset light for number 4 diesel generator was illuminated indicating a fault with the generator which would normally prevent its operation, as was the case during the power failure.

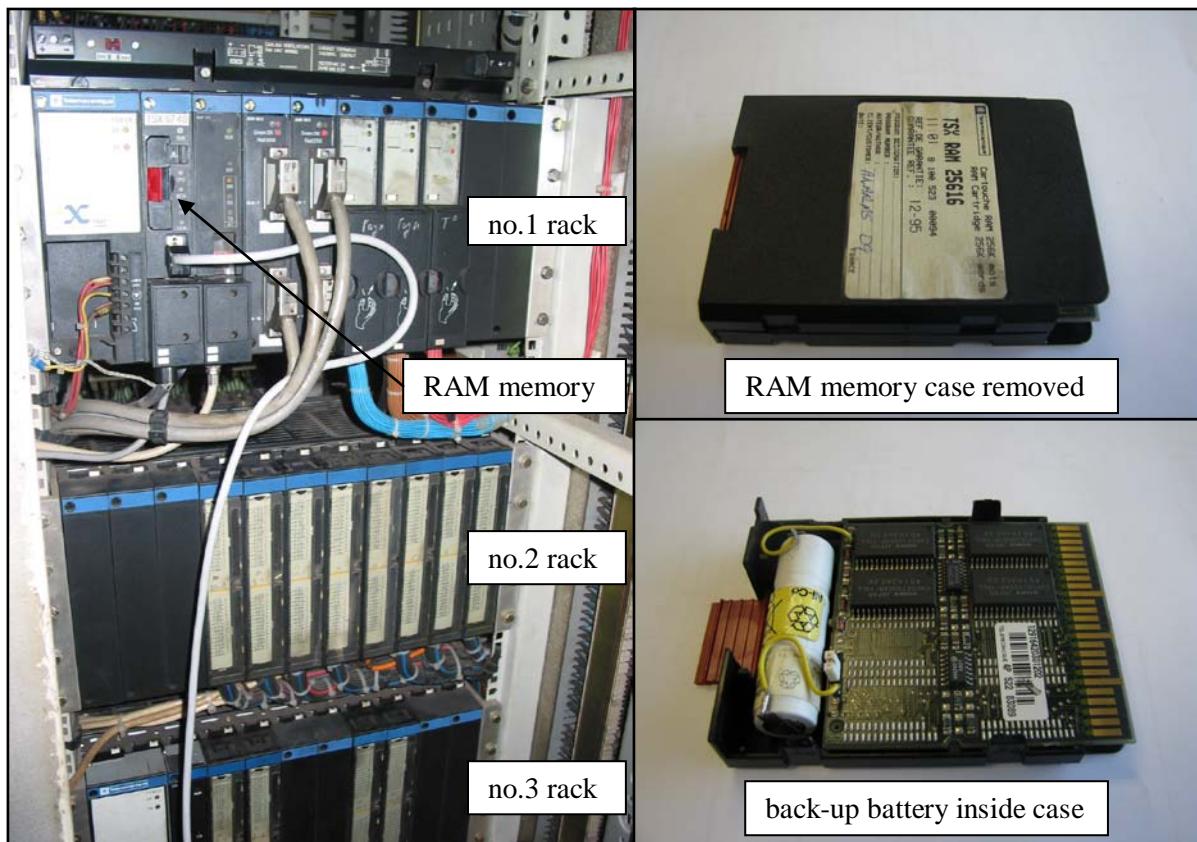
**Figure 8**  
**Alarm PLC and processor memory**

- 1.7.2 The PLC program was stored in a battery-backed RAM. The battery was a 3.6 volt nickel cadmium rechargeable battery that fitted inside a case in the central processor unit card. It could not be replaced without stopping the PLC (see Figure 8).

- 1.7.3 The technical staff on-board were concerned that if the PLCs were powered down to carry out maintenance, some or all of the RAM back-up batteries would not support the PLC memories. If the battery could not support the RAM when normal supplies were turned off, the control program would be lost. This situation would have rendered the PLCs inoperable and could have effectively disabled the ship.

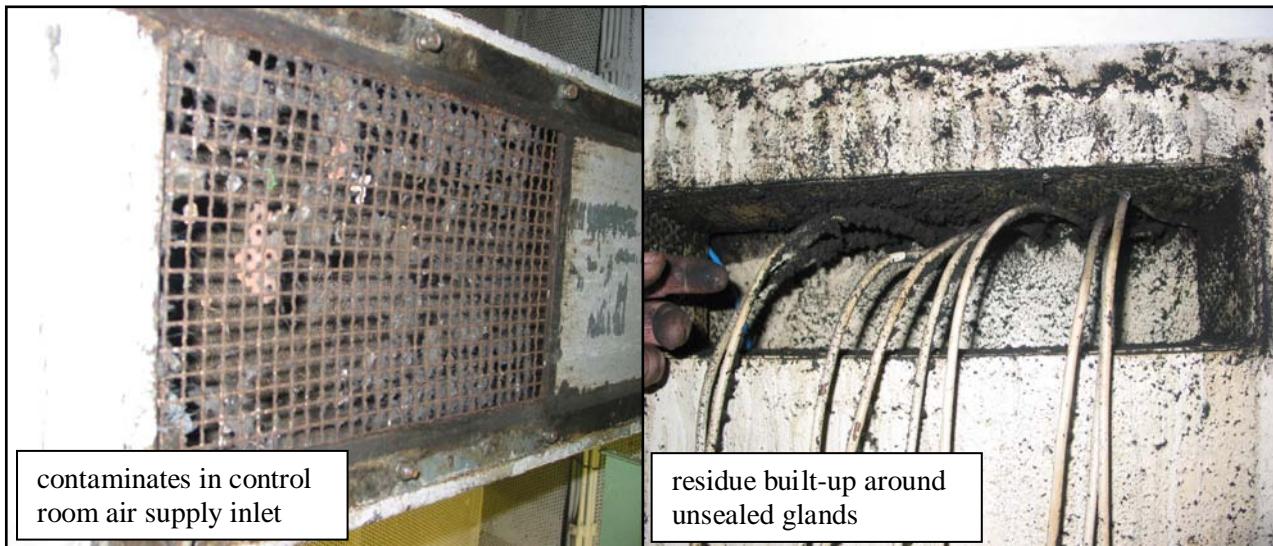
**Figure 9**  
**Control room air supply and atmosphere**

- 1.7.6 The right-hand photograph in Figure 9 shows the carbon residue on the outside of the control room where contaminated air from the engine room had been leaking through a poorly sealed cable entry duct. Strait Shipping said that the carbon deposits had been accrued from large exhaust leaks in the main engines under the previous owner's operation, prior to the ship's arrival in New Zealand. These leaks were fixed by Strait Shipping when the ship arrived in New Zealand.

- 1.7.7 It is not unusual for the atmosphere in an engine room to be at a higher pressure than that in the control room. This pressure differential can be higher during periods when main engines are running at reduced power, requiring less air than that provided by the ventilators. On the *Monte Stello* contaminated air from the engine room was forced into the control room through the unsealed cable glands and covers. The main switchboard was not completely covered and components were not protected from this atmosphere. This air was also drawn through the unfiltered PLC ventilation fans and blown over the PLC components (Figure 10).

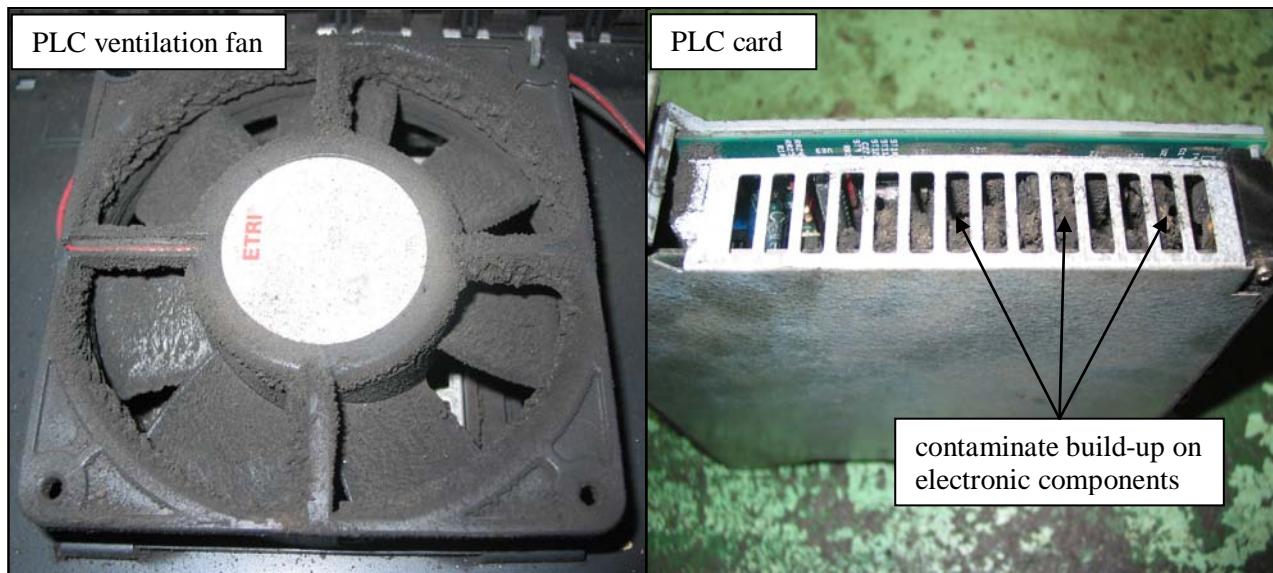
**Figure 10**  
**Greasy carbon deposits on alarm PLC components**

- 1.7.8 All of the 3 remaining original PLCs were covered with a greasy carbon residue and other particulates typically produced by diesel engines running on intermediate fuel. Each of the original PLCs was cooled by two small fans which blew unfiltered air from the control room over the cards in each rack and contaminate was observed inside the PLC card (see Figure 10).

- 2.25 The physical condition of the PLC was not ideal, with greasy carbon deposits from years of unfiltered cooling air built-up within the case and across the cards within the unit. Switching the unit on and off again in an attempt to re-boot the system did not work, even when an alternative power supply was connected to it. The nickel cadmium battery backing up the RAM was later tested and found okay, so re-booting the system should have restored it. The fact that it did not supports the theory that there was a fault within the alarm PLC. However, as mentioned above, this alone should not have disabled the generators because the alarm PLC performed a monitoring function only.

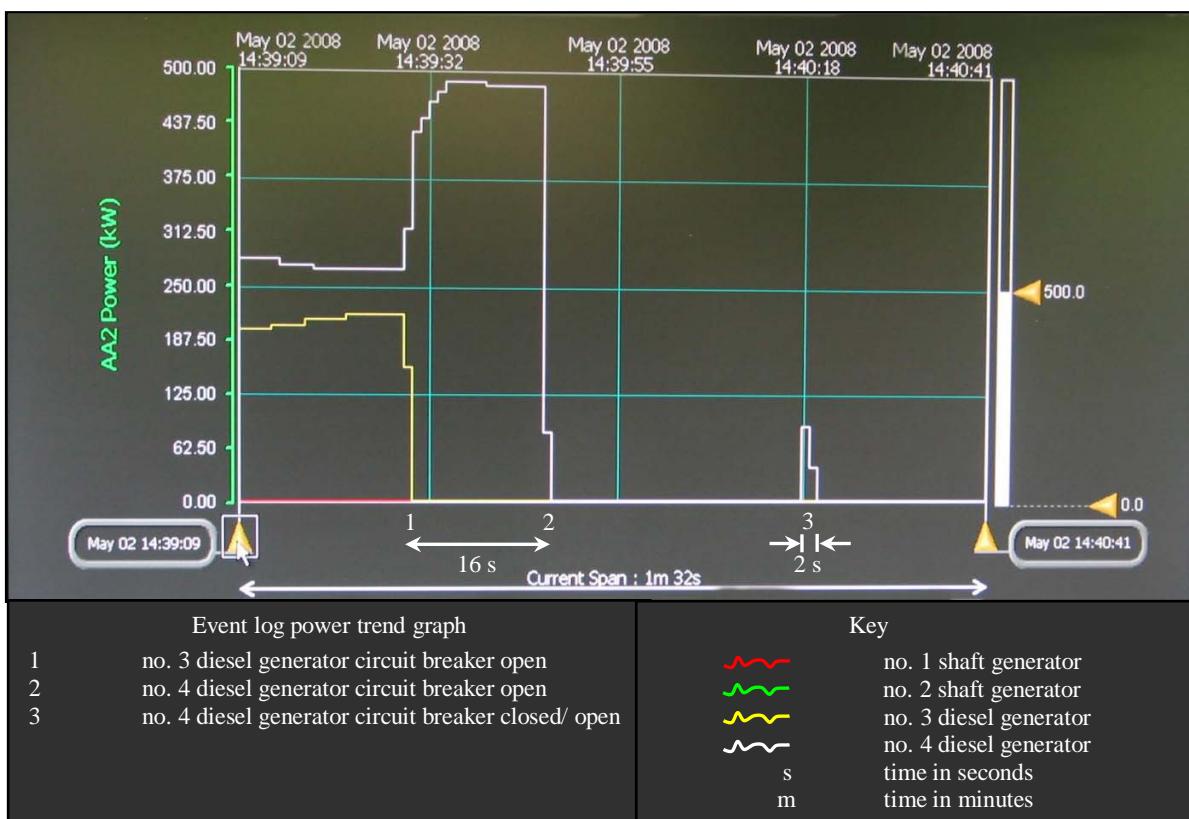
**Figure 13**  
**Load trend graph at time of power loss**

- 2.15 Figure 13 shows that prior to the power interruption number 3 and number 4 diesel generators were supplying a combined load of about 488 kW. At 14:39:28, number 3 diesel generator instantaneously shed its load. At the same time the load shed by number 3 generator was taken up by number 4 diesel generator. The resultant total load on number 4 generator was less than its design rating, meaning that it should not have been overloaded.

- 2.16 After several seconds the load on number 4 diesel generator stabilised for about 16 seconds before its circuit breaker opened also. There was then no power supply to either number 1 or 2 bus-bars, after which the main engines protection devices operated shutting the main engines down.

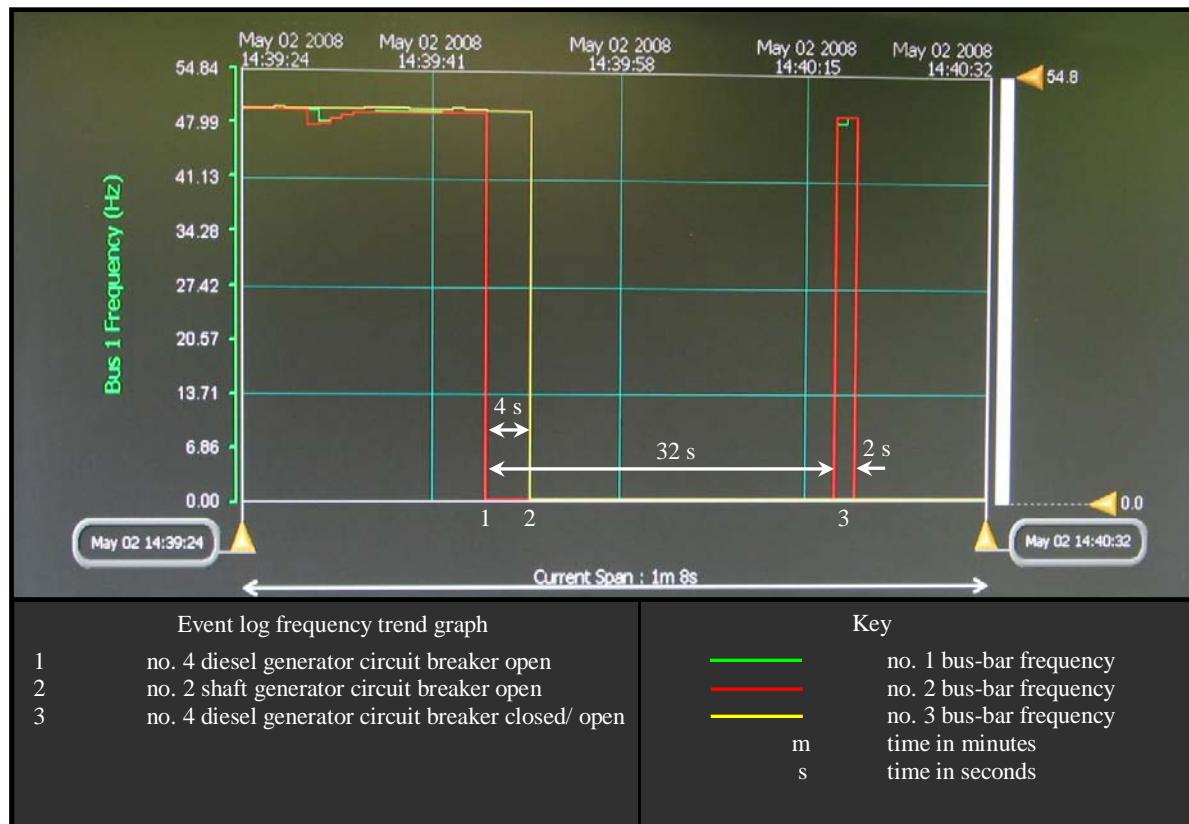
**Figure 14**  
**Frequency trend graph at time of power loss**

- 2.17 Figure 14 shows the generator frequency trend over the initial period of the black-out. It shows that prior to either generator circuit breaker opening there were no large fluctuations in frequency on the bus-bars. A conclusion can be drawn that both diesel generators stopped supplying load due to their respective circuit breakers opening rather than due to a fault on either generator. Supporting this conclusion was that a mechanical or running fault on either diesel engine (e.g. fuel starvation) would be expected to show some fluctuations in the bus-bar frequency as the generator automatic voltage regulator (avr) responded to changes in the engine speed, which was not the case. The frequency was steady until the instantaneous trip occurred.
