**Report 08-205: fishing vessel, San Cuvier, dragged anchor and grounded,  
Tarakeha Point, Bay of Plenty, 27 July 2008**

**Report 08-205**

**fishing vessel  
*San Cuvier***

**dragged anchor and grounded**

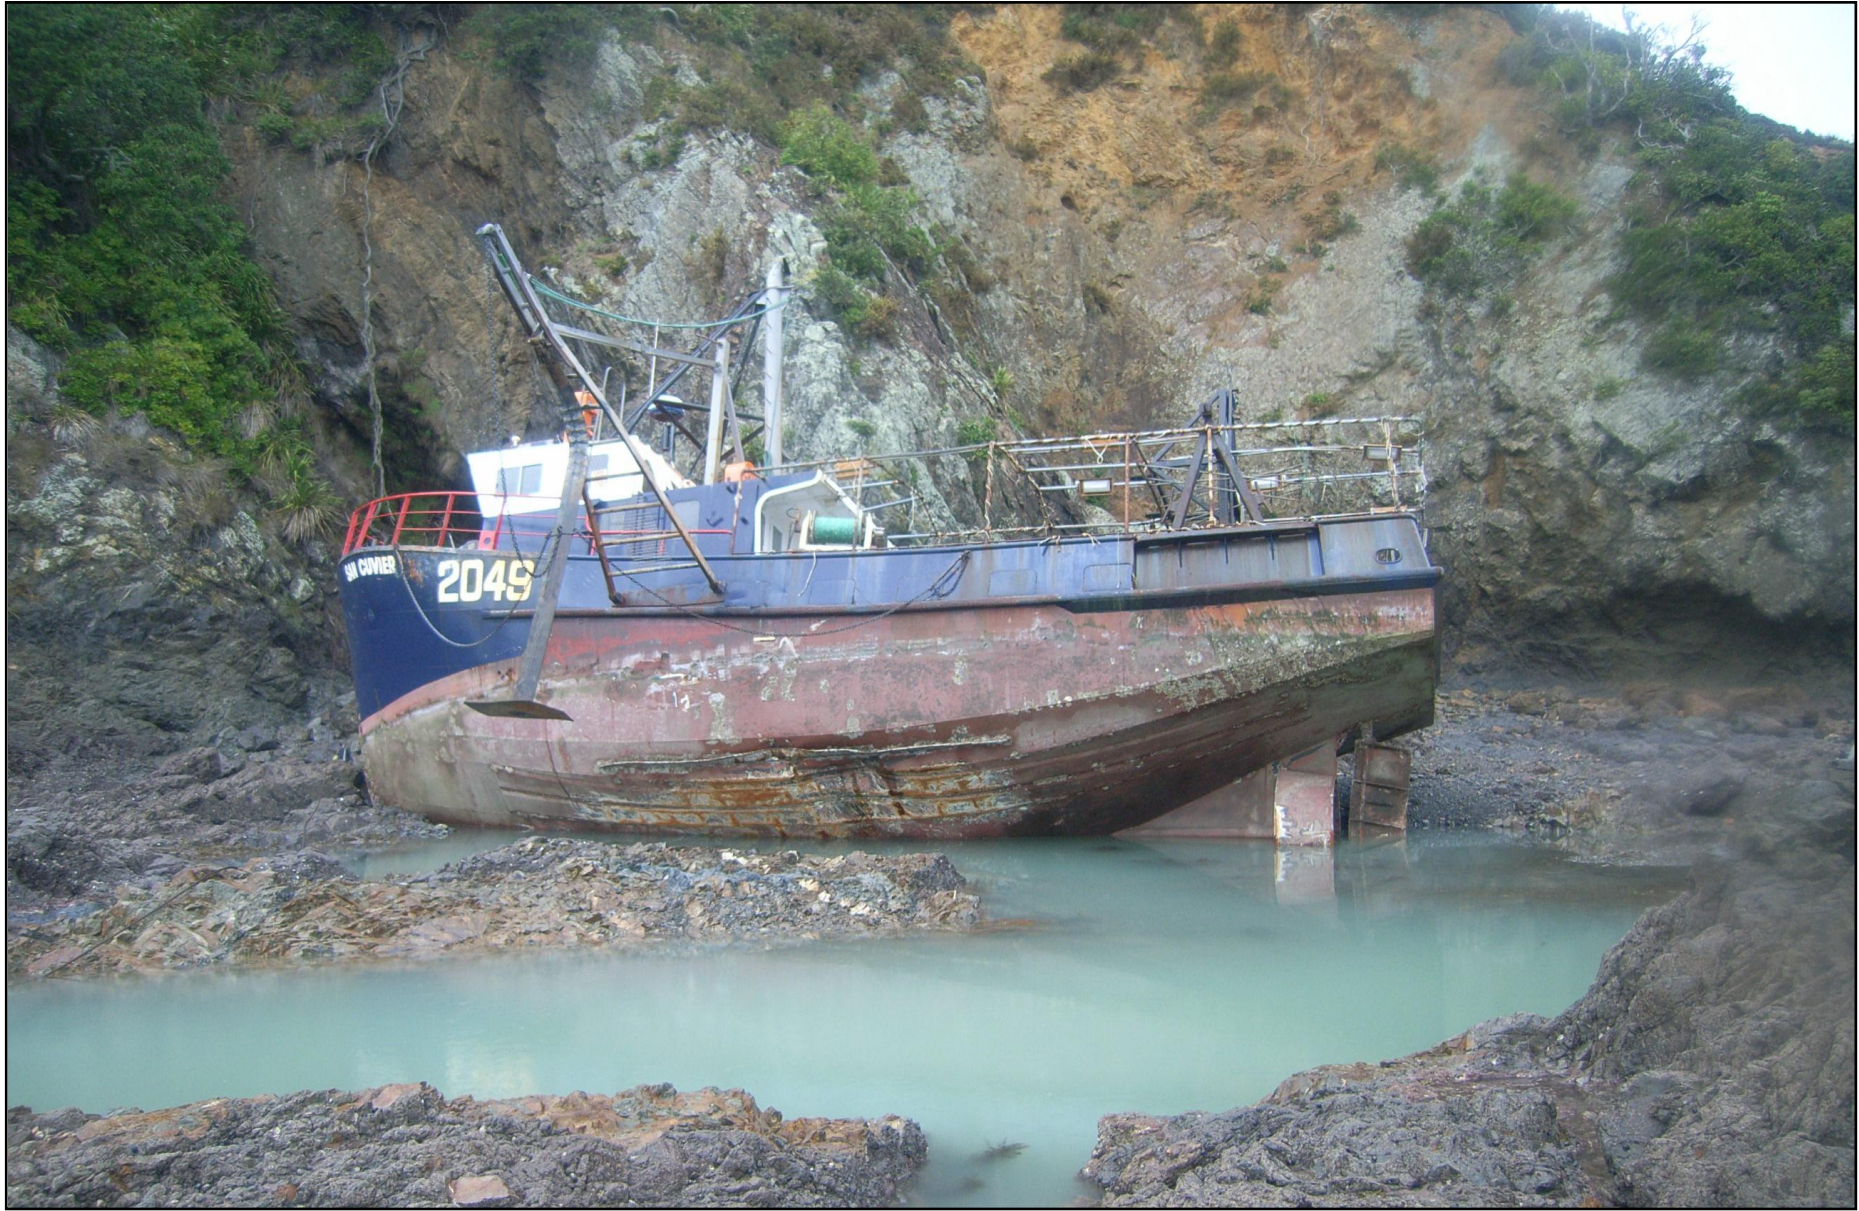
**The *San Cuvier* aground at Tarakeha Point**

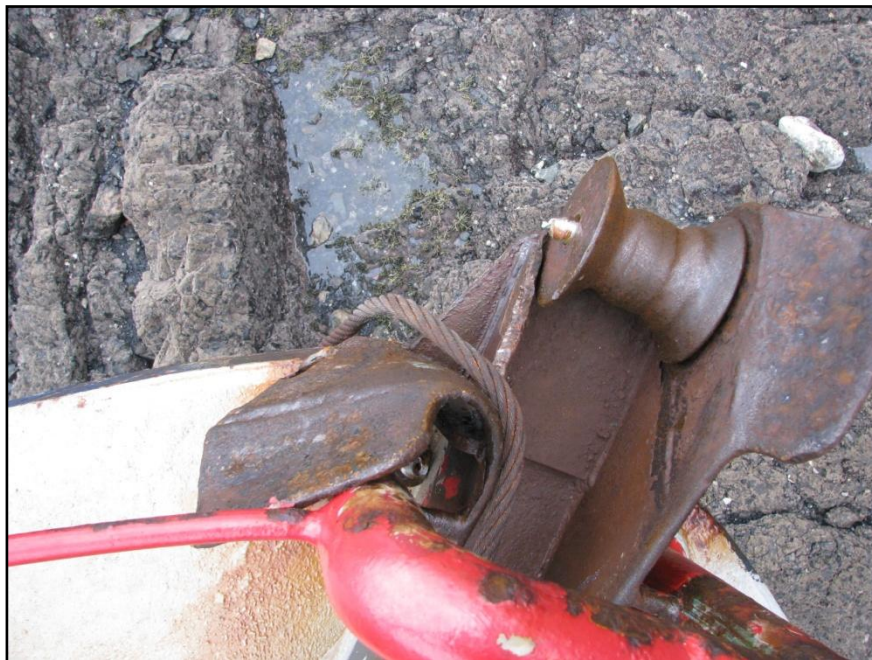
**Figure 5**  
**Damaged forward fairlead**

1.5.1 The damage to the vessel was largely superficial:

- the fishing equipment on the afterdeck was strewn around the deck or washed overboard, and the canvas awning was in tatters
- the bulwark on the starboard side was stove-in and there was severe denting on the upper part of the hull where the vessel had been rolled onto the rocks
- the gantry and mast on top of the deckhouse was bent with the topmost section missing probably from where it had made contact with an adjacent rock when the vessel rolled to starboard
- the anchor warp fairlead on the bow was damaged, with the port cheek torn and bent through more than 90 degrees (°) (see Figure 5), almost certainly from the extreme weight that had come onto the anchor warp
- the vertical arm of the stabiliser was bent at right angles, from the vessel rolling to port during the grounding.

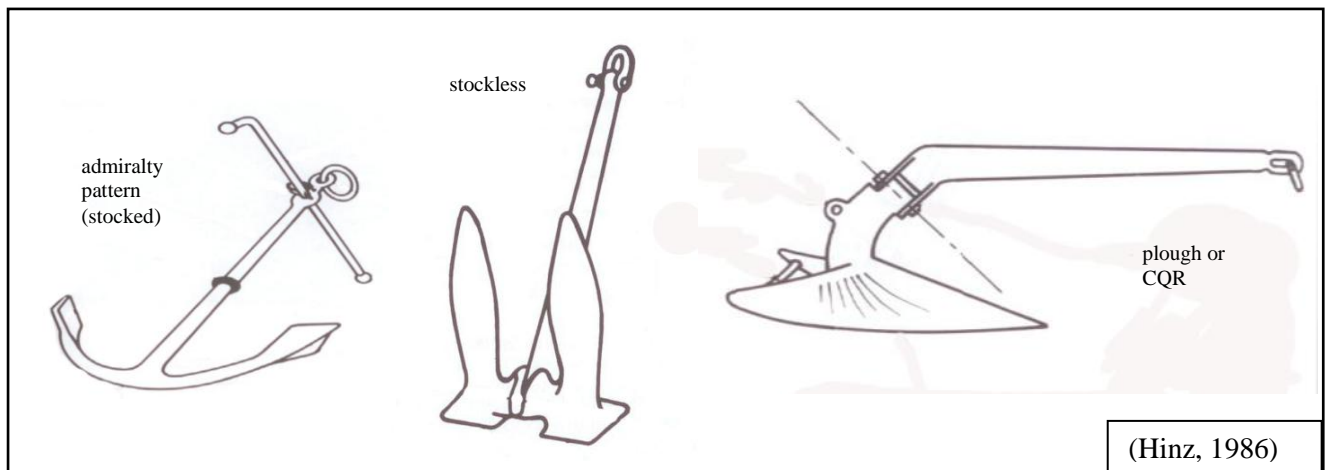
**Figure 6**  
**Types of anchor**

- 1.6.4 The safe ship management documentation showed that the *San Cuvier* had been fitted with 2 anchors, a 115 kg stockless anchor and a spare 81 kg stocked anchor (see Figure 6). The spare stocked anchor was still stowed on the foredeck of the *San Cuvier* after the accident. When the vessel was being broken up, the anchor wire, chain and anchor shank were recovered. The head of the anchor had parted from the shank and was not recovered. The recovered anchor shank (see Figure 7) was that of a plough or CQR type anchor and not that of the documented stockless anchor. There was no documentation concerning the change of anchor nor could the operator confirm when the new anchor had been fitted to the vessel. On its recovery, the anchor shank was photographed by an insurance assessor before being transported, together with the wire warp, and chain to a rope warehouse in Auckland. On its arrival there, the warp and chain were measured and tested before being stored in the warehouse yard. A sample of the 19 mm 6 x 19 galvanised wire rope was tested to destruction, breaking at 28 000 kg. The 24 mm regular link chain of the anchor cable was tested to 23 000 kg, where it stretched but did not break.

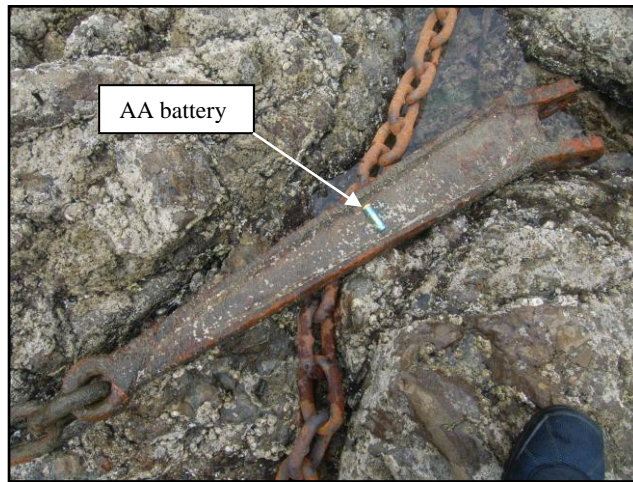
**Figure 7**  
**The recovered anchor shank**

Determining the size of an object from a photograph is more complex than might first appear, and does involve some estimation and allowance for the parallax of the object in the camera lens. The estimation of the weight of the anchor did vary considerably, with one maker estimating between 48 kg and 64 kg.

- 2.19 The main anchor on the *San Cuvier* was estimated to weigh less than the weight prescribed in the Maritime Rules, and it was estimated to be less than the high-holding-power equivalent of the stockless anchor that it replaced. The length of chain and wire was sufficient to meet the provisions of the Maritime Rules for length of anchor cable. It is not known for sure whether an anchor of the correct size would have held under the conditions in the bay that night, but probably not, again emphasising the need for an appropriate anchor watch to be kept.
