**Report 08-207, Commercial jet boat Kawarau Jet No. 6, roll-over, Confluence of the Kawarau
and Shotover Rivers, 25 September 2008**

Report 08-207

**commercial jet boat
*Kawarau Jet No.6***

roll-over

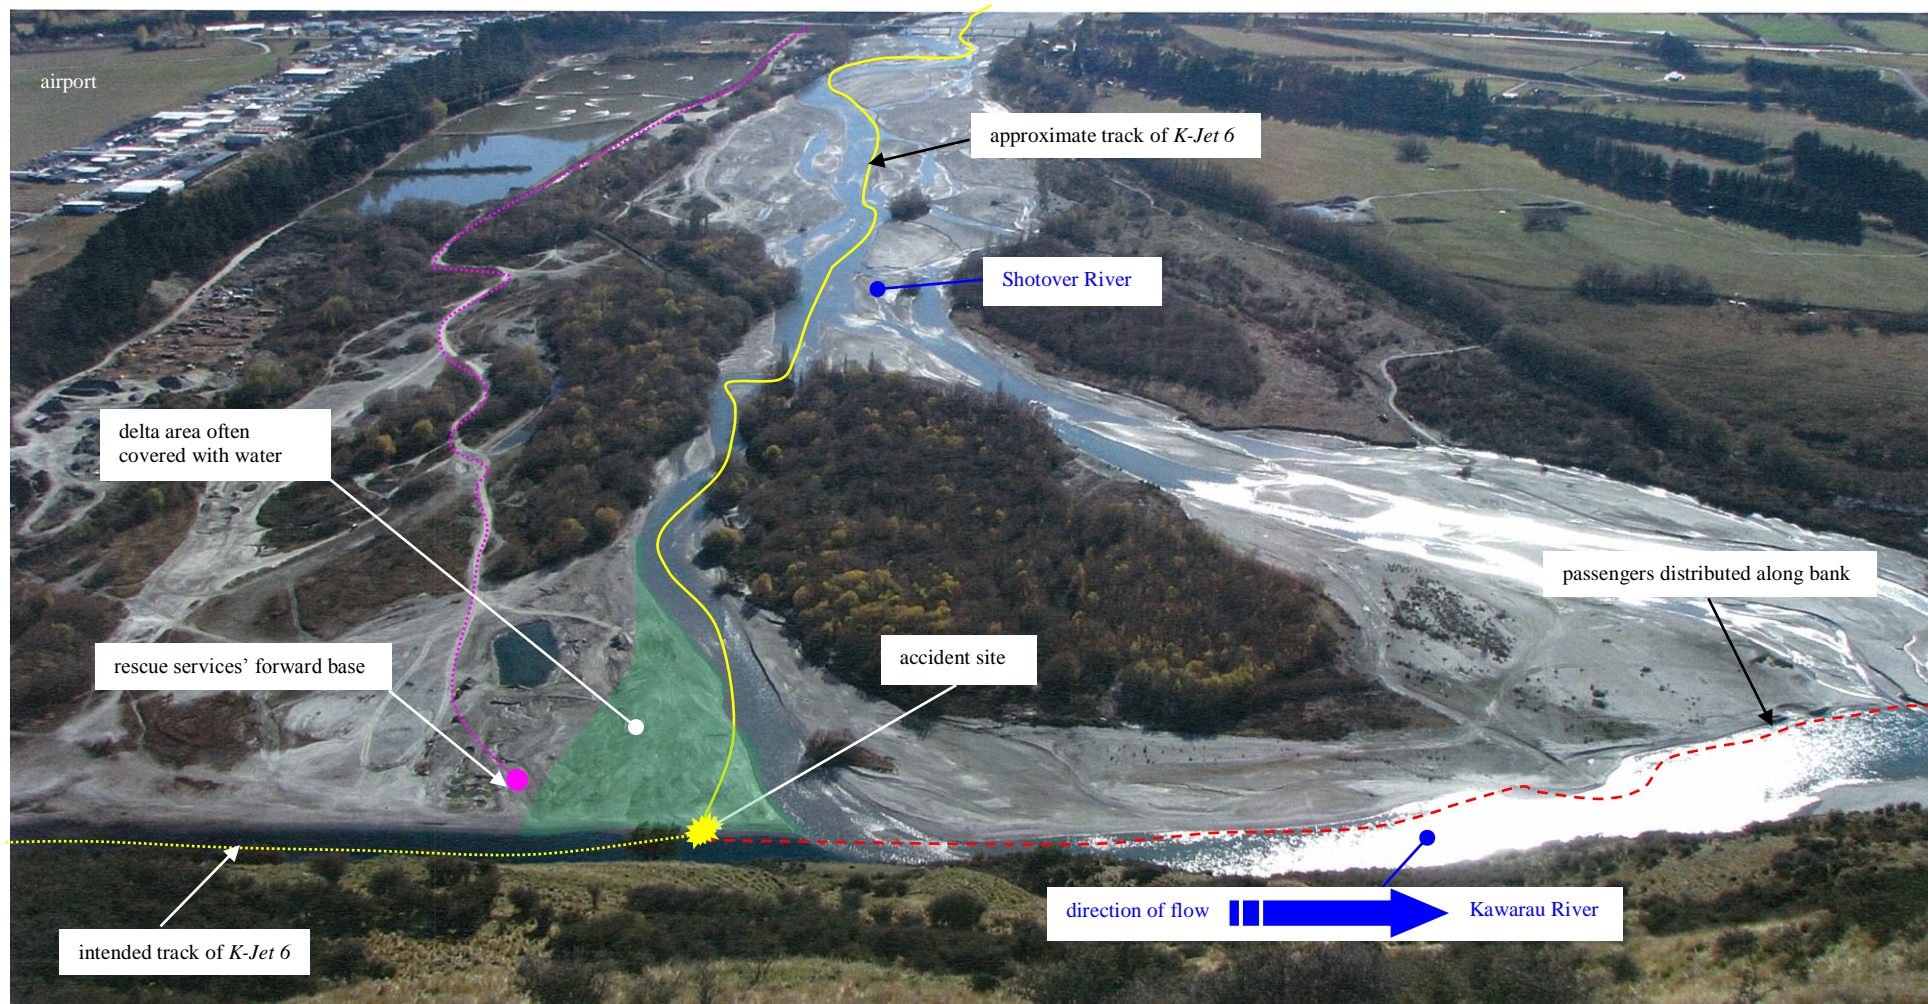
Figure 2
Shotover delta and confluence with the Kawarau River

- 1.1.10 The driver of *K-Jet 6* recalled that as he approached the confluence of the rivers he saw *K-Jet 7* cross ahead of him. He decided to veer right and cross the bar at the confluence and return directly to Queenstown without going downstream as *K-Jet 7* had done; he had done this on his previous 2 trips that day. When he looked at the bar he saw what he thought was clear water ahead of the boat, but as he adjusted his helm to turn the boat upstream, a sand bar appeared in front of the boat. *K-Jet 6* touched the bar as it was in a sliding turn to the right, the momentum causing it to roll-over and come to rest upside down.

- 1.4.7 At the confluence where the Shotover River runs into the Kawarau River, silt and debris carried down the Shotover River are deposited at the mouth in the form of a bar. This bar is always present but is prone to change in size and shape. When the river level is high enough, there can be sufficient water over the bar for jet boats to navigate across it. At other times of low river level, areas of the bar can become exposed, requiring the jet boats to follow the main channel out into the Kawarau River before turning upstream.

- 3.2 The depth of water over the sand bar was marginal for the safe passage of the fully-loaded *K-Jet 6*. The effects of interaction between the shingle bar and another fully-loaded jet boat nearby caused water to be drawn from the shingle bar, exposing it in front of the turning *K-Jet 6*.

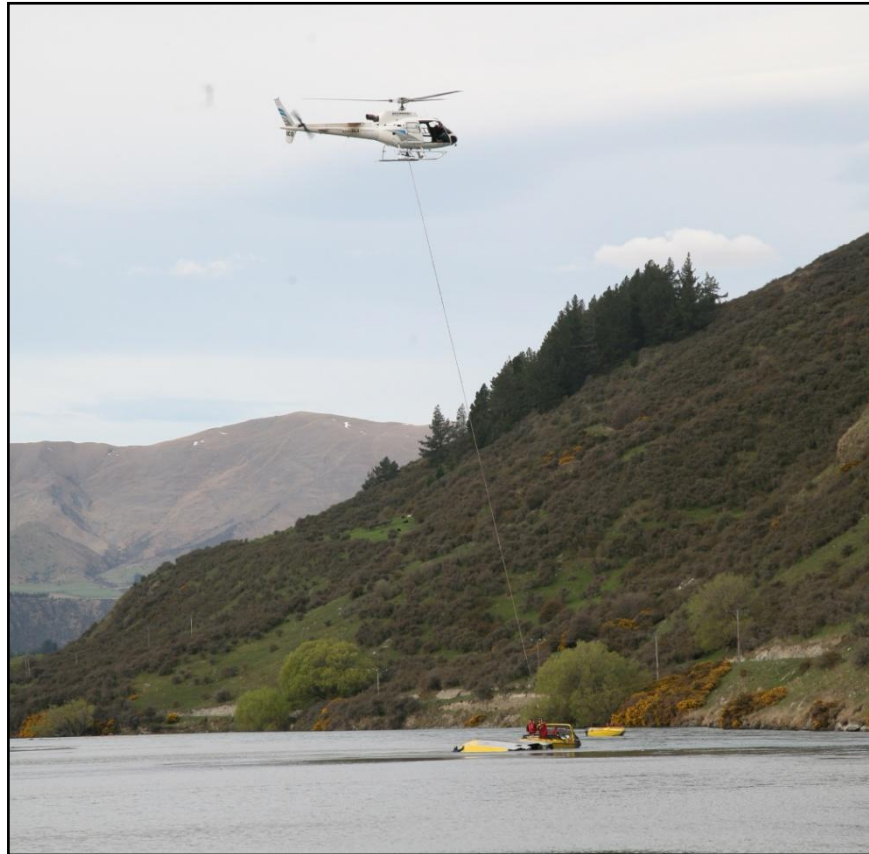
Figure 3

Helicopter lifting *K-Jet 6* to allow divers to access under boat

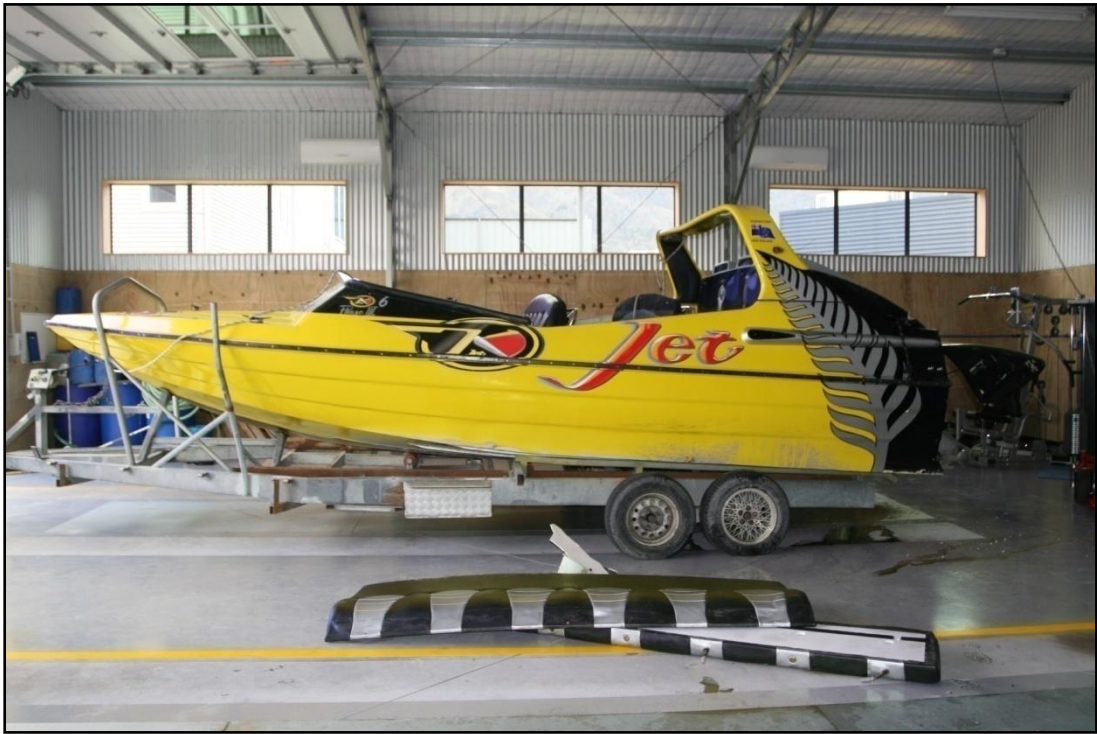
Figure 4
K-Jet 6

- 1.2.7 Apart from superficial damage to the hull and roll structure, the boat was intact. All of the control cables and linkages to the jet unit steering nozzles and reverse buckets were intact and the full range of movement was possible for all components. Both engines operated faultlessly. These findings were consistent with the driver's statement that he had not noticed any mechanical malfunction with the boat leading up to and at the time of the accident.

1.5.1 *K-Jet 6* sustained only superficial damage to the hull and roll bar.

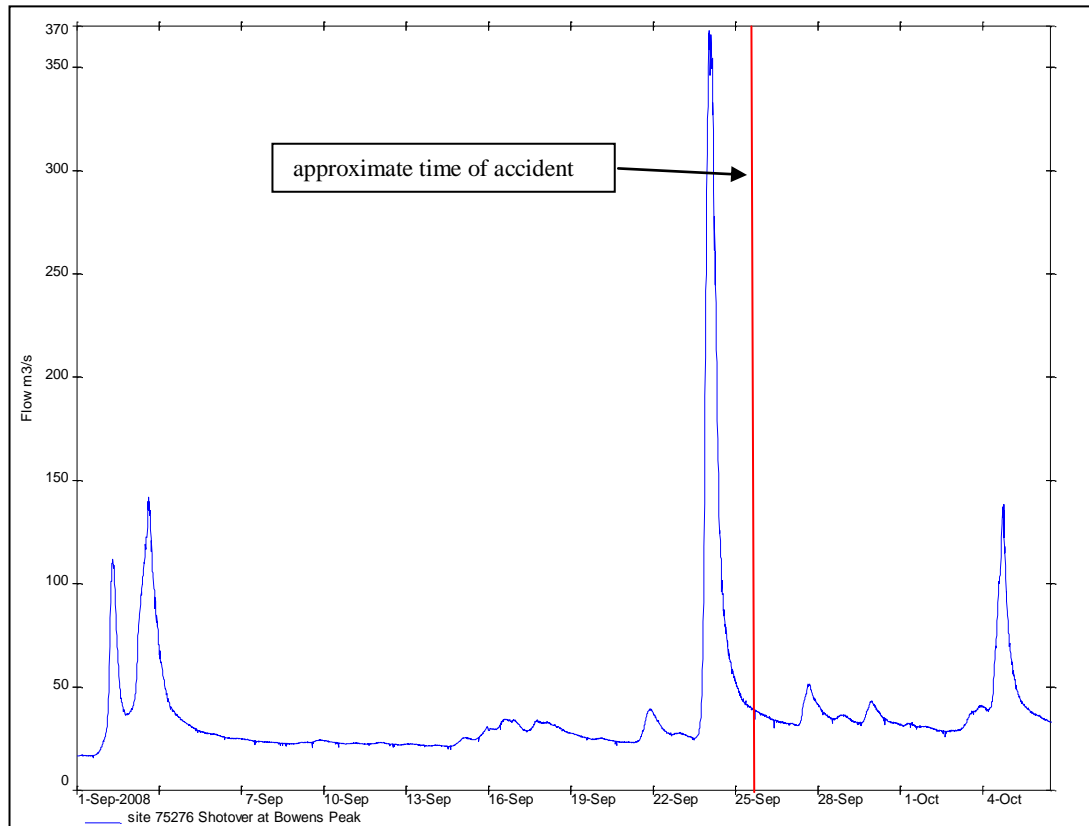
Figure 5
Shotover River flow in cumecs

- 1.4.6 Figure 5 shows the flow out of the Shotover River as recorded by the National Institute of Water and Atmospheric Research(NIWA, 2008) for the month during which the accident happened. The chart shows the large variations that can occur in river flows, particularly in the period immediately preceding the accident. At the time of the accident the river flow was between 52.5 cubic metres per second (cumecs) and 34.4 cumecs, which was considerably lower than the day before when the flow has been between 368 cumecs and 52.5 cumecs. This high flow the previous day had picked up considerable amounts of schist in the water that was still present making the water "milky" in colour and according to experienced jet boat drivers, difficult to "read".
