Transport Accident  
Investigation  
Commission

# **Final report**

***Maritime inquiry MO-2022-201***  
***Charter fishing vessel Enchanter***  
***Capsize***  
***North Cape, New Zealand***  
***20 March 2022***

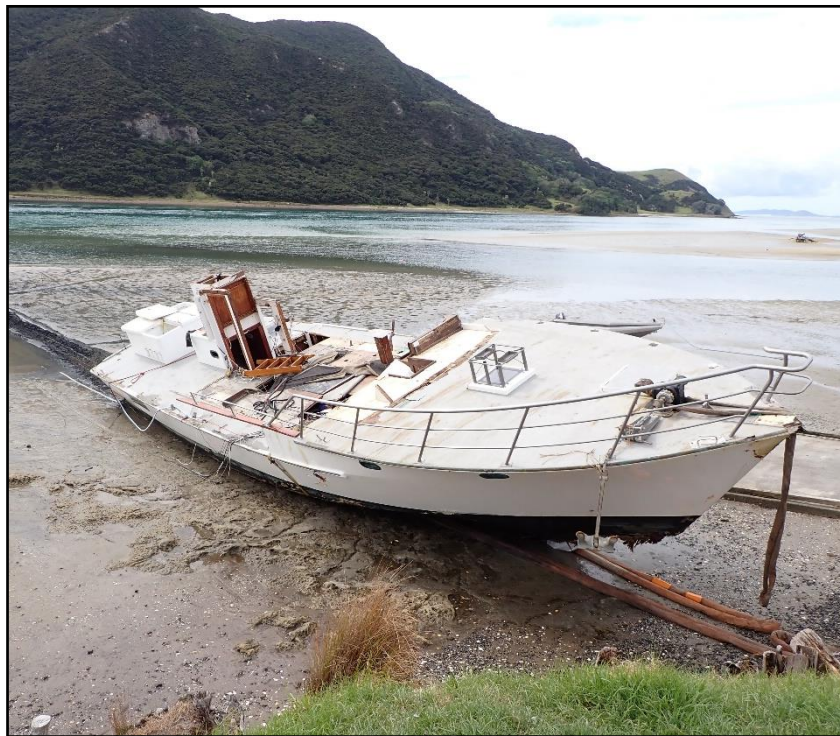
**Figure 5: The *Enchanter*'s hull on the beach at Houhora Heads**

- 2.43 Neither the flybridge from which three survivors were rescued nor any of the structure that formed the main saloon and supported the flybridge was recovered.
- 2.44 The suite of navigation equipment located on the flybridge was also lost. A second GPS located in the skipper's cabin was retrieved. Despite having been submerged in salt water for several days, the Commission was able to extract data from the memory chip. However, the GPS was an older model, so the data was encrypted in a format that yielded no useful track coordinates.

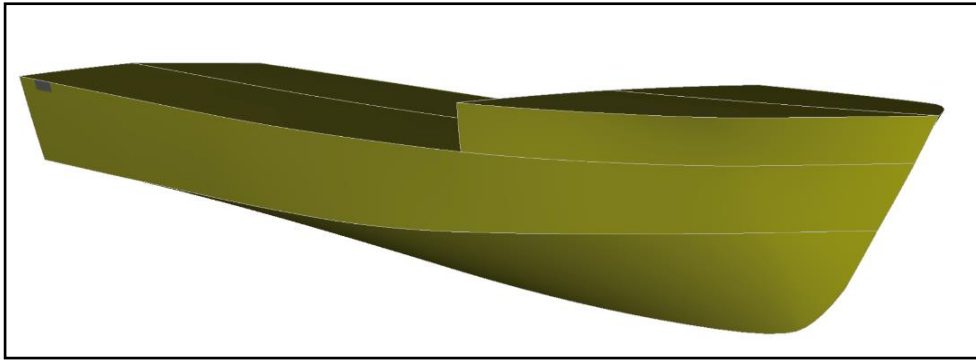
**Figure 16: Extract from the *Enchanter's* stability manual showing the modelled watertight boundary**

- 3.50 The modelled boundary was not watertight in the true sense of the word. Inside the main saloon there were openings leading to the sleeping quarters under the foredeck, the engine room, and the crew's accommodation aft, all of which would allow down-flooding<sup>40</sup> to occur should water enter the main saloon or, as in this instance, if the entire superstructure was lost when the vessel was knocked down.

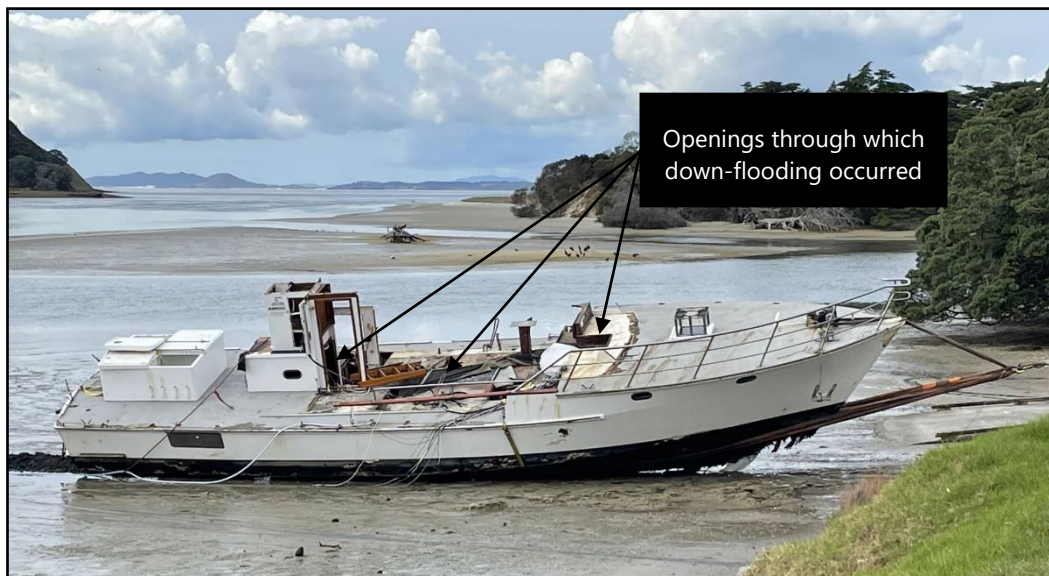
- 3.57 Post-salvage inspection confirmed that the separation of the superstructure from the hull was not because of poor maintenance. The timber around this connection was in good condition and the method of connection was generally in accordance with the standards of wooden boat building for the era of build. The wooden material had failed from simple overload. Figure 19 shows the *Enchanter* after it had been salvaged. Note the total absence of the main superstructure (see Appendix 4 for details of the post-salvage inspection.)

**Figure 19: The Enchanter after salvage**

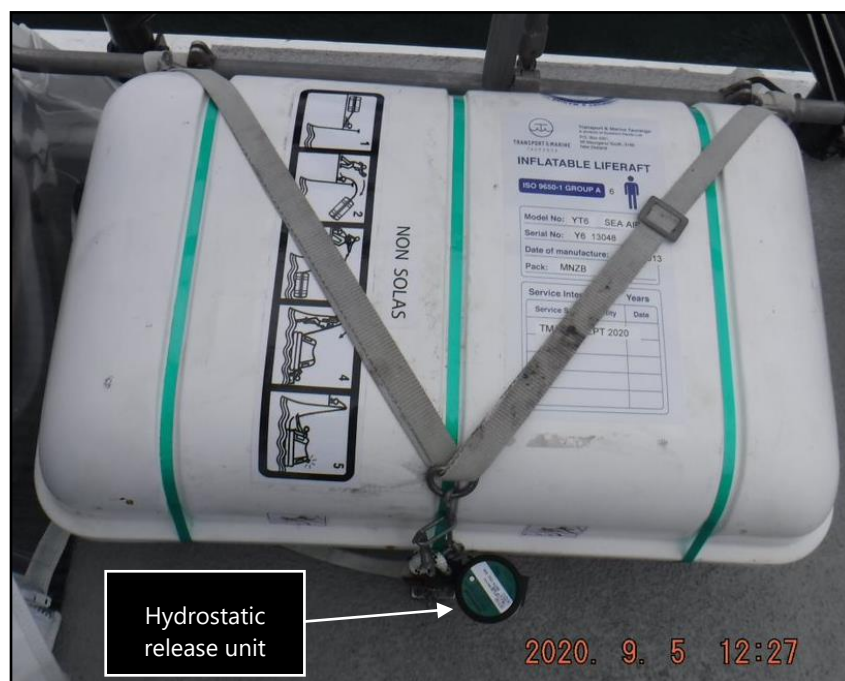
- 1.7 Due to the suddenness of the capsize none of the people were wearing or had access to life jackets, and the life rafts **likely** did not automatically deploy, which left those in the water with no or limited means of flotation.

**Figure 20: Non-SOLAS life raft fitted to the Enchanter**

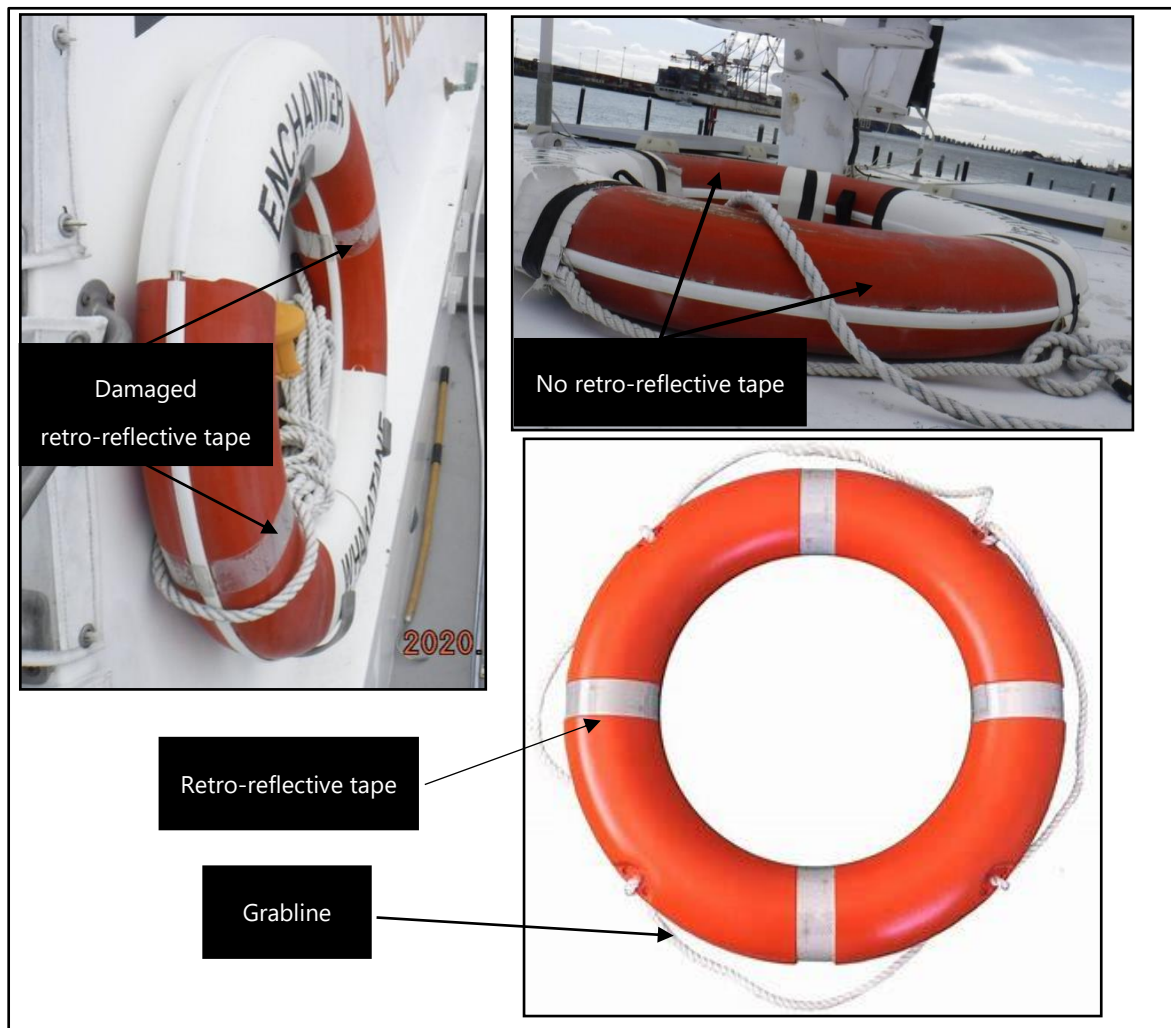
- 1.8 None of the four lifebuoys on board had effective retroreflective tape and only two had a strobe light attached. Add to this the absence of life jackets with their strobe lights and retroreflective markings, it would have been difficult to detect the missing people in the water at night.

**Figure 21: The Enchanter's lifebuoys (top left and right) and a typical compliant lifebuoy (bottom right)**

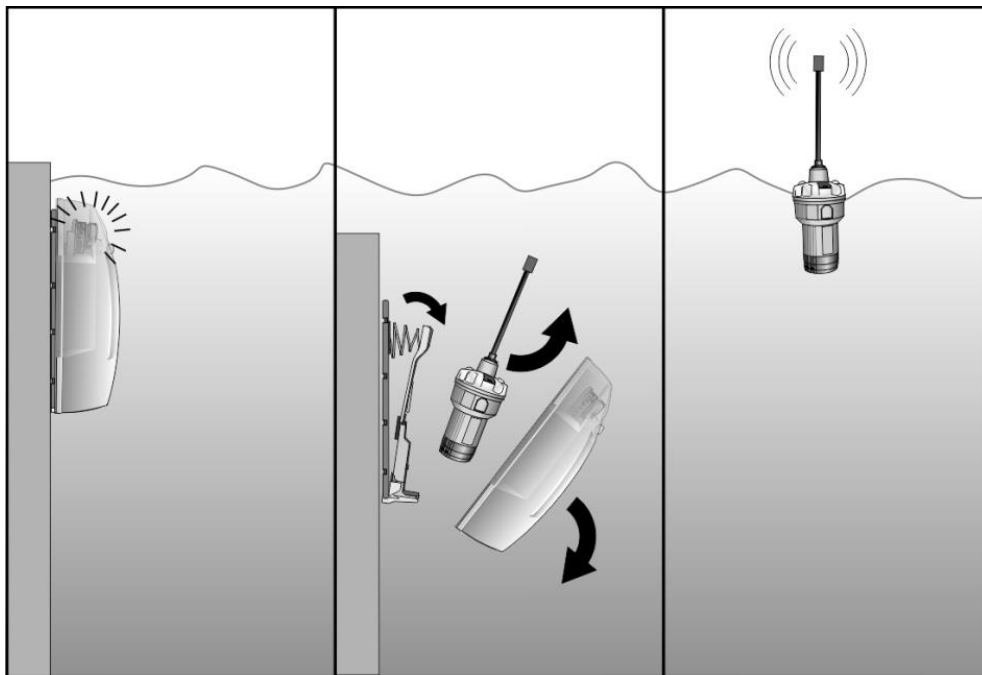
failed previously. Once the EPIRB was manually switched on it performed as designed. The fact that it did not automatically activate is of concern. Had it not surfaced right next to the skipper, it may never have activated, which would have significantly delayed the start of the search and rescue response.

**Figure 22: EPIRB automatic release sequence**

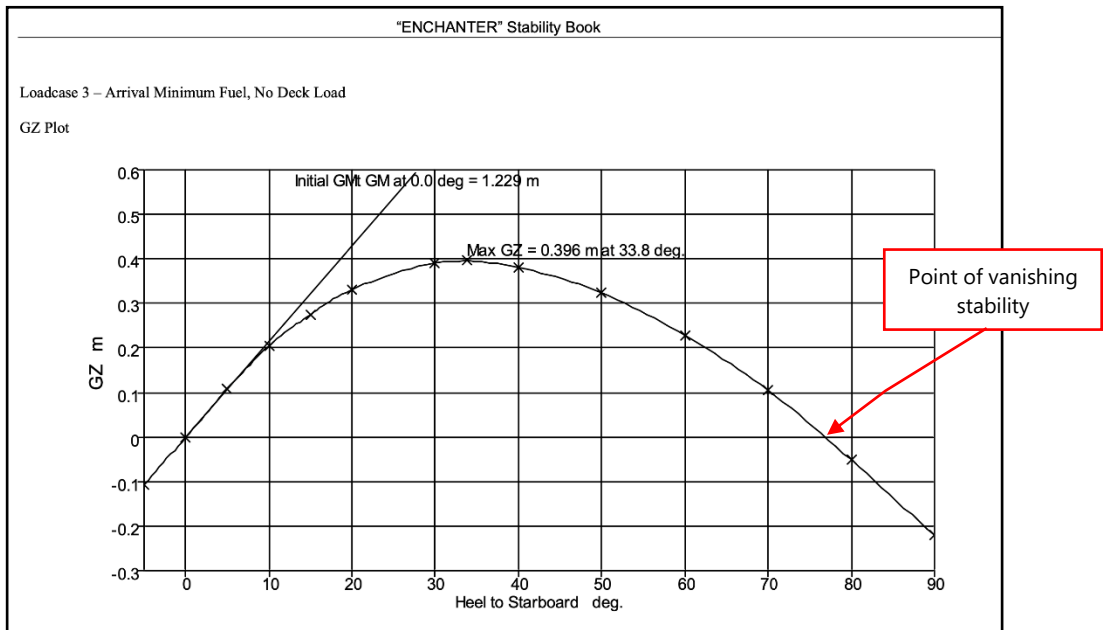
- 2.4 The value for GZ reaches zero at a heel angle of 77 degrees. This is known as the angle of vanishing stability. If the *Enchanter* heeled past 77 degrees, the value of GZ becomes negative. At that point GZ becomes a capsizing lever and the vessel will capsize.

**Figure 29: GZ curve for the Enchanter, representative of its stability condition at the time of the capsizing**  
(Source: The *Enchanter's* Stability Manual)

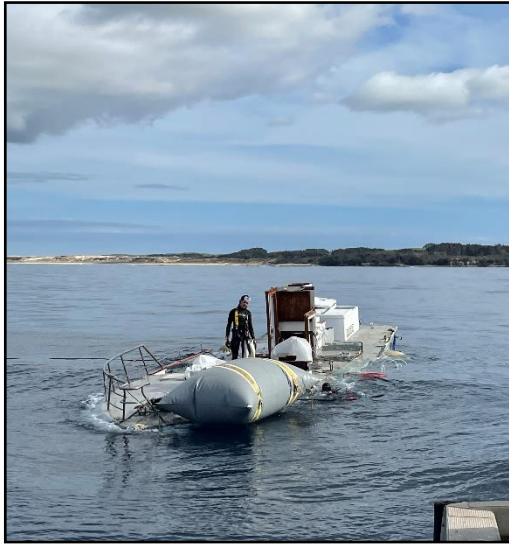
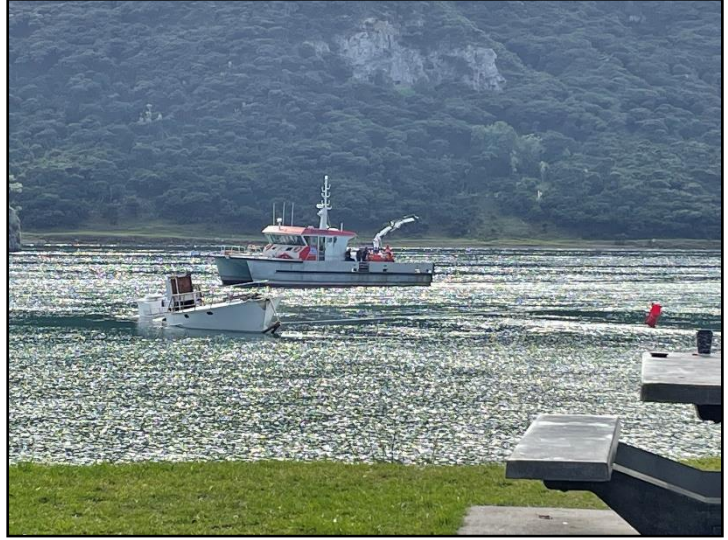
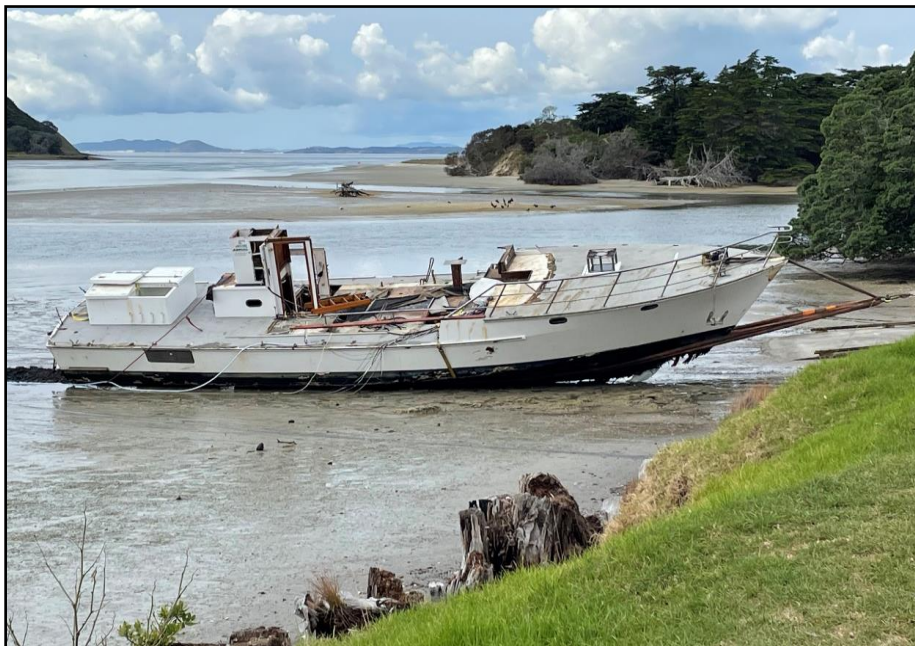
**Figure 31: The Enchanter being prepared for towing after raising (top left); being winched up the beach (top right); on the beach after salvage (bottom)**

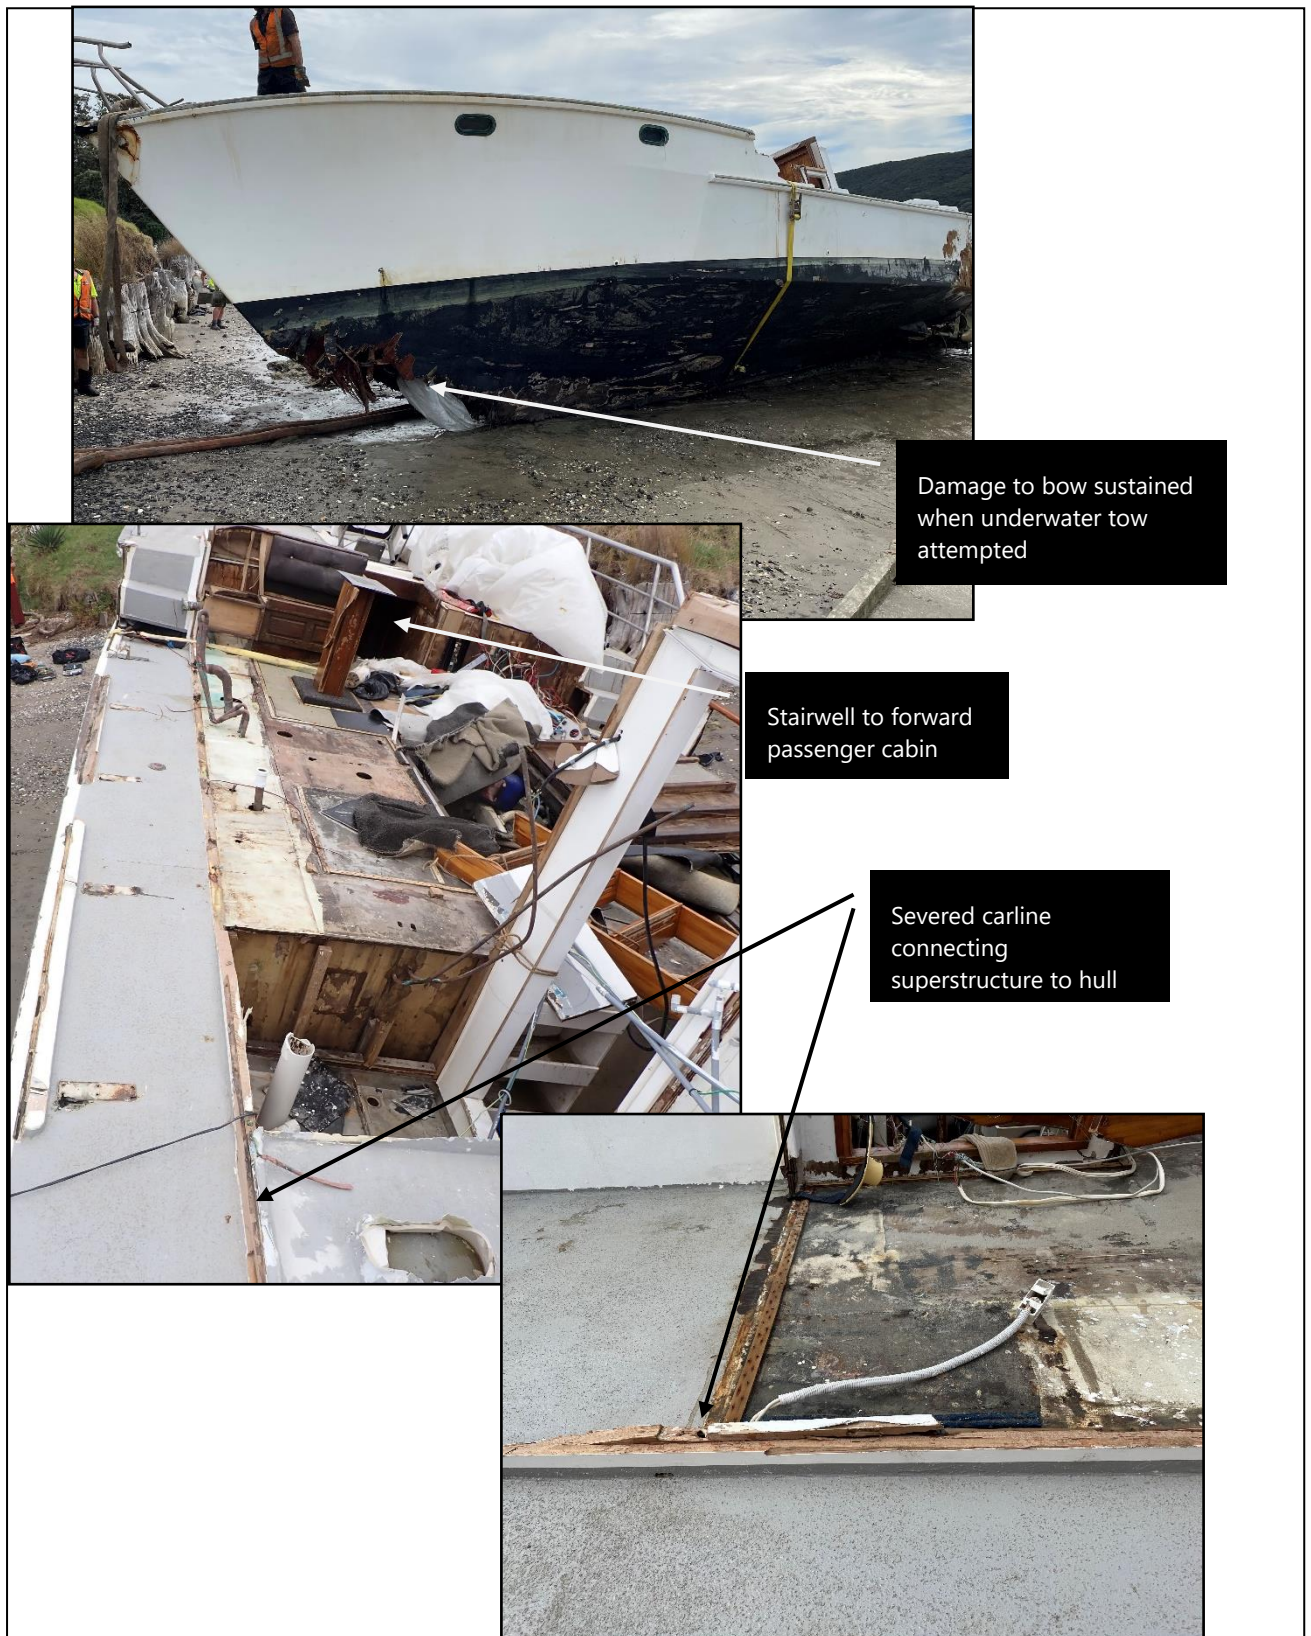
**Figure 32: The Enchanter showing damage to bow sustained during salvage (top); overview of what had been the main saloon (middle); and detail of failed connection between the hull and superstructure (bottom).**
