**Report 09-003, Fairchild SA227-AC Metroliner III ZK-NSS, runway excursion, New Plymouth  
Aerodrome, 31 March 2009**

**Fairchild SA227-AC Metroliner III  
ZK-NSS**

**runway excursion**

**New Plymouth Aerodrome**

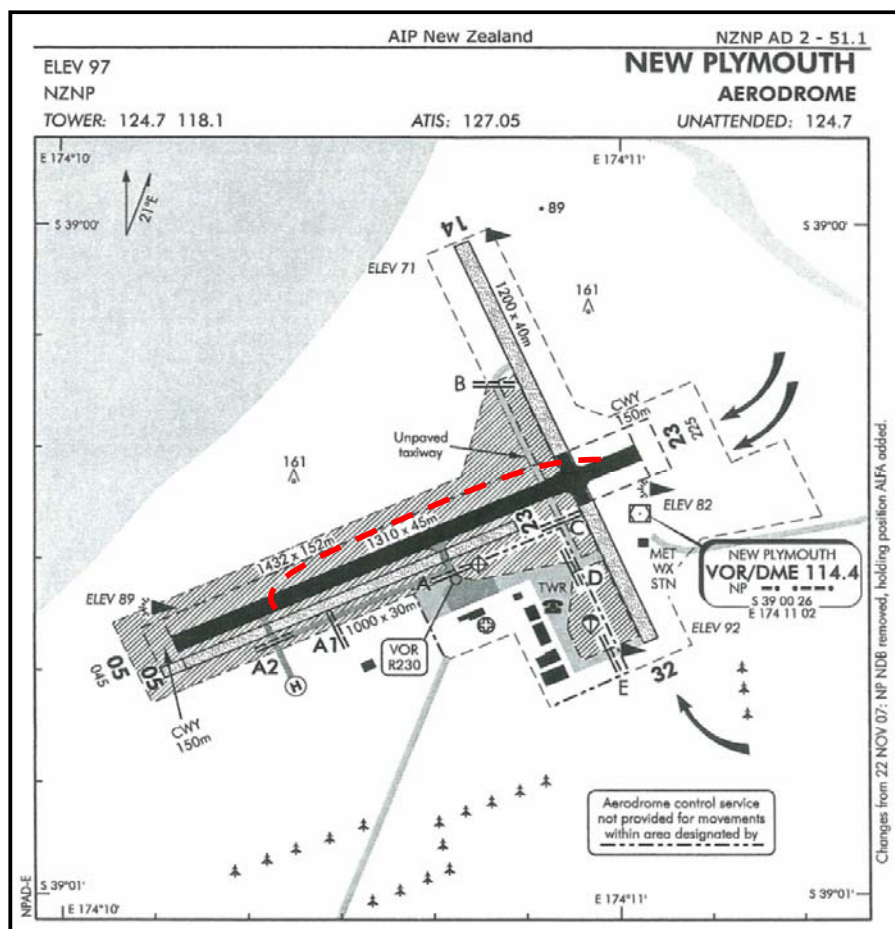
**Figure 2**  
**New Plymouth Aerodrome**  
showing approximate track of ZK-NSS in red

- 1.6.1 New Plymouth Aerodrome (see Figure 2) was owned and operated by the district council, and located close to the coast in undulating farmland at an elevation of 97 ft. The main runway, 05/23, had a bitumen surface 1310 metres long and 45 metres wide.<sup>12</sup> The runway sloped up from each threshold towards the centre, with the runway 23 threshold elevation at 82 ft. The operator's *Route Guide Manual* (Airwork, 2008a, p.6-31) noted that the runway 'is convex in shape which gives an unusual perspective', but neither pilot believed he had ever had a problem with that.

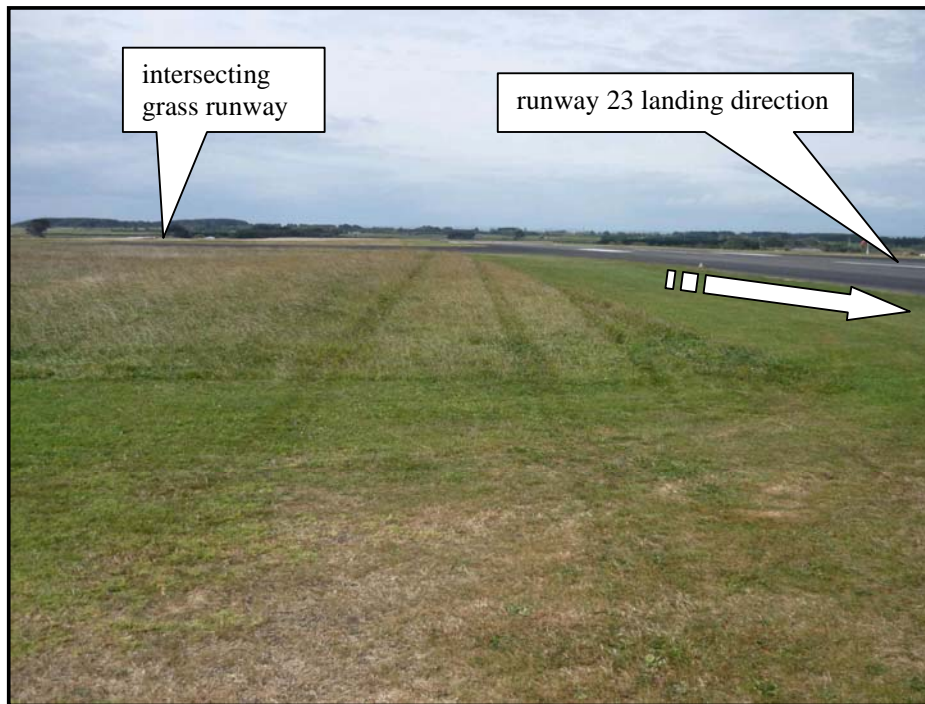
**Figure 3**  
**ZK-NSS wheel tracks**  
 (New Plymouth District Council, 2009)

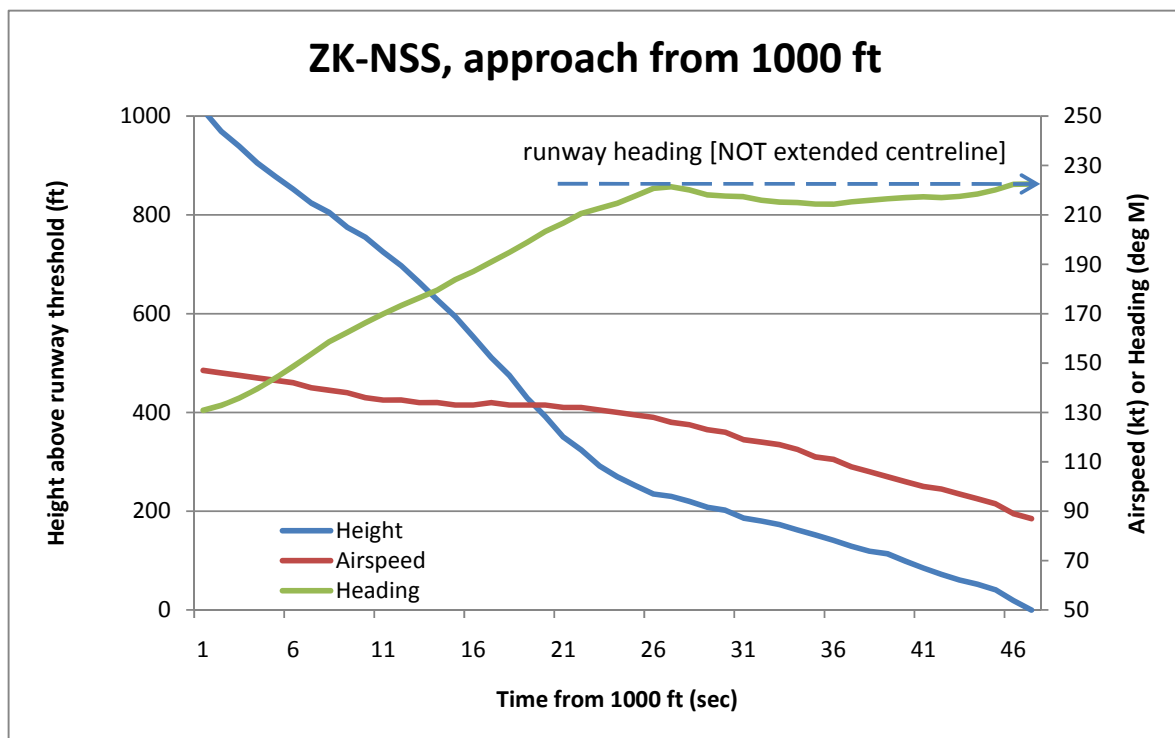
**Figure 5**  
**Flight data for last 1000 ft**

- 2.11 However, the FDR analysis suggests that the pilots were mistaken in their recollections of the approach profile and when the aeroplane became aligned with the runway. The base turn was much closer to the aerodrome and lower than normal, as one of the medical crew on board also observed. The FDR data showed that the aeroplane had descended to about 230 ft above the runway before achieving the runway heading. A comparison of their altitude with their distance from the aerodrome, as given by the distance measuring equipment associated with the instrument approach, was a basic cross-check that ought to have alerted the pilots, but appears not to have been done.

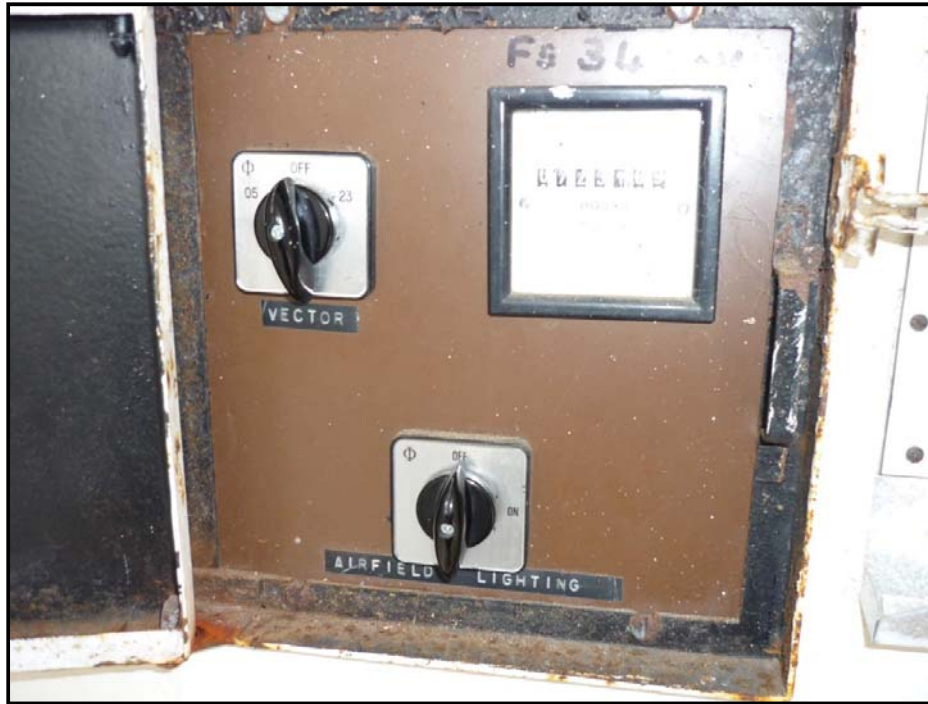
- 1.6.4 Before closing watch each day, the ATC officer on duty would pre-select aerodrome lighting, including the PAPI, to allow its use outside the ATC hours of duty. The lighting selections were not recorded or verifiable. The pre-selected lighting was activated if switched on at the remote control panel located outside near the control tower (see Figure 6).

**Figure 6**  
**Aerodrome lighting remote control panel**  
(New Plymouth District Council, 2009)
