Report 09-007: Piper PA32-260, ZK-CNS, impact with ground following a loss of control after take-off, near Claris, Great Barrier Island, 29 September 2009

Piper PA32-260

ZK-CNS

impact with the ground following a loss of control after take-off

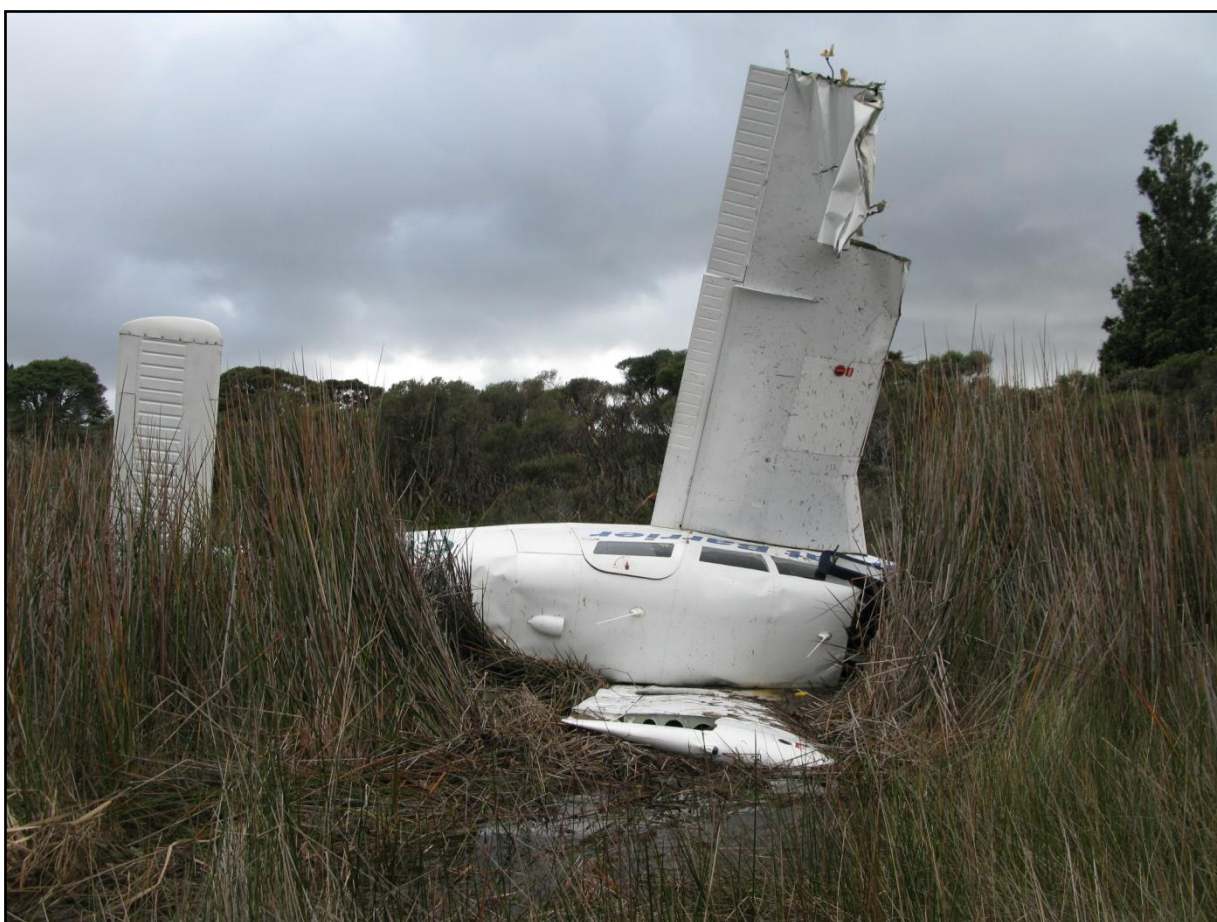
Figure 2
ZK-CNS in the swamp

1.2.1 The aeroplane was destroyed during the impact with the swamp, and came to rest semi-submerged (see Figure 2). All of the aeroplane structure was accounted for at the site and there was no evidence of any pre-impact failure. Pieces of the left wingtip fuel tank were found about 15 m north of the aeroplane by a bush that the wingtip had struck.

1.2.2 The flaps were selected up and found in the up position. The elevator trim was set to about a neutral position. The throttle and propeller controls were set at the take-off maximum power position. Carburettor heat was selected off, the fuel pump was on and the outboard fuel tanks

were selected, being the normal selections for take-off. The fuel gauges were submerged and provided unreliable readings. The wingtip fuel tanks were destroyed and the left inboard tank ruptured. The fuel cap was off the right wing inboard tank that was semi-submerged and full of water. A significant smell of fuel emanated from around the aeroplane and some fuel and oil pools could be seen in the water around the fuselage and engine.
