Report 09-102: Passenger fatality after falling between platform and passenger Train 8125,
Newmarket West station, 1 July 2009

Rail Inquiry 09-102
Passenger fatality after falling between platform and passenger
Train 8125, Newmarket West station, 1 July 2009

Approved for publication: February 2011

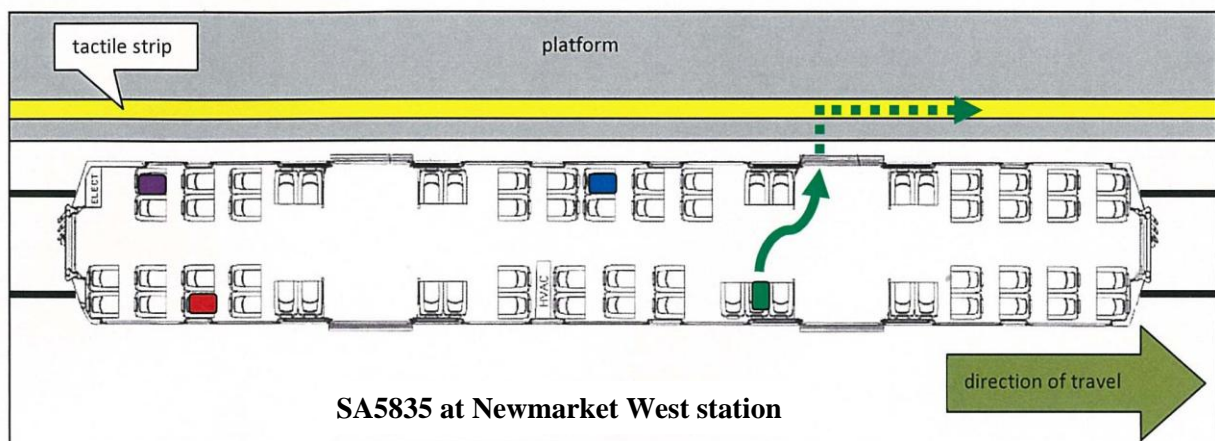
Figure 2
Reported seating positions and movement of accident victim (carriage plan obtained from KiwiRail)

- 3.1.3. At about 1245, a senior male passenger, travelling alone, boarded the second carriage at New Lynn station and sat down on the right side, opposite the forward door (refer seat coloured green in Figure 2). The passenger was aged 69 and was vision impaired but otherwise was reported to be physically well. He had been registered with the Blind Foundation since 2006.

- 3.1.9. Other witnesses were seated in the same carriage at seats coloured purple and red in Figure 2, and others were on the platform.

- 3.1.10. The accident victim stood up before the train stopped at the platform and was holding on to the inside grab rail near the forward door to steady himself. When the train stopped and the doors opened he was seen to reach out and use the external grab rail to steady himself as he stepped down onto the platform. He did not appear to have any difficulty achieving this.

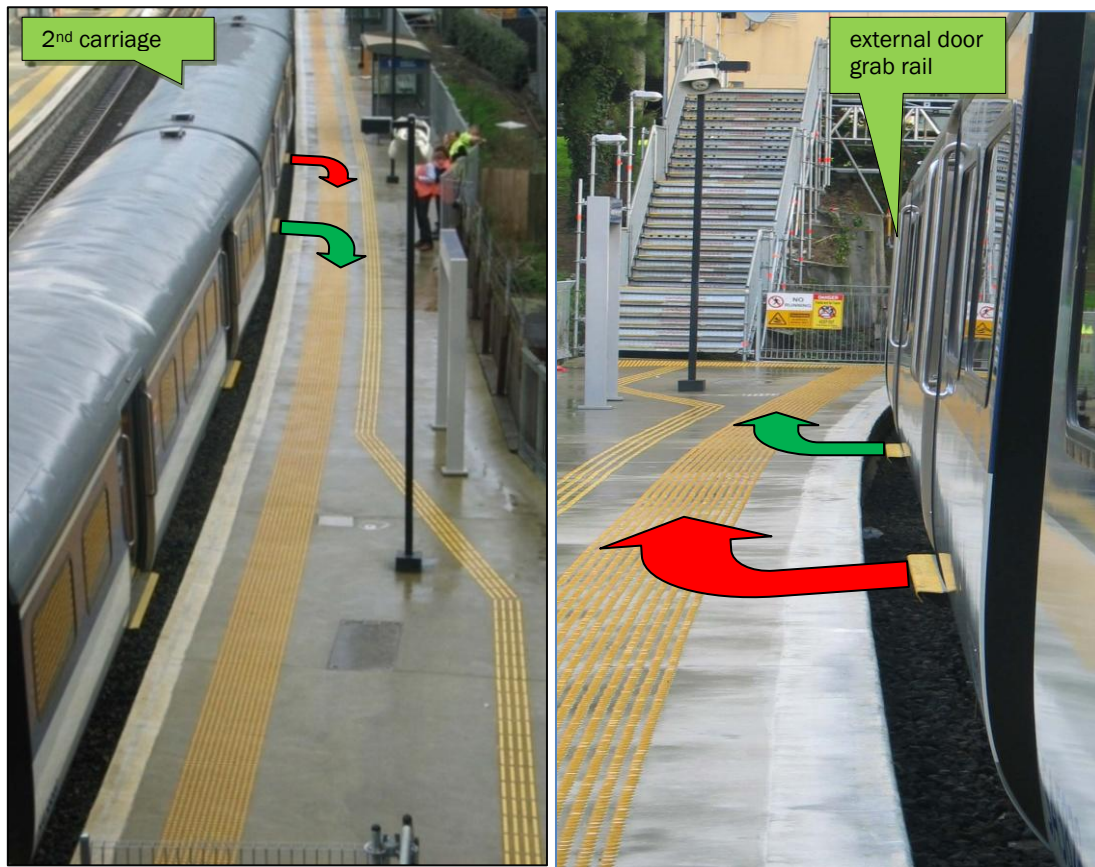
- 3.1.11. Once on the platform the accident victim moved about one metre from the platform edge and stopped, standing on the band of yellow tactile buttons installed on the platform surface. He appeared unsteady on his feet as he grappled with extending his symbol cane for a few moments. He then turned and walked parallel with the platform edge for about 5 or 6 steps while the train was still stationary. A second key witness who had alighted from the rear door of the same carriage said that the end of the accident victim’s symbol cane was not in contact with the yellow tactile buttons as he walked.

- 3.1.12. As the train started to move off from the platform, the accident victim was seen to continue walking but veer right towards the moving train, where-upon he leaned against it, spun around and fell through the gap between the moving train and the curved platform, and onto the ballast below. Figure 3 shows the gap between the train and the curved part of the platform.

(Left) a push/pull train standing at Newmarket West station and (right) the platform and approximate movement of the accident victim (green arrow) and second key witness (red arrow)

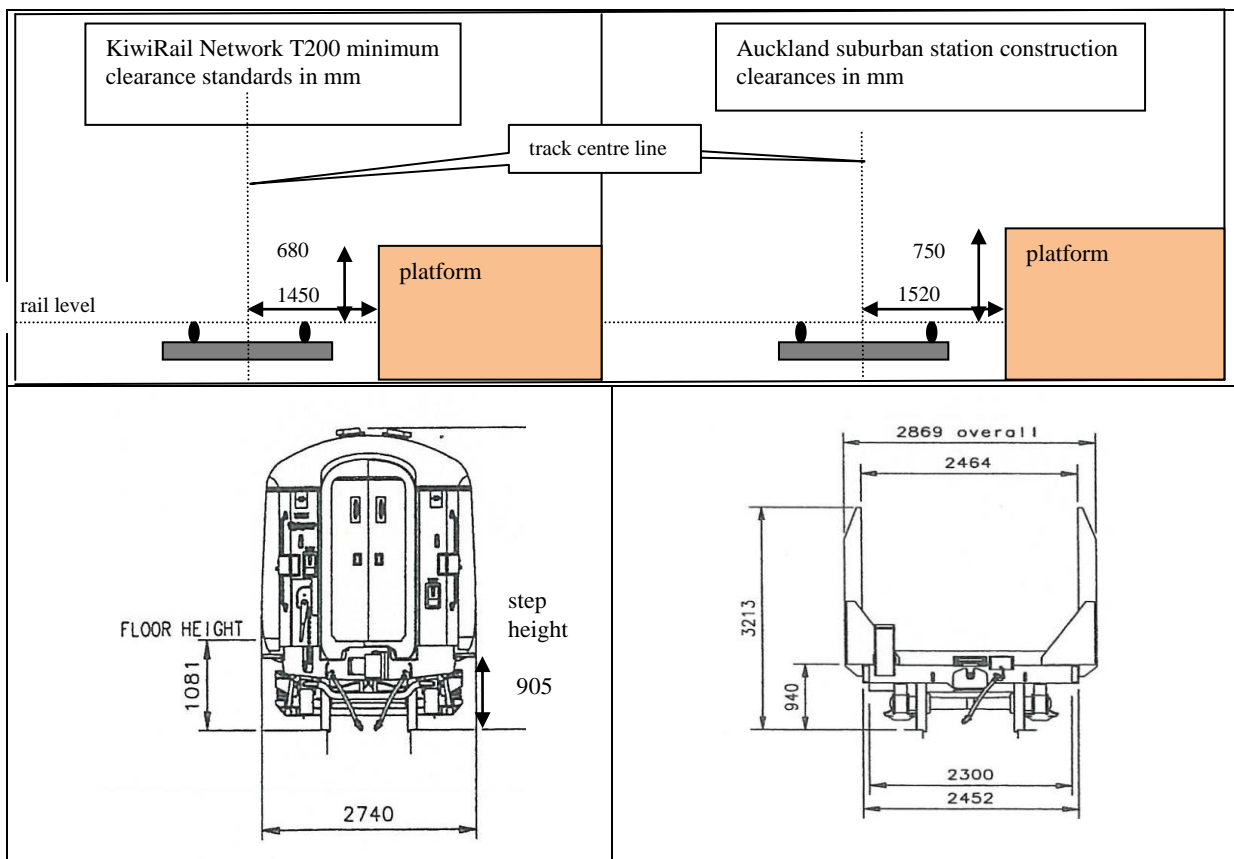
Figure 6
Platform clearances at top, and bottom, the end elevation of an SA/SD vehicle (left) and a USL wagon (right), (drawings not to scale)

3.5.7. The end elevation of the USL wagon shows that at about platform height, this class of freight wagon was 129 millimetres (mm) wider than an SA/SD carriage (refer Figure 6).

3.5.8. Following the accident, clearances at 2 m spacing over a 12 m distance back from the end of the platform (where the accident occurred) were measured and were found to be compliant with both sets of minimum clearances.

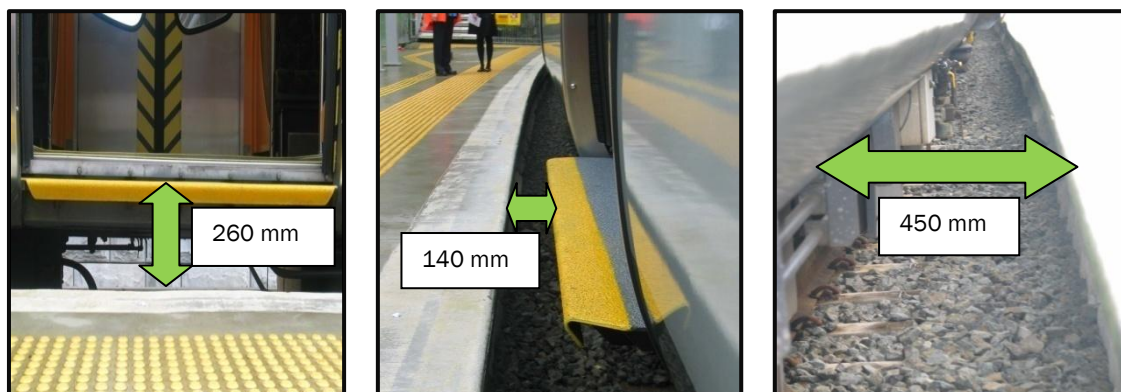
Figure 7
Height and width measurements taken at rear door and mid way along the second carriage

3.5.9. Height and width measurements at a second carriage of an empty push/pull train and the Down platform edge at Newmarket West station are shown in Figure 7.

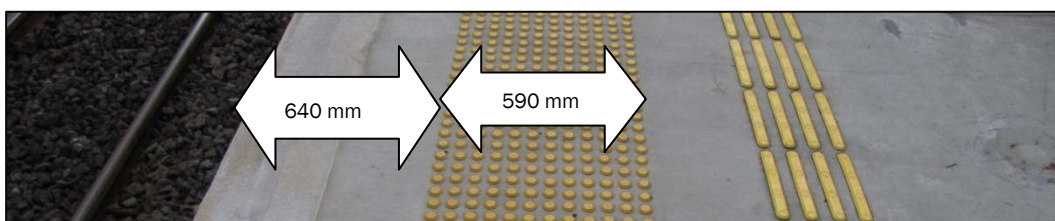
Figure 8
Ground surface indicators on the Down platform at Newmarket West station

- 3.7.3. The Guidelines specified the design, installation and performance standards for new pedestrian facilities and those that were being upgraded. There were 2 features that were installed for blind and vision-impaired people: tactile ground-surface warning button indicators and directional strip indicators. Figure 8 shows examples of each type installed at Newmarket West station platform.

Finding Newmarket West station was laid out and marked in accordance with the guidelines catering for vision-impaired and blind persons, to the satisfaction of the Blind Foundation.
