Report 09-103: Passenger Train 1608, collision with slip and derailment,  
Tunnel 1, Wairarapa Line, Maymorn, 23 July 2009  
(incorporating investigation 08-106, collision with slip and derailment on the Johnsonville Line)

### Rail Inquiry 09-103

Passenger Train 1608, collision with slip and derailment, Tunnel 1,  
Wairarapa Line, Maymorn, 23 July 2009  
(incorporating investigation 08-106, collision with slip and  
derailment on the Johnsonville Line)

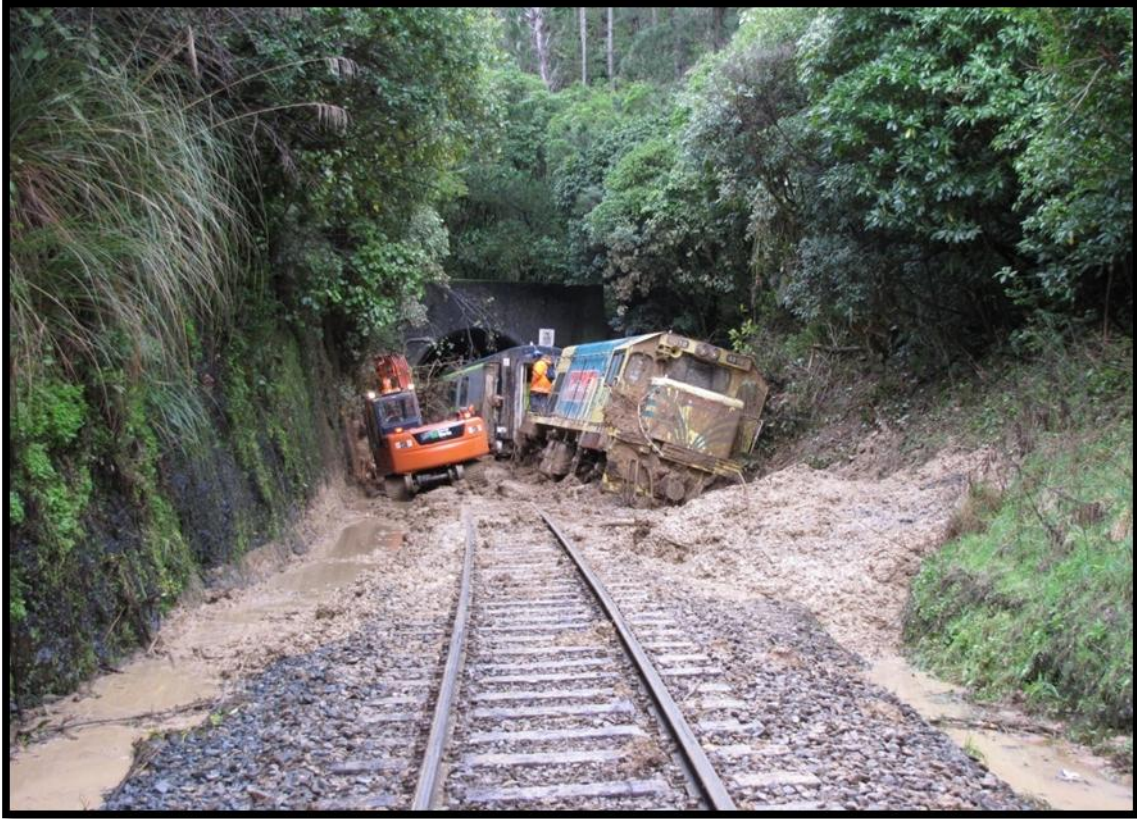
Figure 2  
Resting position

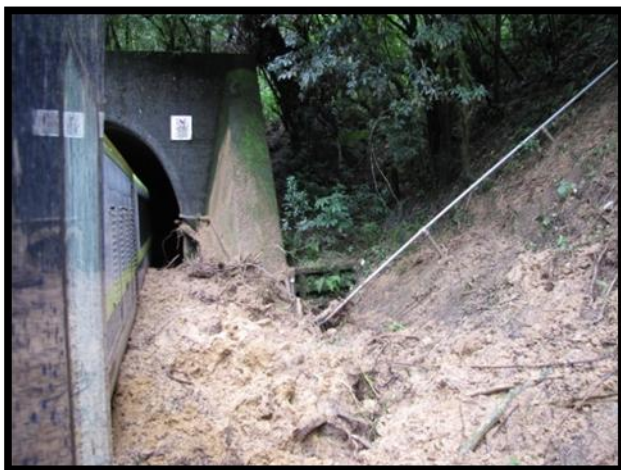
Figure 3  
Portal 2, Left-hand side

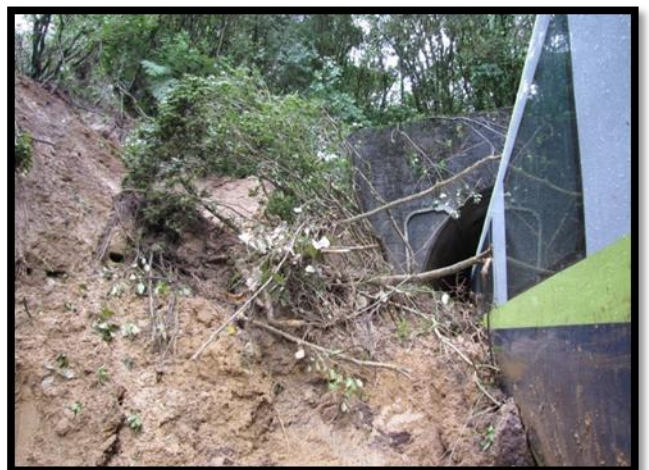
Figure 4  
Portal 2, Right-hand side

- 3.4.8. The Ontrack report concluded that movement may have been partly exacerbated by the saturation of the toe of the slide from high water levels in the water course to the right-hand side of the slide when looking from the track (Figure 5). The report noted that the slip occurred at the end of a 6-hour rainfall event when the soil was likely to be at maximum saturation combined with high run-off.

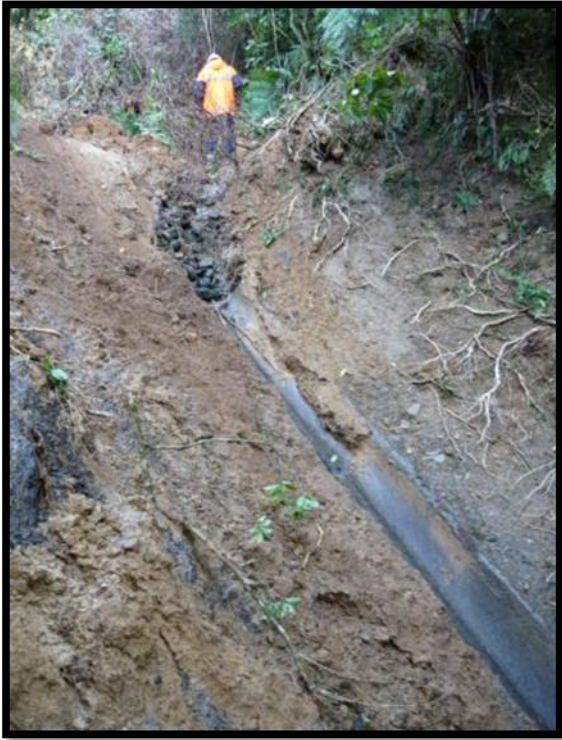
Figure 5  
Formed drainage chute

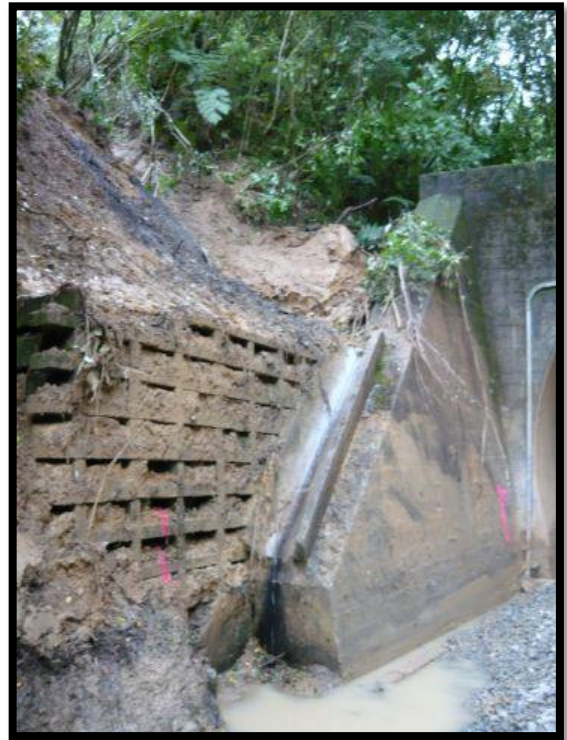
Figure 6  
Portal 2, Drain to track

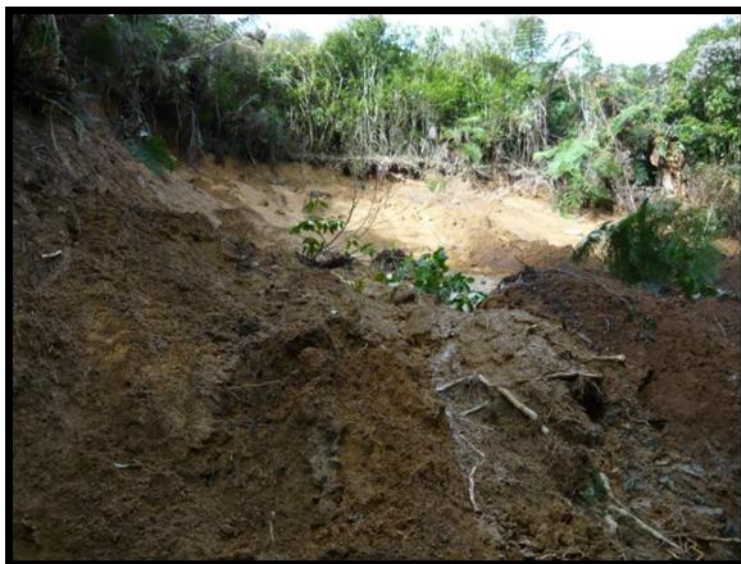
Figure 7  
Landslide footprint

- 4.2.4. Heavy rain at the time of the landslide may have been so intense that the slope around portal 2 became saturated and failed naturally. The landslide occurred at the end of an intense 6-hour period of heavy rain, totalling 62 mm during a relatively dry period. This proved sufficient to initiate what had always been a potential landslide.

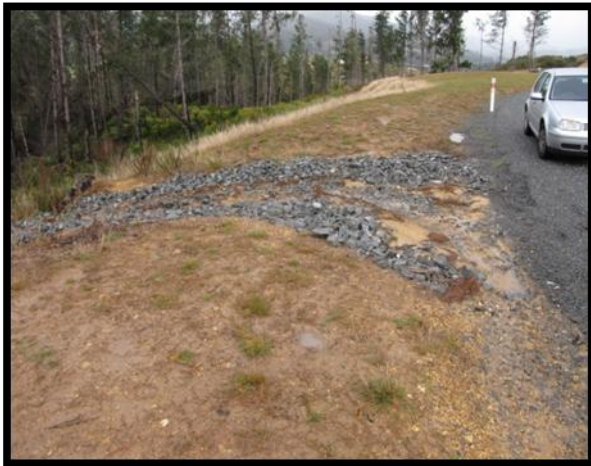
**Figure 8**  
Drainage from ridge towards tunnel

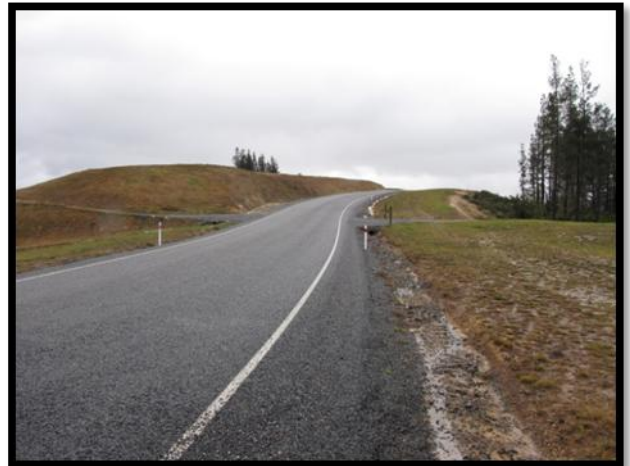
**Figure 9**  
Cleared ridge above tunnel
