Report 09-201: collision: private jet-boat/private watercraft
Kawarau River, Queenstown, 5 January 2009

Final Report

Marine inquiry 09-201
Collision: private jet-boat/private personal watercraft
Kawarau River, Queenstown, 5 January 2009

Approved for publication: March 2011

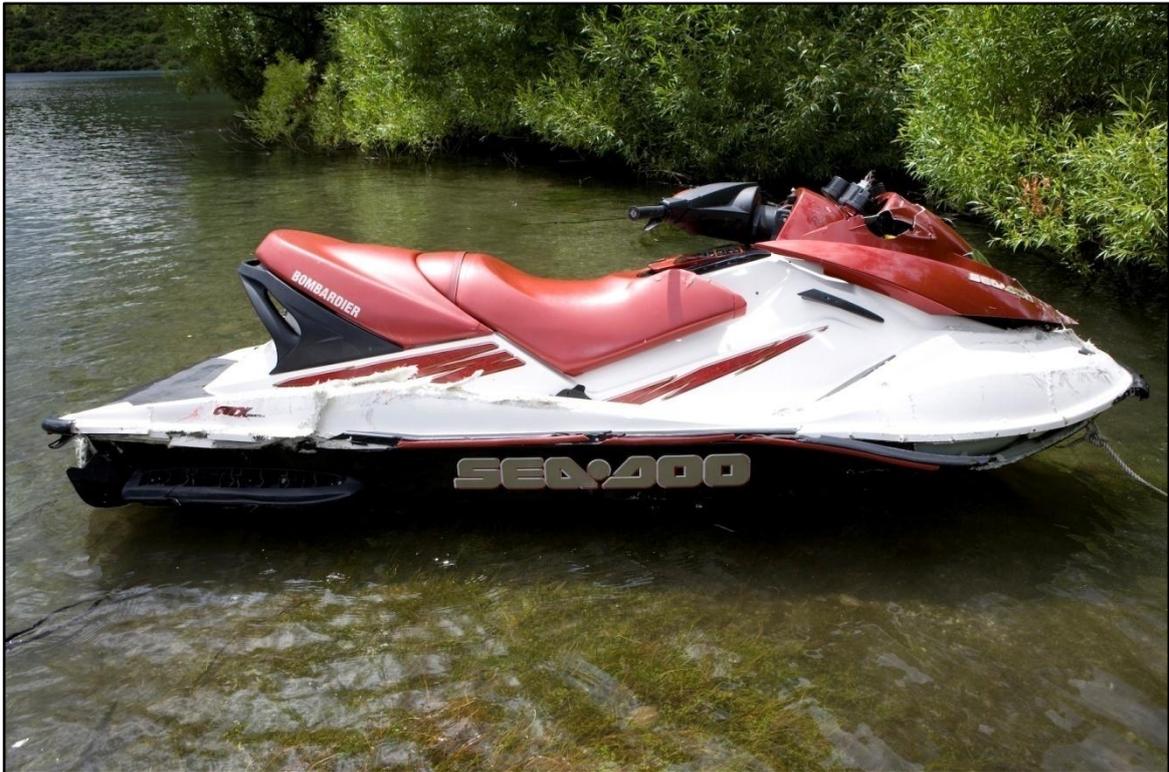
Personal watercraft Sea-Doo GTX 155 post accident

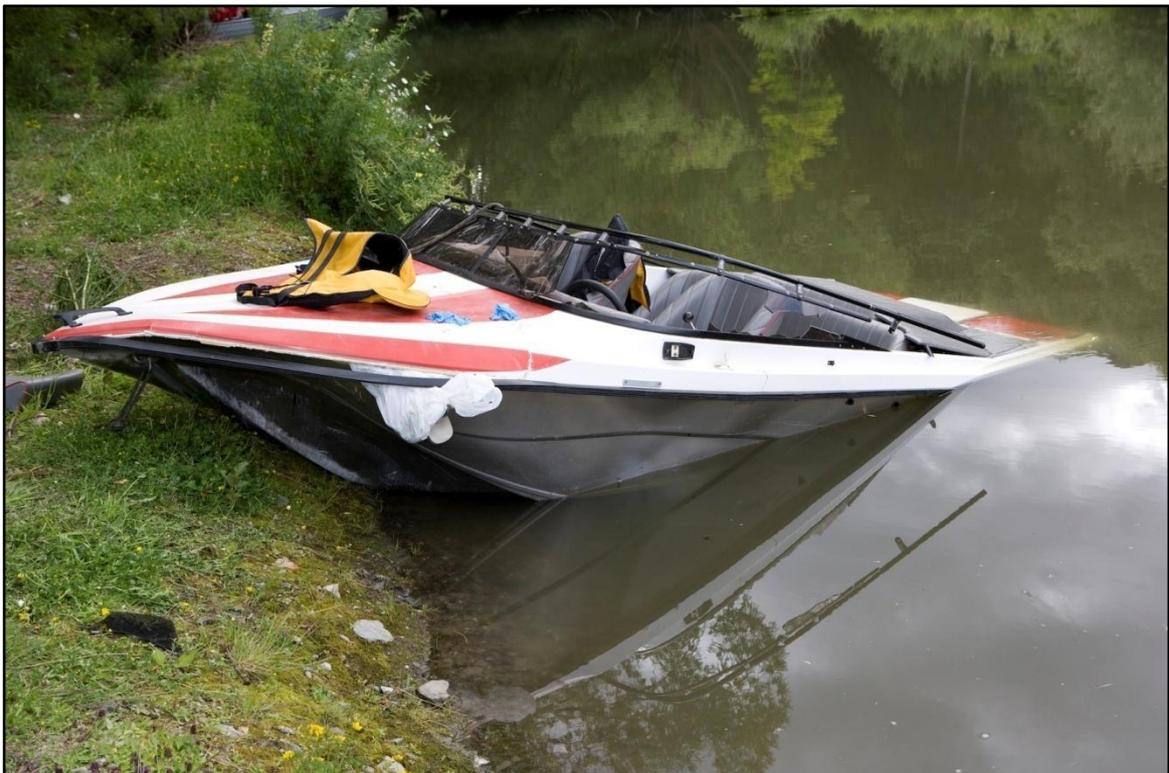
Jet-boat Hamilton Jet 151A post accident

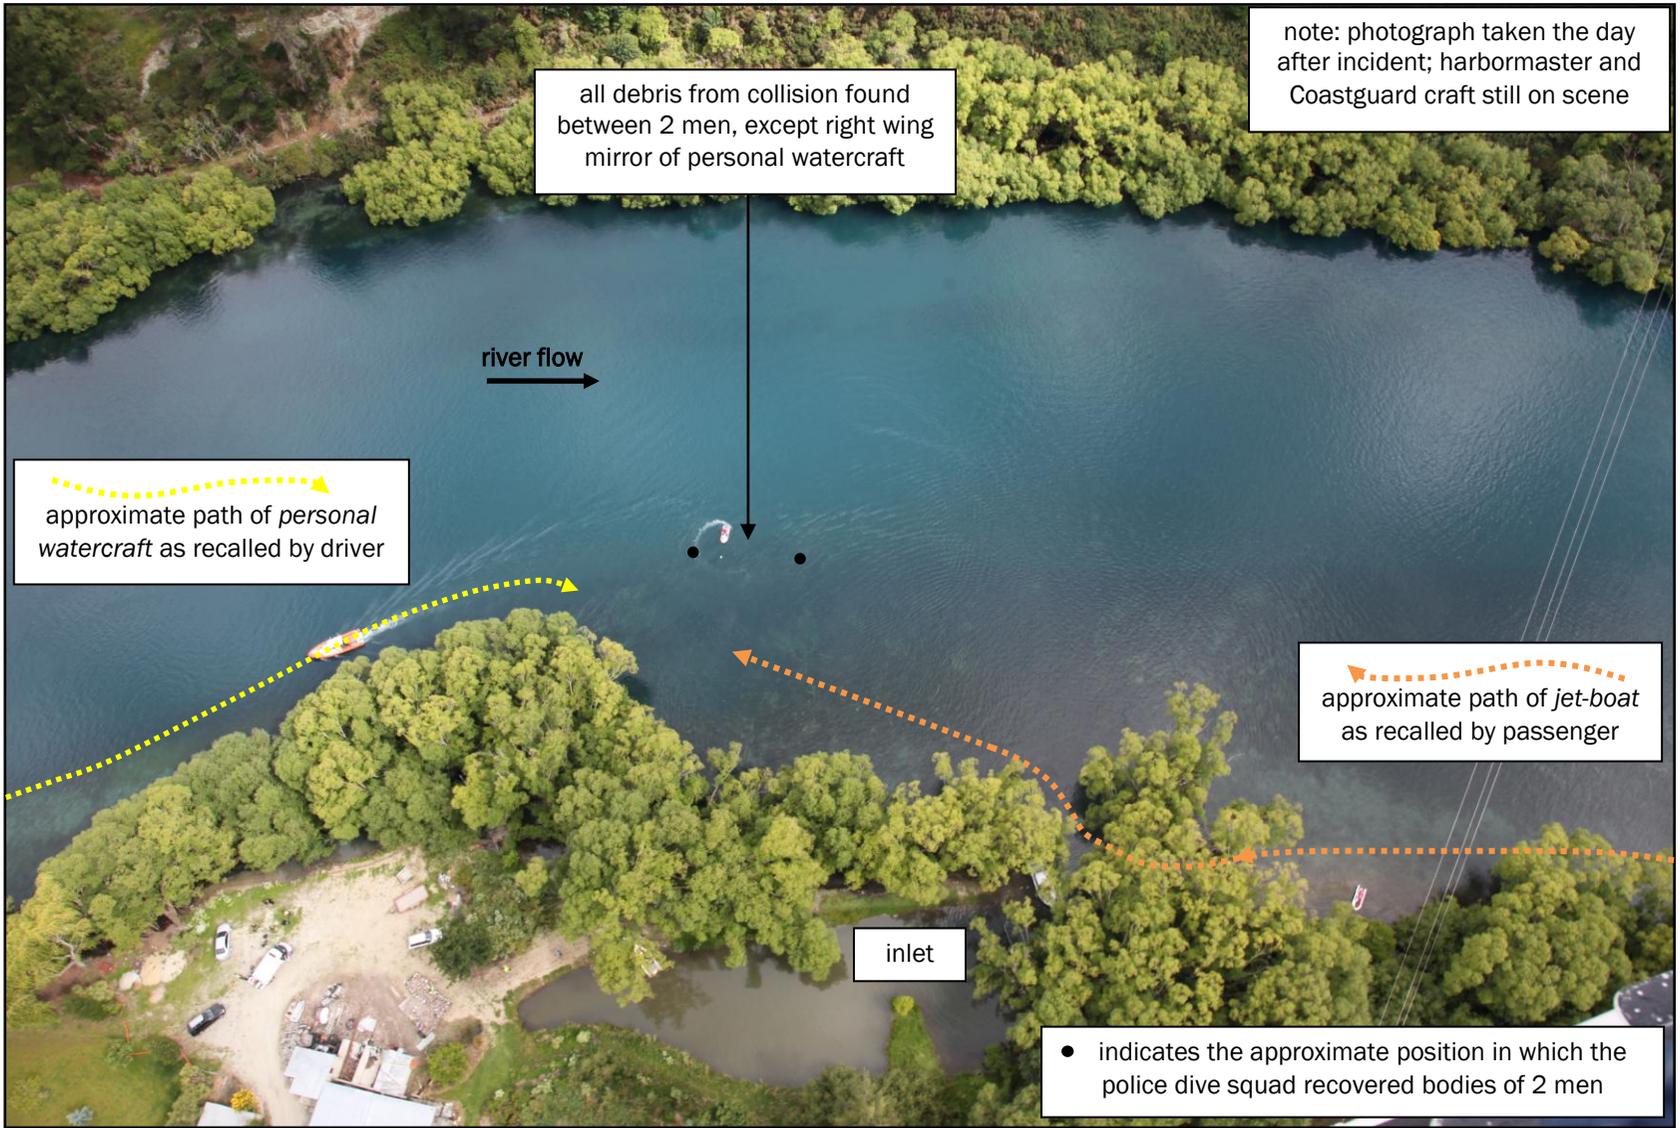
Figure 3
Close up view of accident site

- 3.1.33. The search resumed the next morning. By about 1010, the river conditions had improved enough for spotters in a helicopter to locate the bodies of the 2 missing men on the riverbed (Figure 3). Police divers recovered the bodies at about 1230.

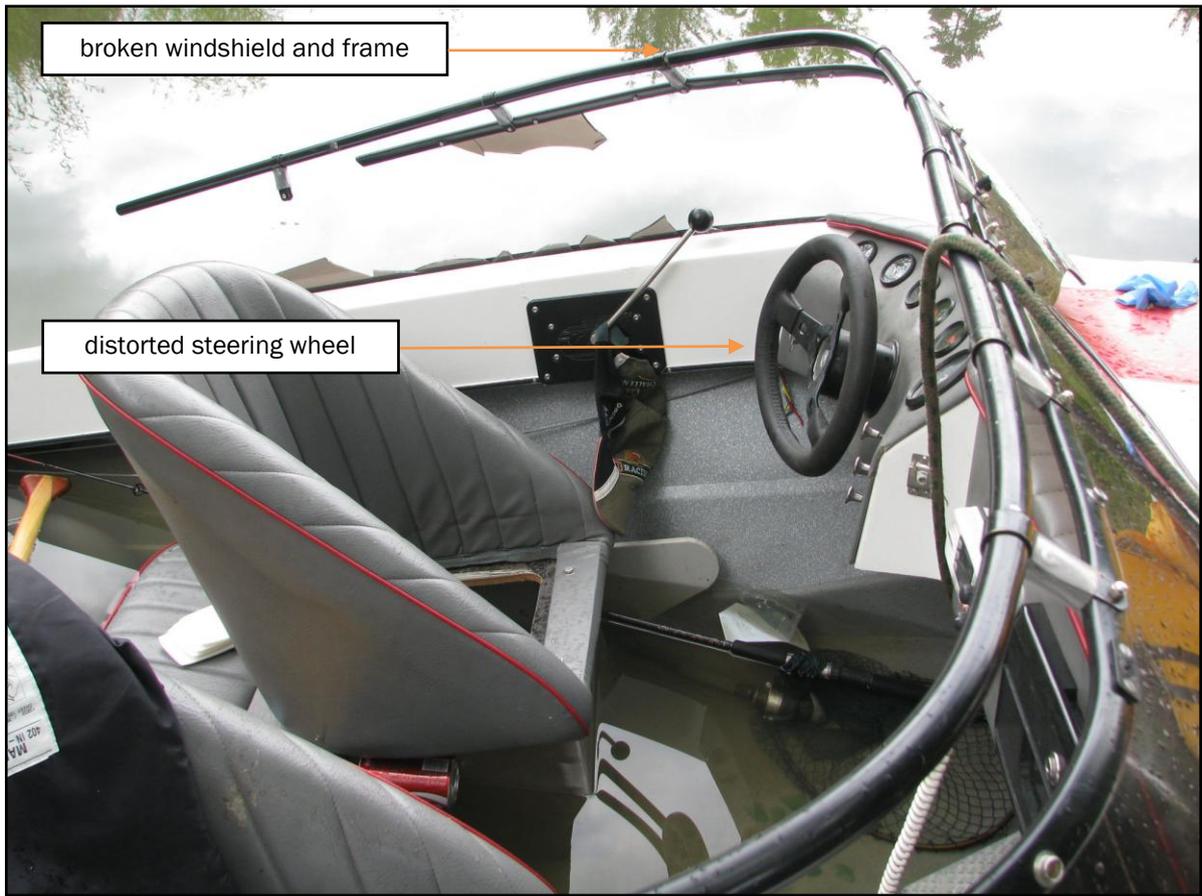
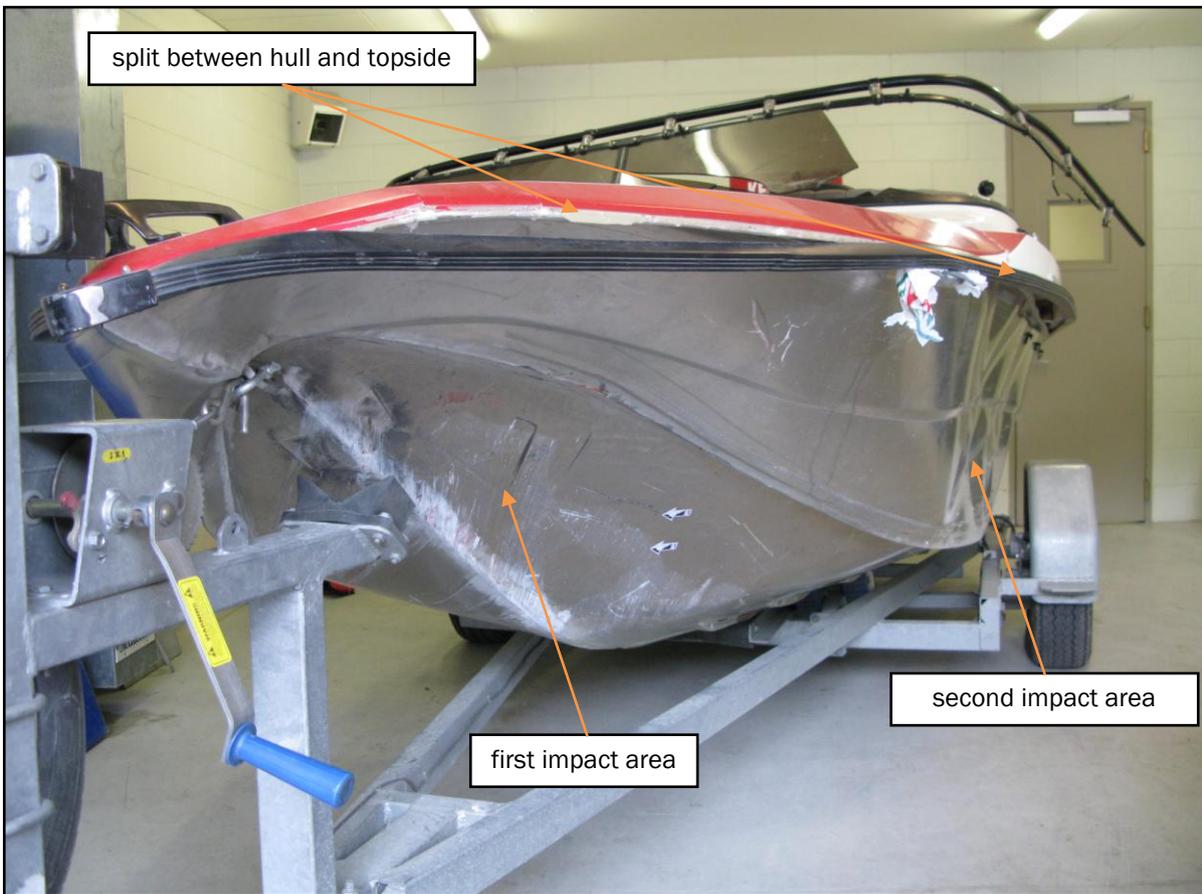
Figure 4
Damage to jet-boat

- 3.5.2. Both craft were substantially damaged in the accident and subsequently declared constructive total losses.
- 3.5.3. An Inspection of the *jet-boat* showed that the boat had been struck on the port forward shoulder and amidships on the port side. The following damage was noted (Figure 4):

- there was impact damage on port forward quarter with the hull pushed in about 300 millimetres
 - there was impact damage port side and amidships with failure of joint between hull and topside in that area

- the windshield support frame had been dislodged and shield broken
 - the steering wheel and gear lever had been distorted
 - there was general damage to fittings.

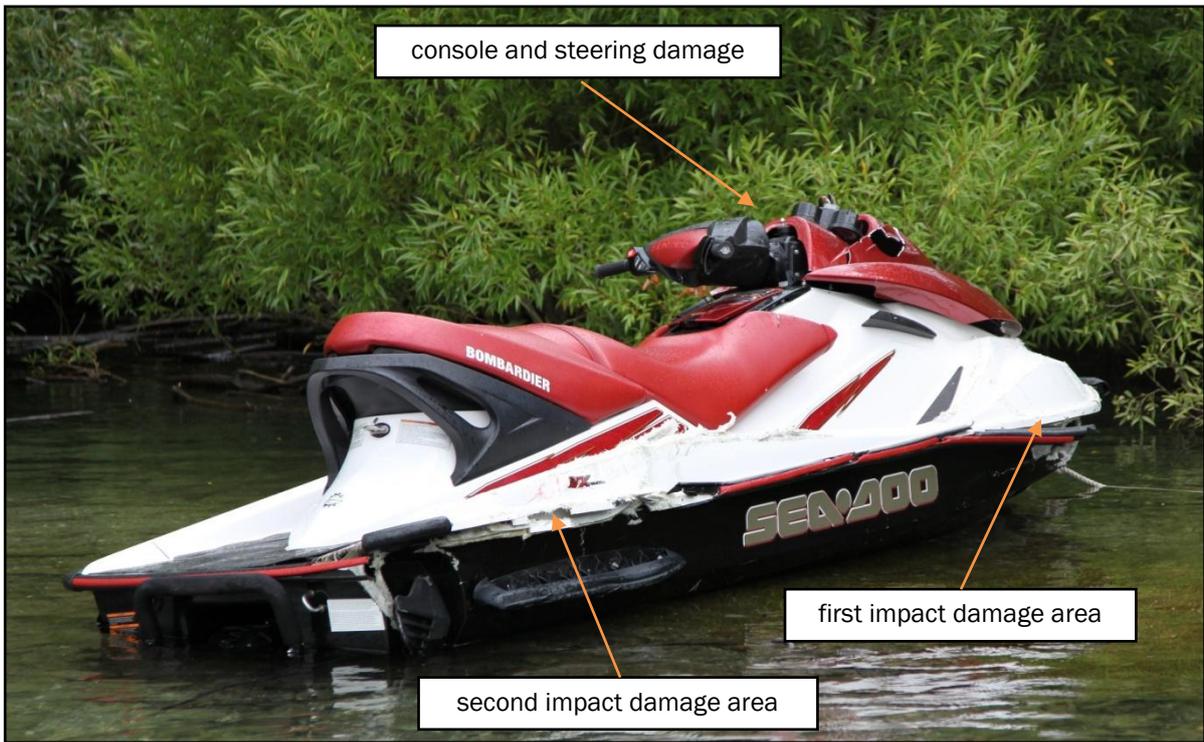
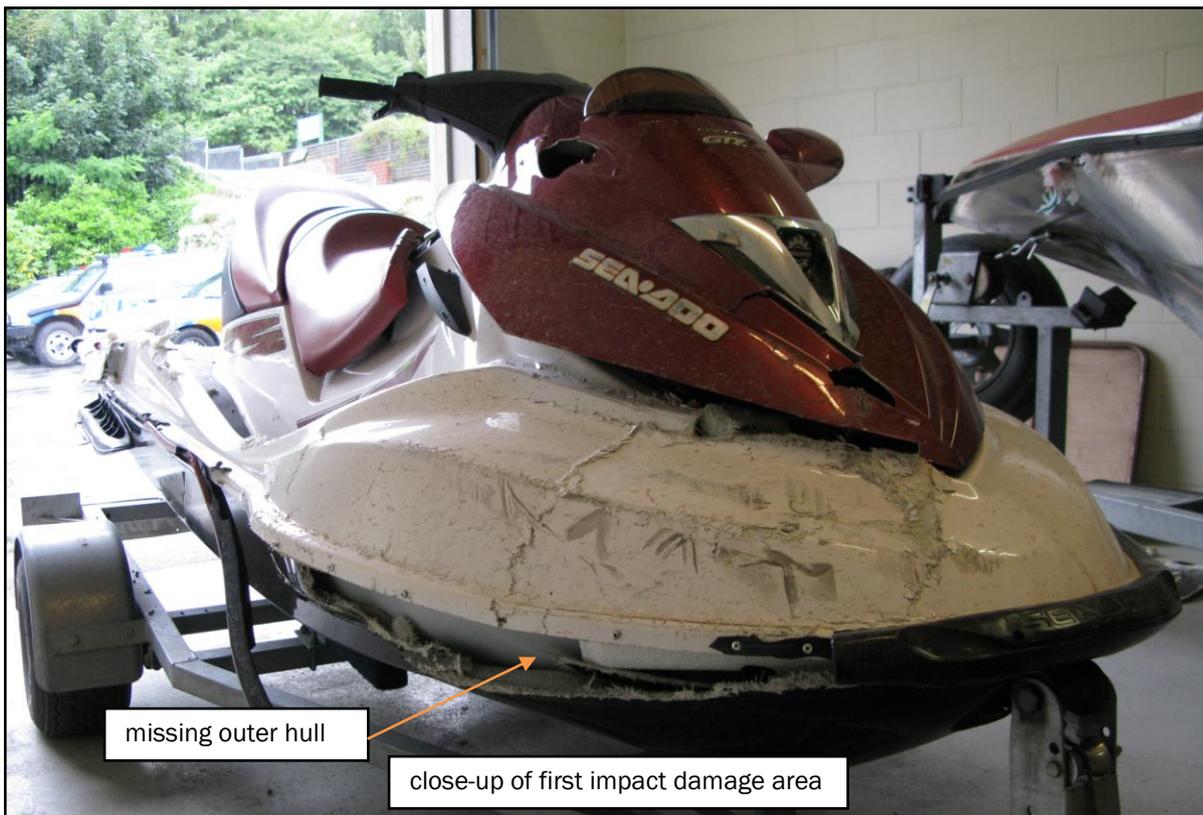
Figure 5
Damage to *personal watercraft*

- 3.5.4. An inspection of the *personal watercraft* showed that the boat had been predominantly damaged on its starboard side. The following damage was noted (Figures 5 and 6):

- there was impact damage on starboard forward shoulder, cracking to resin and part of outer hull missing
 - there was impact damage to starboard aft quarter of hull, cracking and failure of joint between hull and topside

- there was damage to the steering column and gauges.

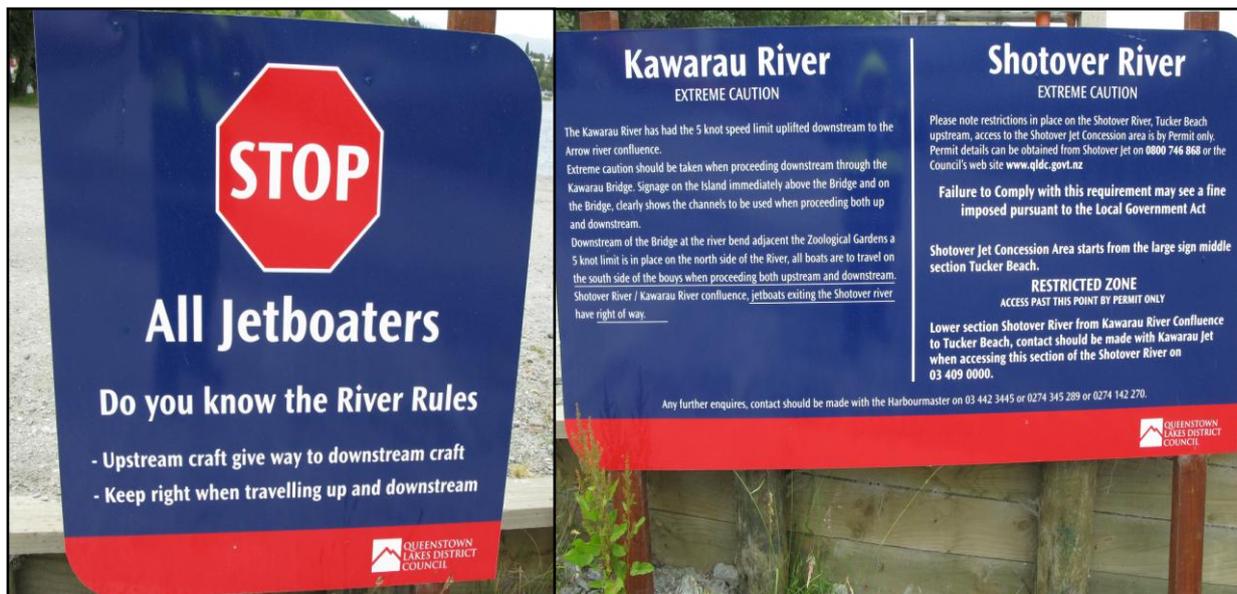
Figure 7
Advisory signs at Frankton Marina

- All vessels operating on rivers must keep to the right side at all times with boats going up river giving way to boats going down river.
- 3.6.23. Queenstown Lakes District Council had signs posted adjacent to the slip at Frankton Marina and on the Kawarau River, which advised of the speed uplifting on the river and the requirements for vessels travelling the river (Figure 7). It stated in part:

- upstream craft give way to downstream craft
 - keep right when travelling up and downstream
