Final Preliminary Report

Prepared by the Transport Accident Investigation Commission

The Royal Commission of Inquiry into the Sinking of the
MV Princess Ashika

15 February 2010

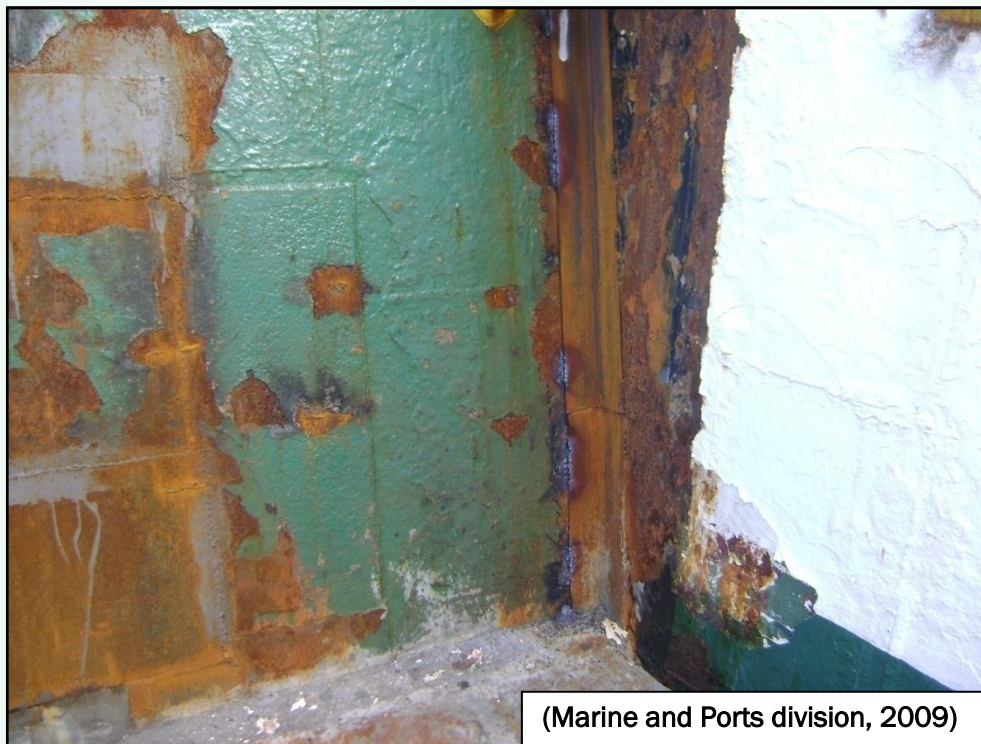
Figure 12 Welded bow ramp with cement covering the hinge

- 1.3.79. Welders from Patterson's repaired the bow ramp by cutting it vertically along its centreline, before straightening it, re-welding it and using doubling plates to reinforce the repaired section. To prevent the ramp falling open again should the ship encounter heavy seas, the shore workers welded lengths of angle iron between the side casings and the inside of the ramp to hold the ramp closed and also to reduce the ingress of water (see Figure 12). To further reduce the ingress of water, the gap at the base of the bow ramp was filled with cement. While these repairs were being carried out, the crew replaced the starboard anchor, which had been recovered from the harbour.

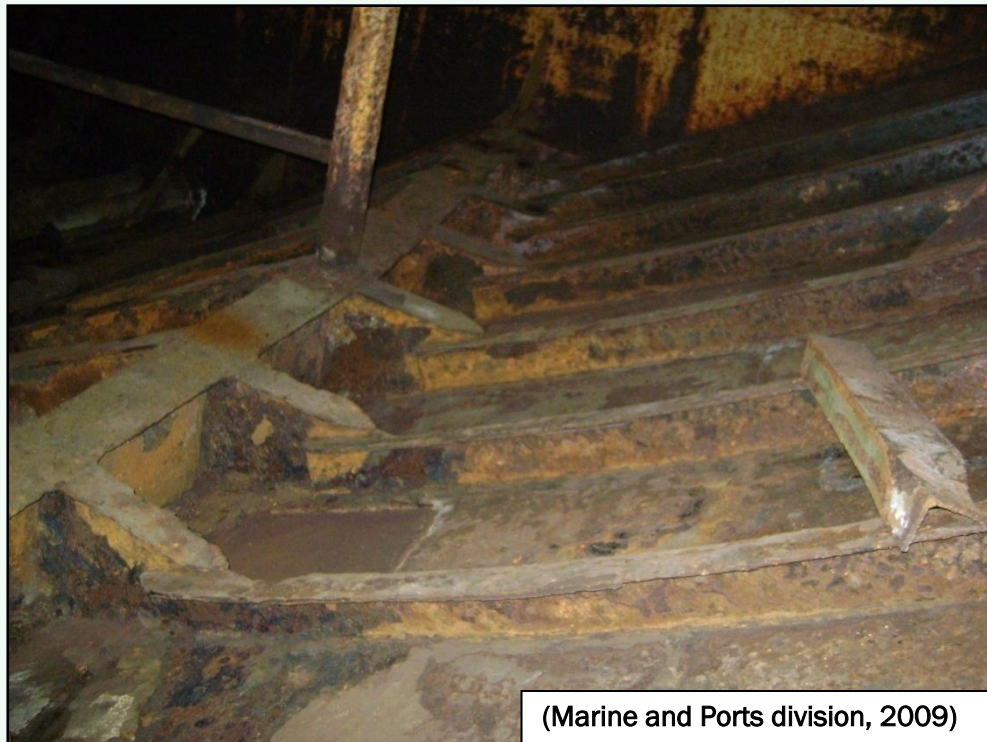
Figure 14 Corroded void space

- 1.3.84. The senior deck surveyor was very concerned about the condition of the ship. He reported that it was very rusty and there were patches welded to the deck. He noticed several rust holes through the side of the ship above the waterline. He also noticed that the deck scuppers had no flap or non-return arrangement to prevent water coming in through them. In addition, he noted the cargo ramps did not close properly and did not seal (see Figure 13) and the void spaces were heavily corroded (see Figures 14 and 15).

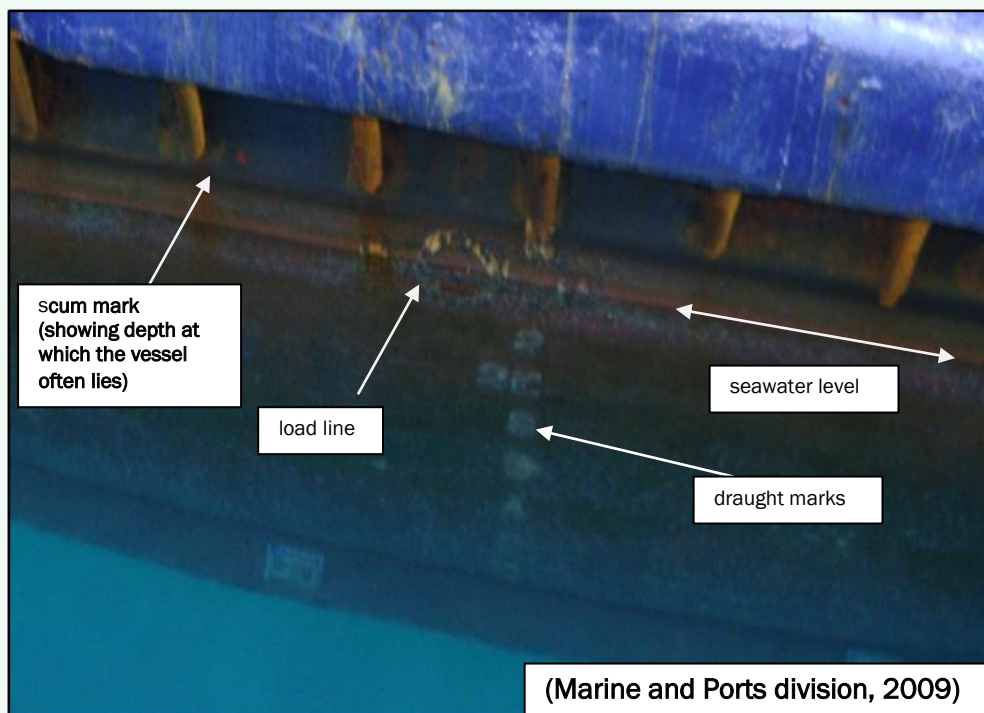
Figure 16 Submerged load line on 2 July 2009

- 1.3.85. The senior deck surveyor remembered having seen the ship on the slip in Fiji several years earlier and at that time he had noticed a watermark above the load line, suggesting that the ship's load line was usually submerged. On 2 July, as part of his survey, he specifically checked the load line and found it to be submerged (see Figure 16). At that time, the ship had on board no cargo, the remaining fuel from the delivery voyage, an unknown amount of fresh water and an unknown amount of ballast water.

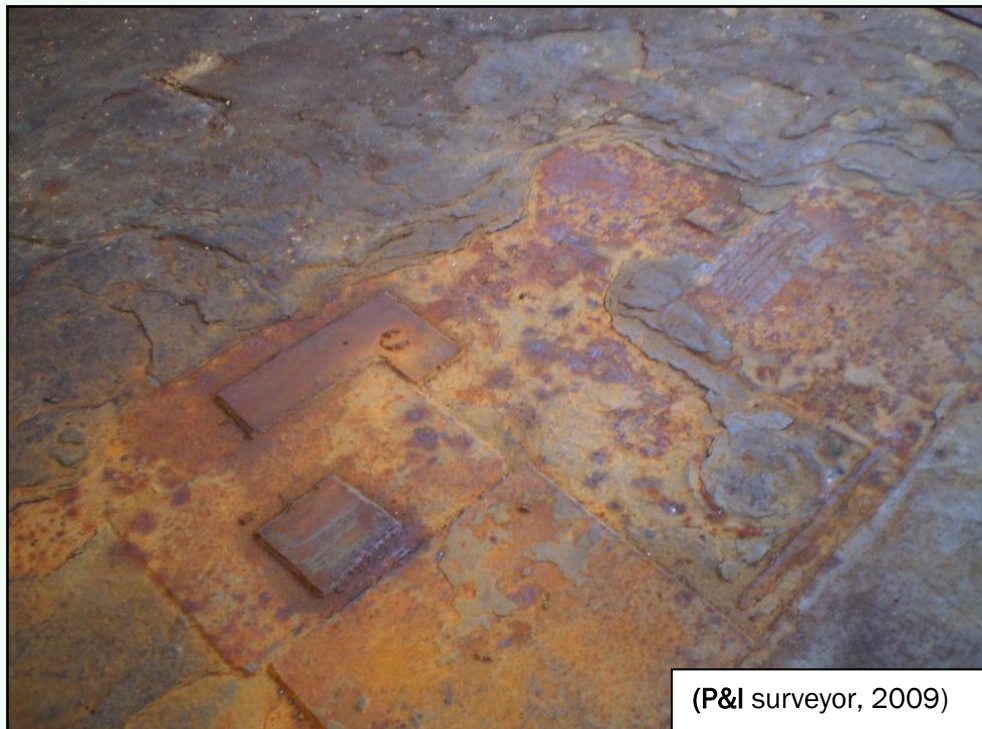
Figure 18 Corrosion on deck, with multiple doubling plates

- 1.3.107. On 4 and 5 August, a surveyor on contract to the ship's Protection and Indemnity (P&I) Club⁸ surveyed the ship as part of its underwriting process. He found the ship to be in poor condition, with scuppers open to the sea (see Figure 17) and large areas of heavy corrosion covered by many doubling plates (see Figure 18).

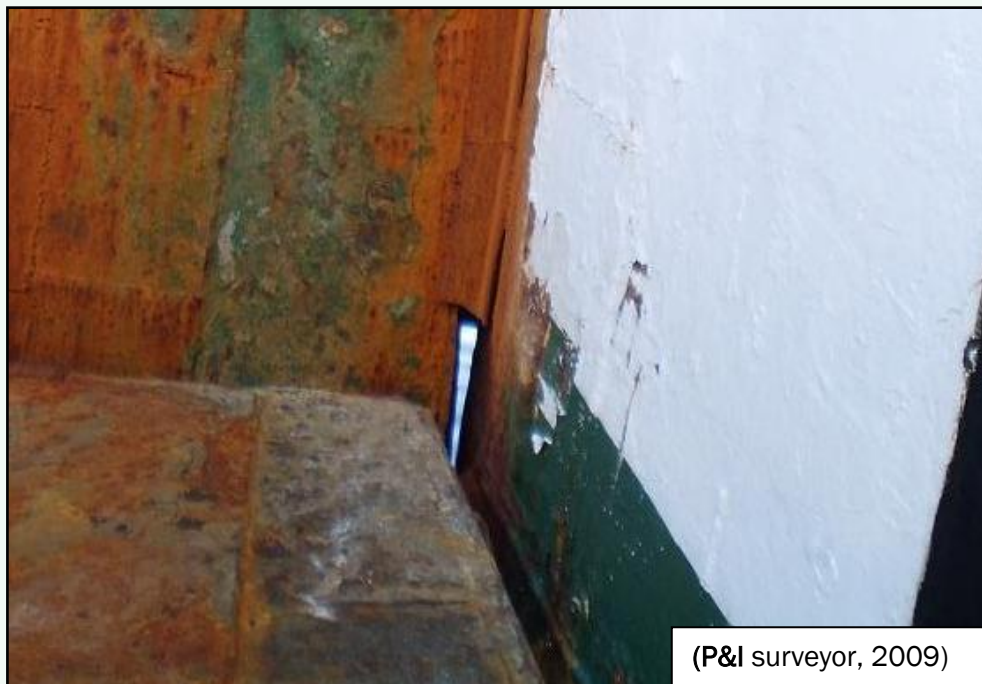
Figure 19 "Gap" beside bow ramp after cement removed

1.3.108. The P&I surveyor also noticed a large gap between the ship's bow ramp and surrounding structure (see Figure 19). On the morning of 5 August, as part of the survey, he had the forward ballast tanks filled. However, he said, it took too long for them to fill, so he cancelled the test when they were only partly filled. At that time, he noted that the manhole to the forward port ballast tank, which was located in the port forward store on the vehicle deck, did not have a cover either fitted or adjacent to the opening (see Figure 20).

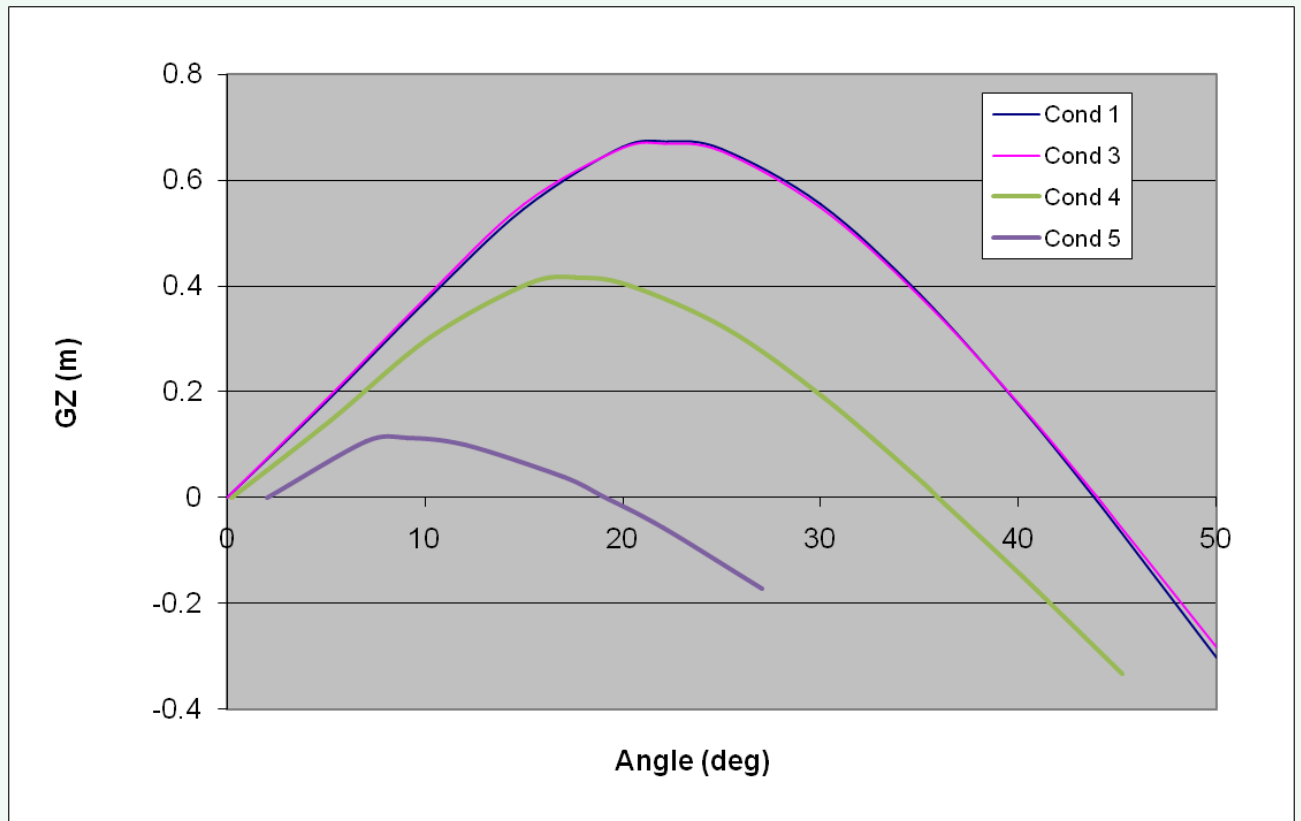
Figure 26 Changes in stability up to the accident voyage

- 1.6.27. The minimal freeboard, combined with the deteriorated condition of the bow ramp, permitted the accumulation of water on the cargo deck, which started a sequence of downflooding and increasing water accumulation. This had a significant impact on the vessel stability owing to the reduction in freeboard and large free surface effect created by water in many tanks and on deck.

- 1.6.28. At an intermediate stage, the crew decided to pump out the after starboard water ballast tank. While this decision did not worsen the stability situation, it did increase the trim by the head, so allowed more water to enter the cargo deck around the bow ramp. At an early stage, the focus of the crew should have been on eliminating the accumulation of water on the cargo deck. In the absence of such action, the situation worsened until the vessel lost all stability and reserve buoyancy.
