Inquiry 09-210: Bulk carrier, Taharoa Express, cargo shift,  
Port Taharoa, 16 December 2009

Marine inquiry 09-210  
Bulk carrier, Taharoa Express, cargo shift  
Port Taharoa, 16 December 2009

Approved for publication: November 2013

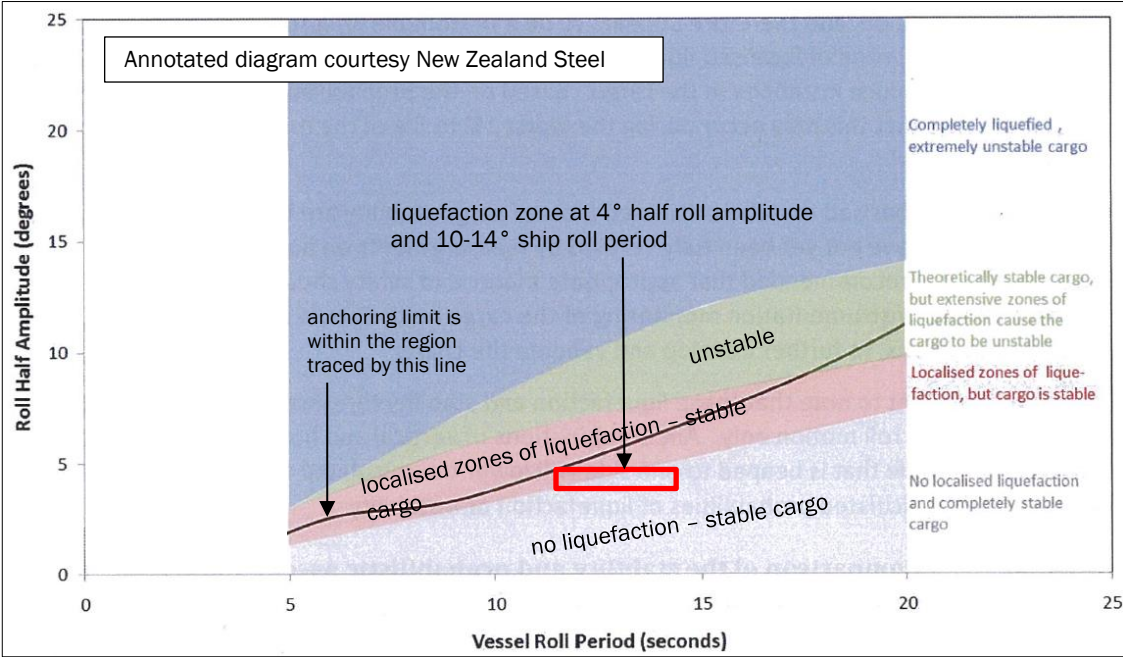
**Figure 7**  
**Calculated liquefaction and stability thresholds for a half-full cargo hold**

- 4.2.9. A half roll amplitude of 4° and a ship roll period between 10 and 14 seconds (the upper limit of the ship motion observed during the monitored cargo loading phases) had the potential to generate considerable localised liquefaction in a half-filled hold, but not enough to cause the ironsand to become unstable (the red rectangle in Figure 7).

- 4.2.10. In conclusion then, it is possible that localised pockets of liquefaction contributed to triggering the shift of cargo, but this would not have been the main cause.

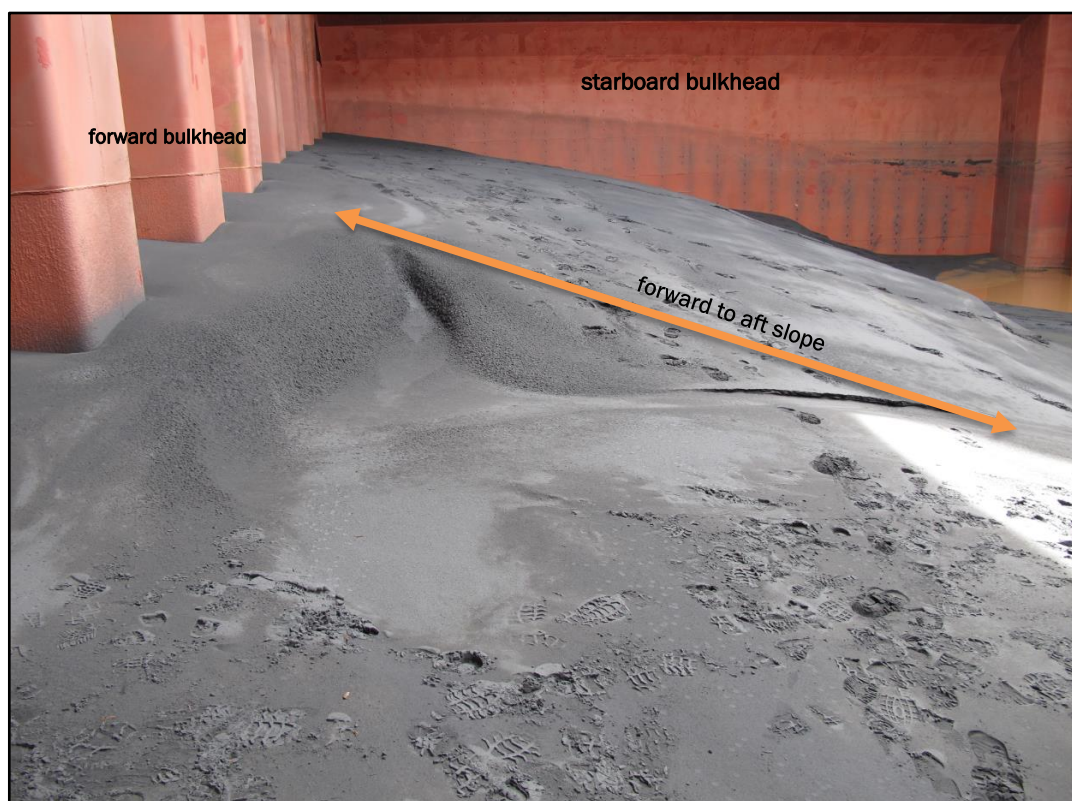
**Figure 8**  
Number 7 cargo hold

- 4.2.13. Figure 8 shows a photograph taken of the ironsand profile in number 7 cargo hold after the incident. The cargo profile is biased toward the starboard side of the cargo hold. The characteristic slope can be seen forming from forward to aft due to the loading nozzle being located at the forward end of the cargo hold. No ullage records were available for before the ship acquired a list.

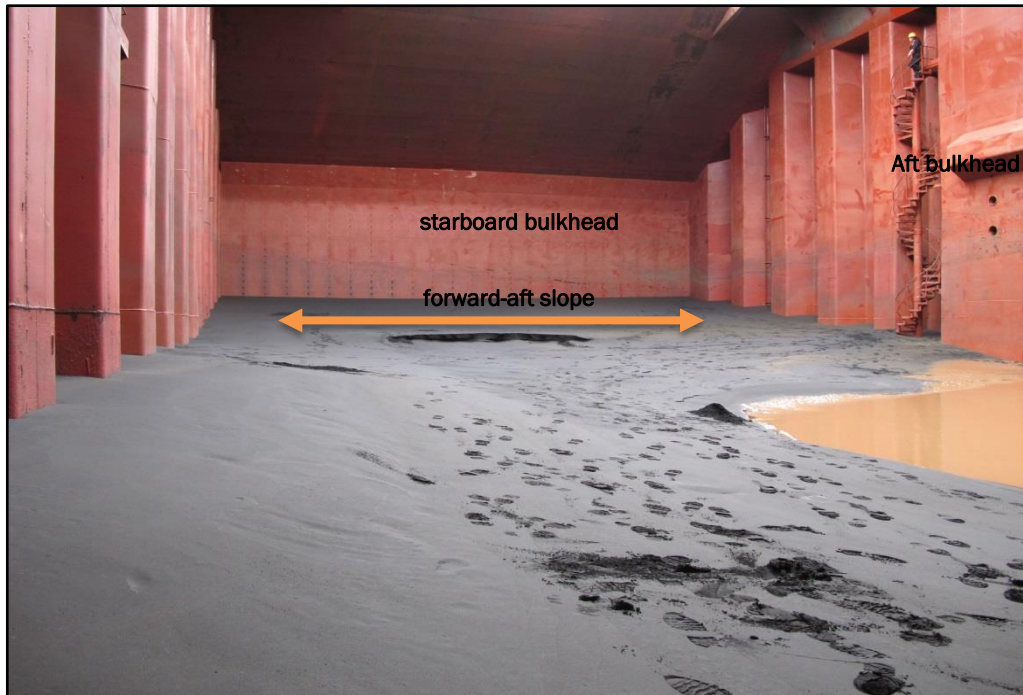
Figure 9  
Number 3 cargo hold

- 4.2.14. Figure 9 shows a photograph taken of the ironsand profile in number 3 hold after the incident. The ironsand in this hold showed the most significant signs of having shifted. There was no appreciable cargo slope from forward to aft, particularly on the starboard side, indicating that the cargo may have shifted from the port forward to the aft starboard corner of the hold.

- 4.2.15. Numbers 3 and 7 holds were being loaded simultaneously at the time of the incident. The *Taharoa Express* was lying side-on and rolling gently to the swell at the time. The loadmaster recalled feeling a series of slightly larger rolls just before the ship suddenly began to list. It is feasible that the ironsand was piled towards one side of the cargo hold's centreline, close to its underwater angle of repose. The bigger rolls felt just before the ship listed could have tipped the slope angle beyond  $24.7^\circ$ , causing the cargo to flow across number 3 hold and causing the initial sudden list. The sudden  $5^\circ$  list could also have initiated similar slumps in the other cargo holds. This would explain the list progressively increasing to  $9^\circ$ .

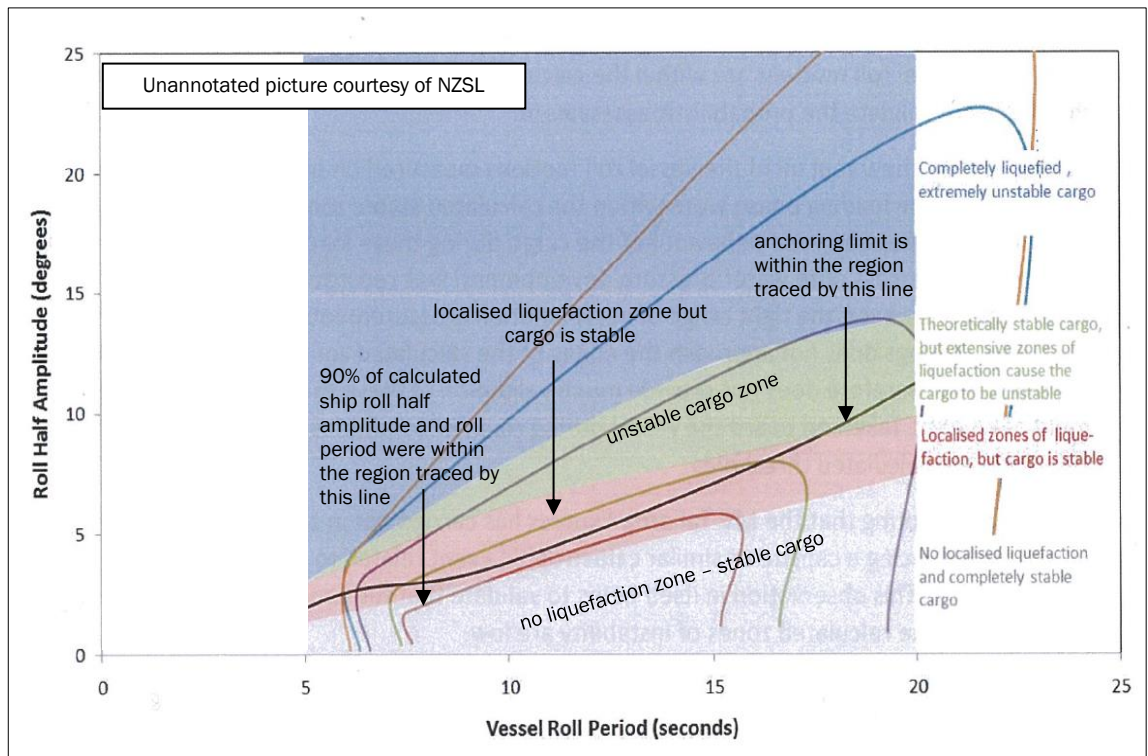
Probability of ship roll behaviour superimposed on the calculated zones of cargo liquefaction and stability for a half-full cargo hold (5-metre-deep, saturated ironsand)

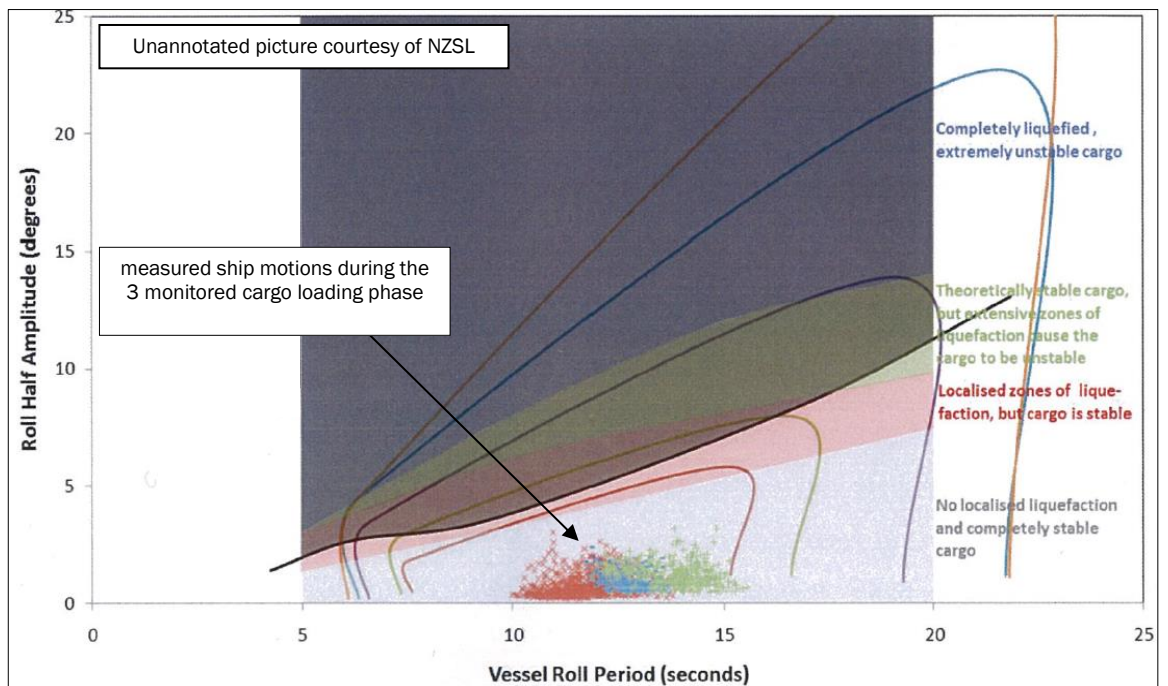
Measured ship motions plotted against the calculated liquefaction and stability thresholds for a half-full cargo hold (5-metre-deep, saturated ironsand)

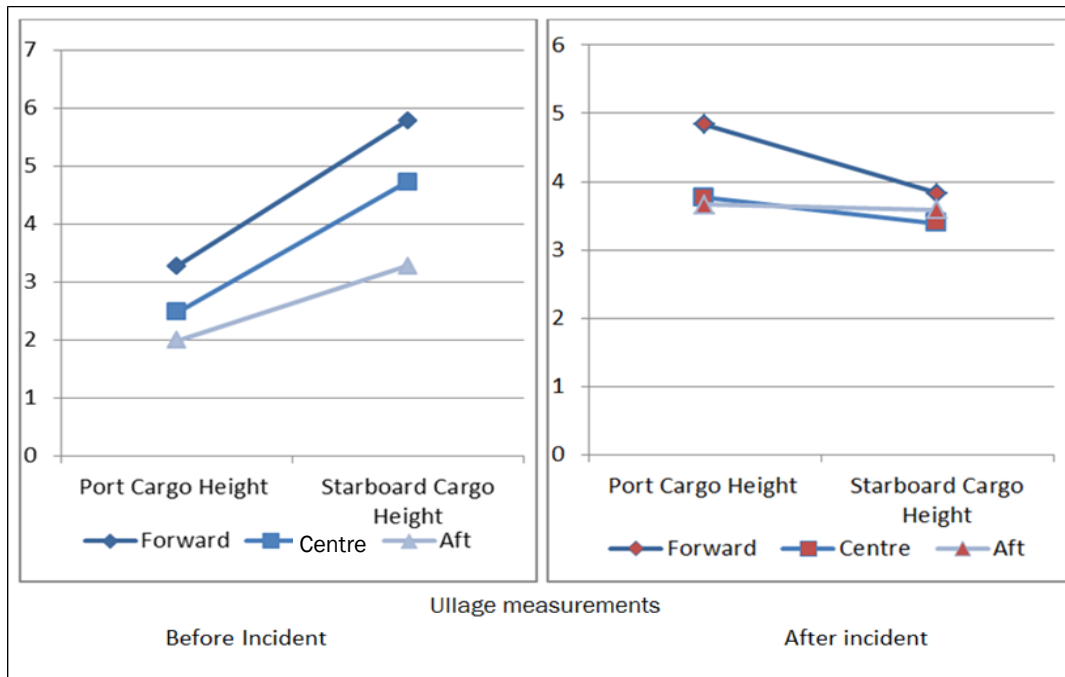
Ullage measurements number 1 hold

Number 1 hold: The measurements taken prior to the incident suggested that the ironsand was trimmed more to starboard than port. Post-incident measurements suggested that the ironsand moved in particular from forward starboard to aft port.

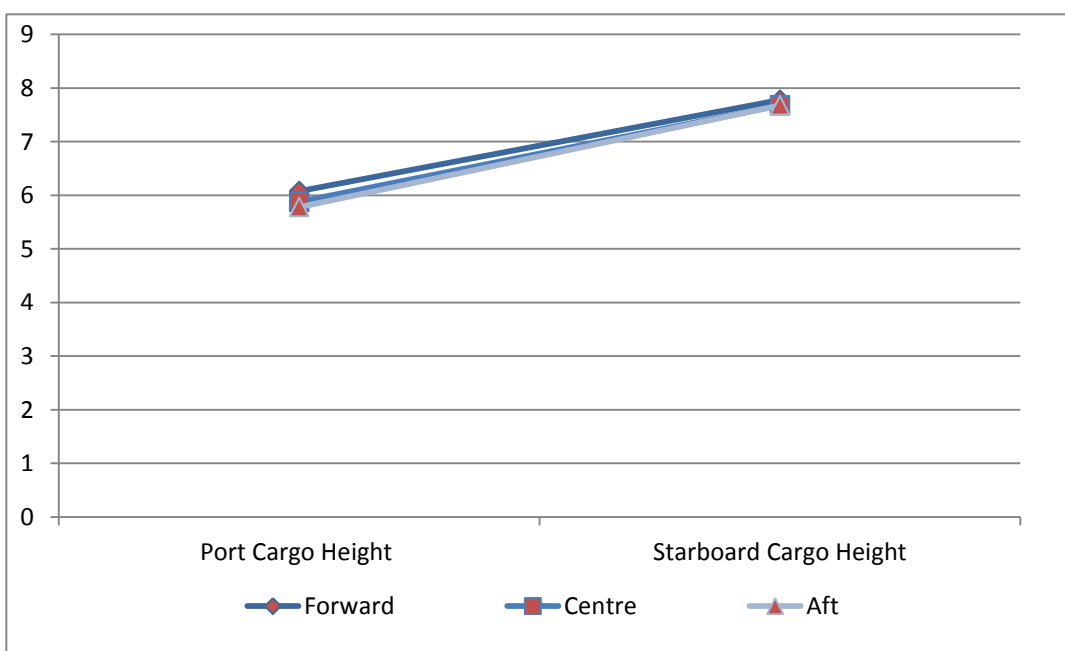
Ullage measurements - number 3 hold (after incident)

Number 3 hold: No ullage measurements were taken before the incident. The measurements taken after the incident indicated that the ironsand in the hold did not have an expected forward to aft slope. Ironsand had shifted towards the starboard side of the hold, particularly towards the aft starboard quarter of the hold.

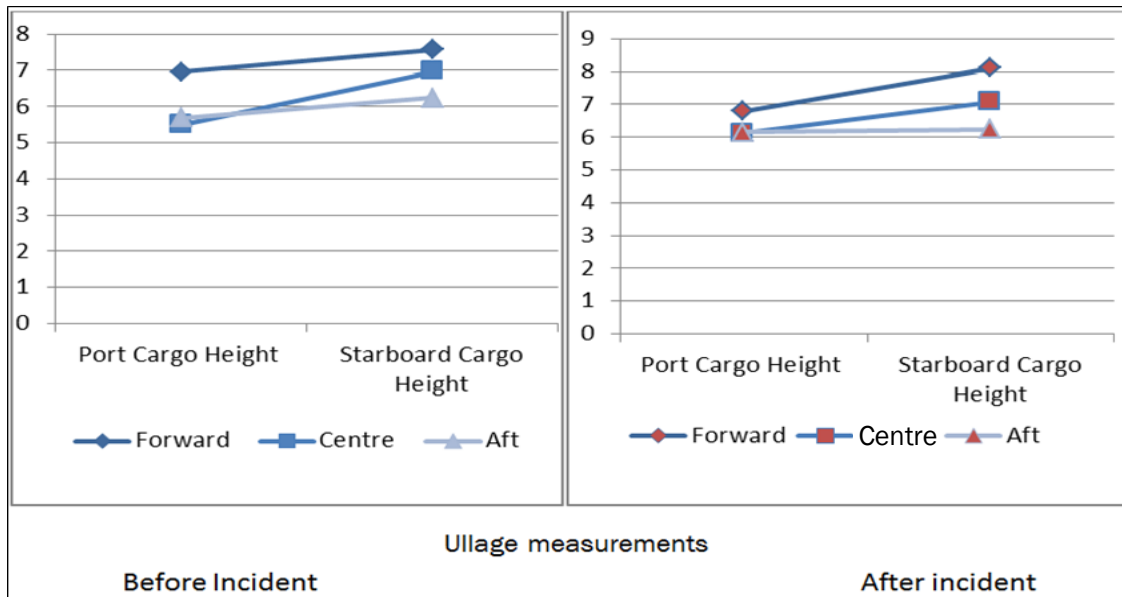
Ullage measurements – number 5 hold

Number 5 hold: Ullage measurements taken prior to the incident indicated that ironsand was trimmed more to starboard than port. The ironsand was sloping from forward to aft of the hold. Ullage measurements taken after the incident suggested that ironsand shifted to the forward starboard quarter and aft port quarter.

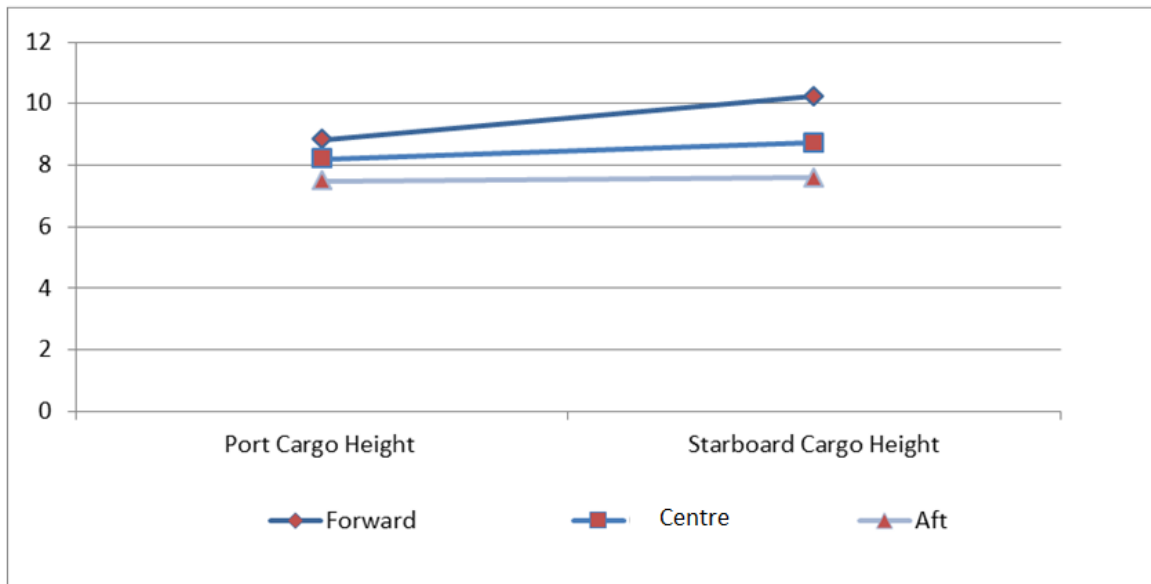
Ullage measurements – number 7 hold

Number 7 hold: No ullage measurements were taken before the incident. The measurements taken after the incident indicated that the ironsand had an expected forward to aft slope. The data also indicated an accumulation of ironsand on the forward starboard side of the hold.

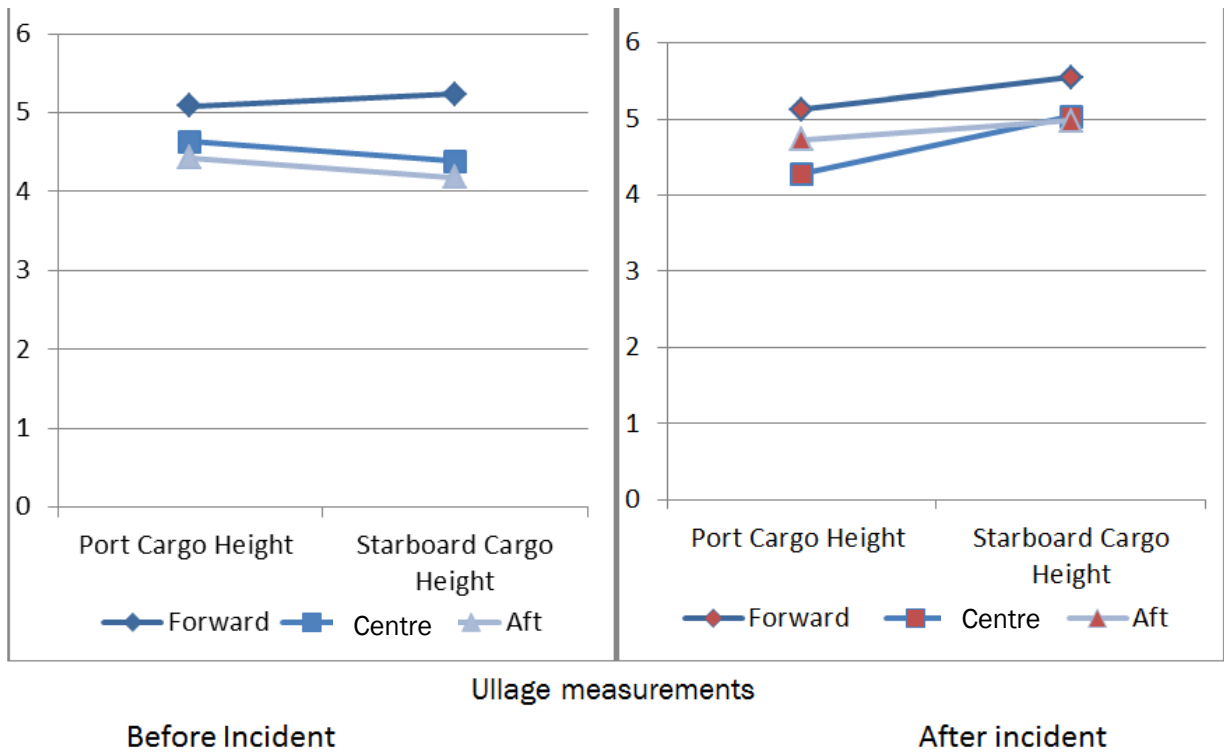
Ullage measurements – number 9 hold

Number 9 hold: Ullage measurements indicated that the ironsand had a forward-to-aft as well as a port-to-starboard slope. Measurements taken after the incident indicated a minor ironsand shift, from aft port to aft starboard.
