Aviation inquiry 10-005
Cessna A152, ZK-NPL and Robinson R22 Beta, ZK-HIE near-collision
New Plymouth Aerodrome
10 May 2010

Final Report

Approved for publication: October 2011

Transport Accident Investigation Commission

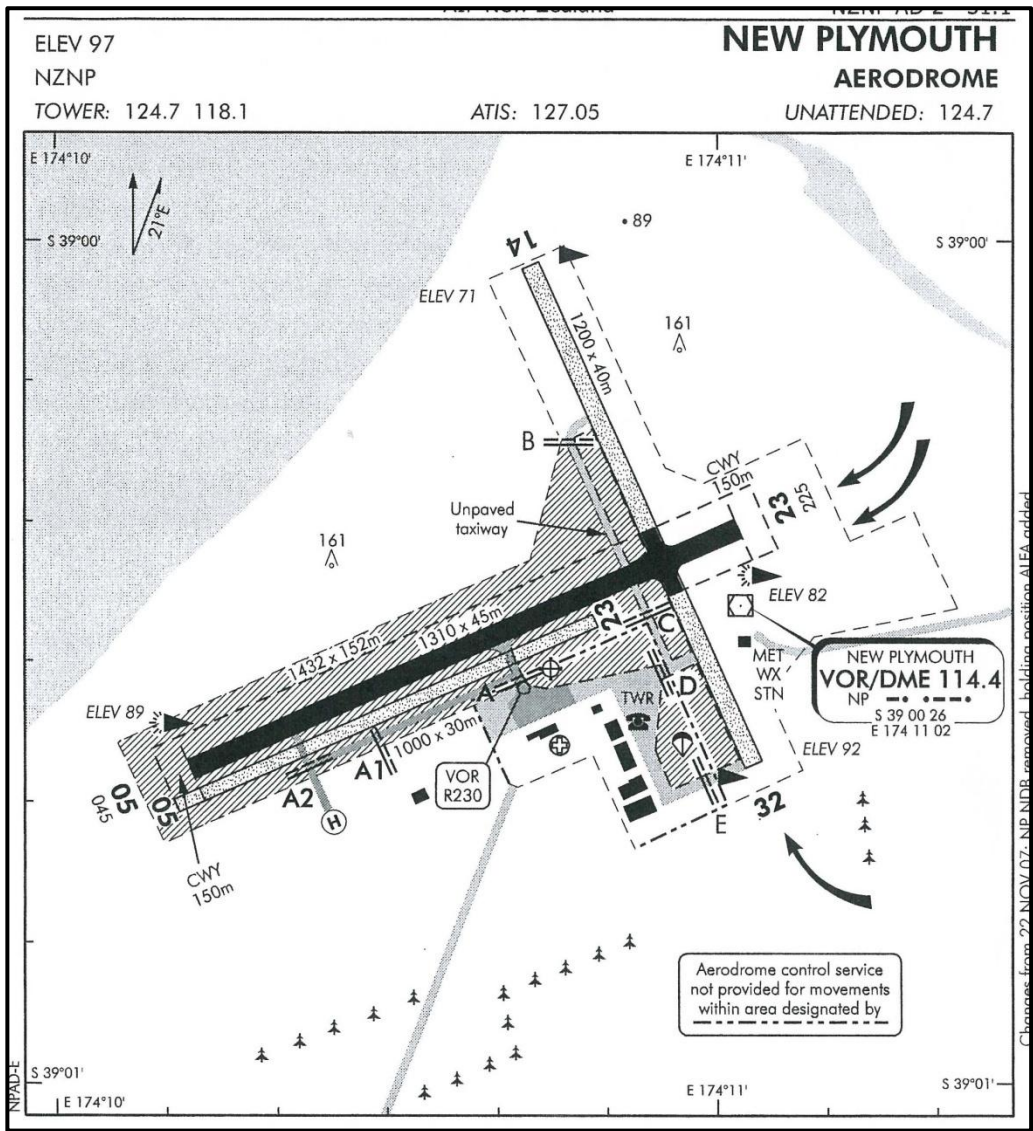
Figure 2
 New Plymouth Aerodrome

- 3.1.1. On 10 May 2010 at 0916, a Cessna 152 registered ZK-NPL (the aeroplane) departed from runway 05² at New Plymouth Aerodrome with an instructor and student on board for a training area east of the aerodrome (see Figure 1). The purpose of the flight, which was conducted under VFR, was consolidation before a flight test for the issue of a private pilot licence.
- 3.1.2. At 0927, a Robinson R22 Beta helicopter, registered ZK-HIE (the helicopter) and also operating under VFR, entered the control zone from New Plymouth city with an instructor and student pilot on board to conduct pre-solo training at the aerodrome. The controller later cleared the helicopter to operate in the runway 14 circuit, a published left-hand circuit (see Figure 2).

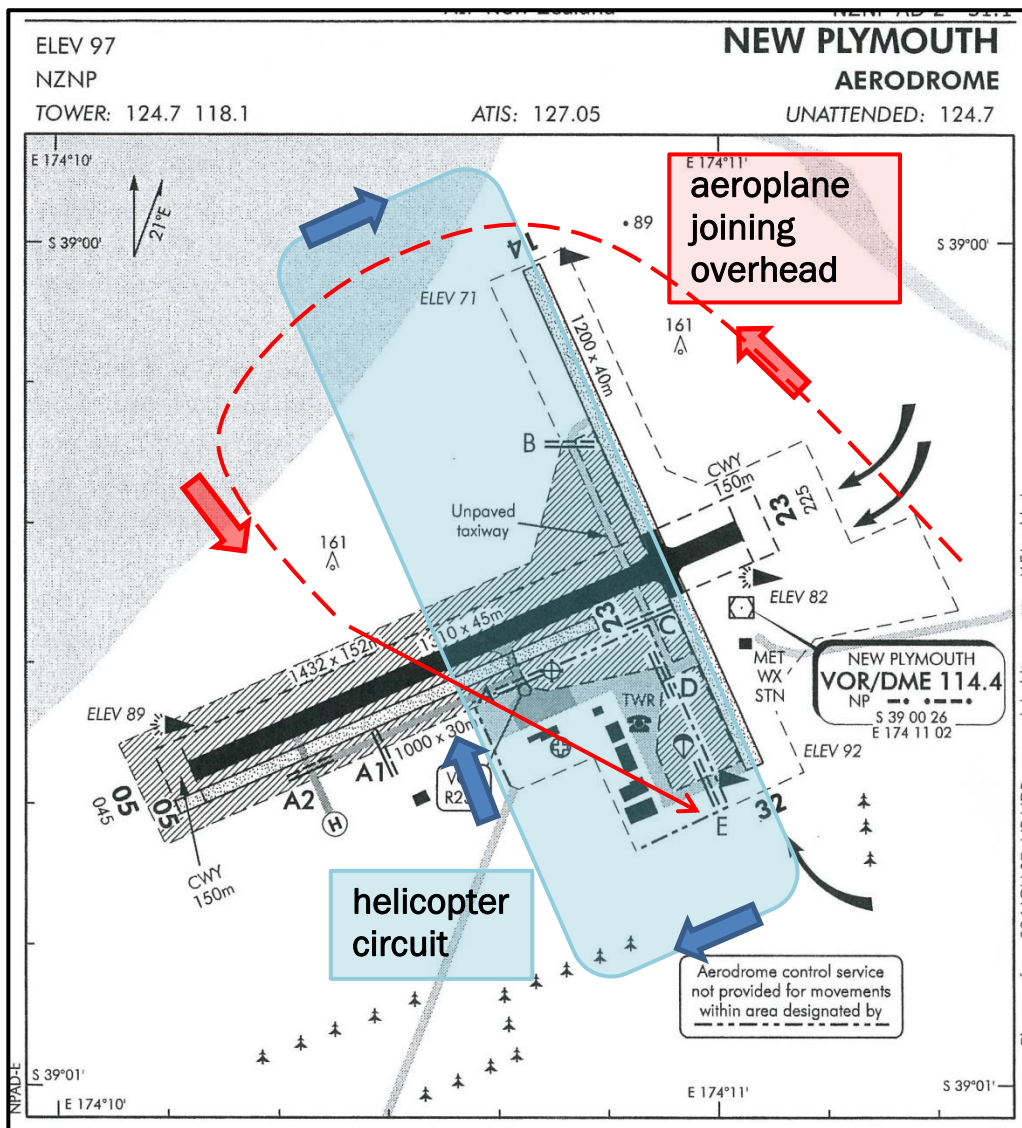
Figure 3
Conflicting flight paths

- 3.1.10. After the aeroplane had been cleared for a 'standard overhead rejoin runway 14', the helicopter instructor realised the aeroplane would descend through the helicopter's circuit. As the student (who was sitting in the right seat) began the right turn for the crosswind leg, the instructor told him to look for the aeroplane. The helicopter anti-collision beacon was on, but the instructor said he thought that the landing light, which was angled downwards for optimum use at night, was probably not on.

- 3.1.11. The helicopter was passing about 1400 ft on the climbing turn to the downwind leg when the instructor saw the aeroplane close above, heading towards him, so he took control and descended the helicopter straight ahead (see Figure 3). The helicopter student could not recall all of the earlier transmissions from the aeroplane and he did not see the aeroplane until the instructor took control. The instructor asked the controller whether the aeroplane had had the helicopter in sight, to which one of the aeroplane pilots replied 'affirm[ative]'.

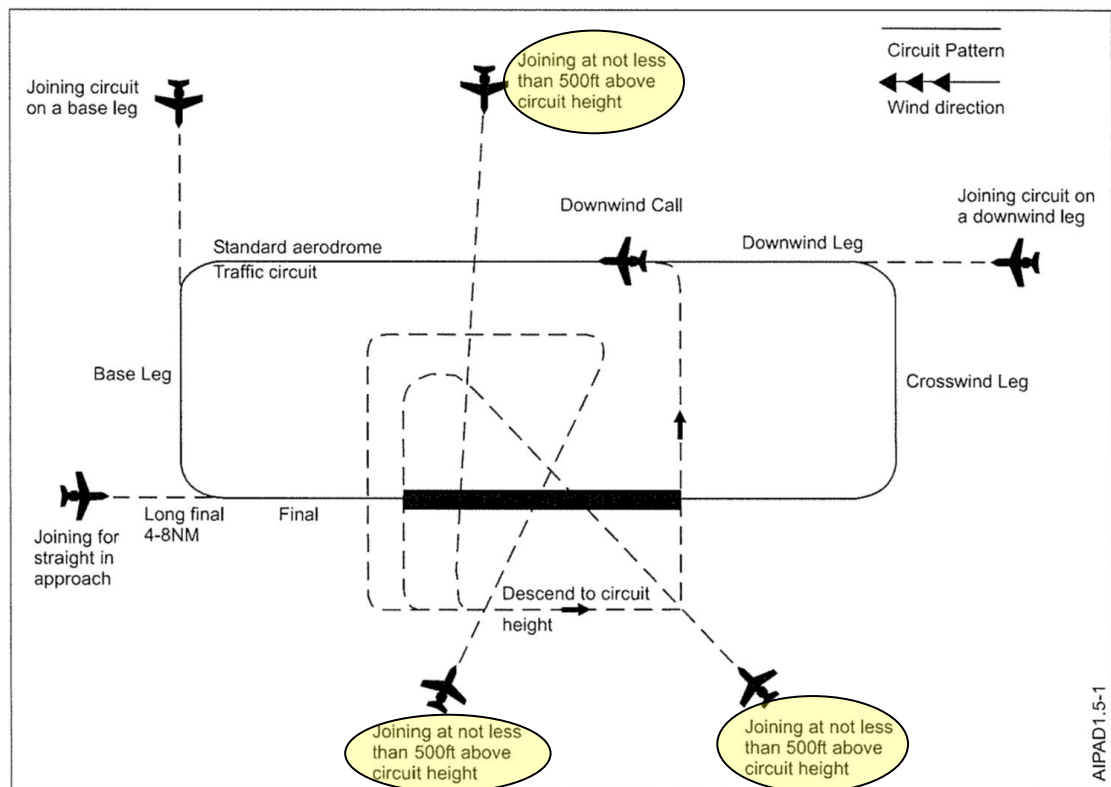
Figure 4

3.5.14. The importance of joining a circuit correctly was illustrated by the CAA flight test standards stating that a pilot who joined contrary to preceding traffic and who failed to maintain sight of the traffic would be declared 'not yet competent' in that criterion.⁶
