Report 10-006: Runway Incursion, Dunedin International Airport, 25 May 2010

Aviation Inquiry 10-006  
Runway Incursion, Dunedin International Airport  
25 May 2010

Approved for publication: December 2010

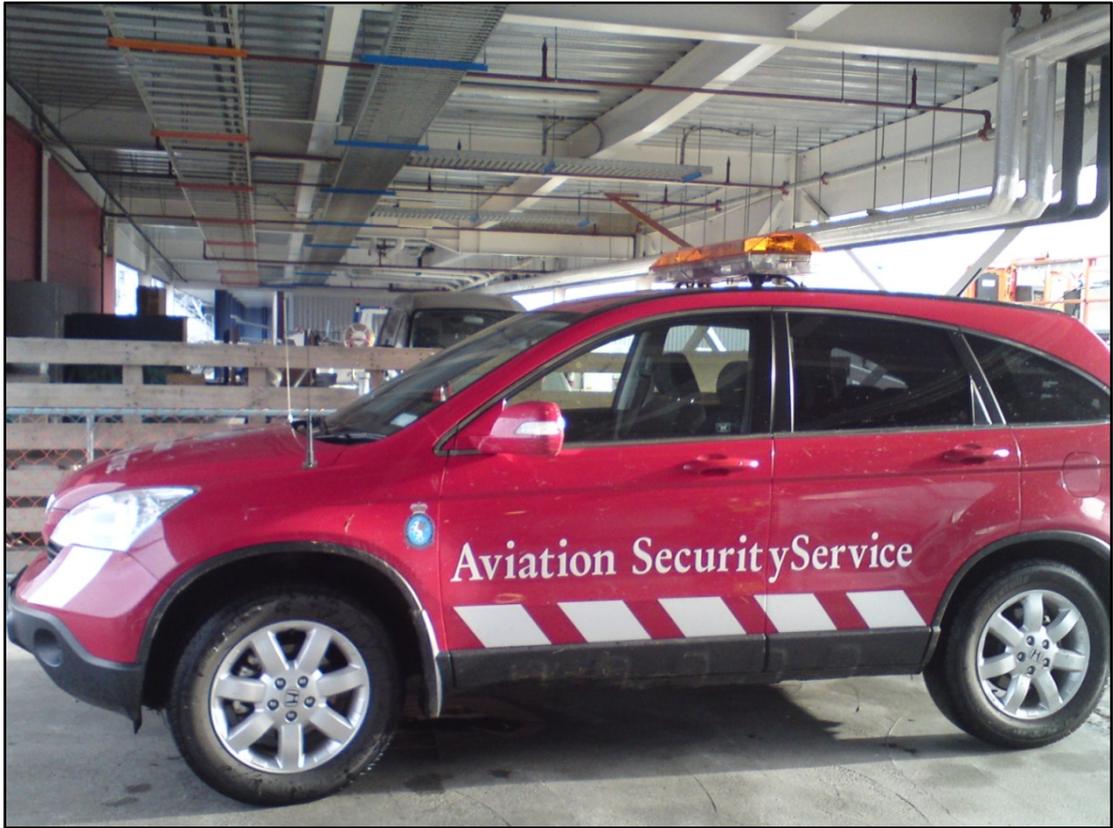
Figure 1  
The Aviation Security Service patrol vehicle

- 3.2.3. The Avsec vehicle was a red-coloured Honda CRV 4-wheel-drive vehicle equipped with rotating hazard beacons and radio communication equipment that met the requirements of Civil Aviation Rules Part 140.<sup>3</sup>
- 3.2.4. The vehicle equipment was serviceable and functioning correctly at the time of the incident. A plan of the airport was available in the cab.

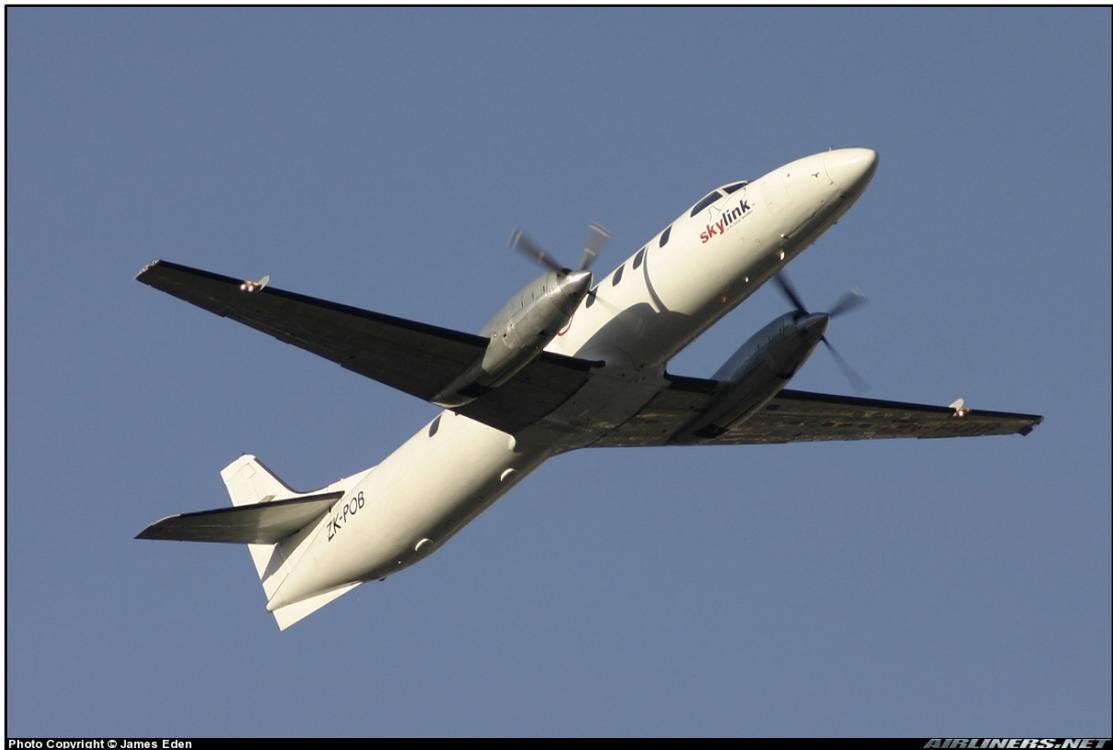
Figure 2  
Metroliner ZK-POB  
(photograph used with permission)

- 3.2.1. The Metroliner SA227-AC was a pressurised twin-turboprop aeroplane with 2 Honeywell (Garrett) TPE331-11U-611 engines, manufactured by Fairchild Aircraft Corporation in the United States in 1985.
- 3.2.2. The aeroplane was designed to be operated by 2 pilots and carry passenger, cargo or mixed loads. The maximum certified take-off weight was 16 000 pounds (7257 kilograms).

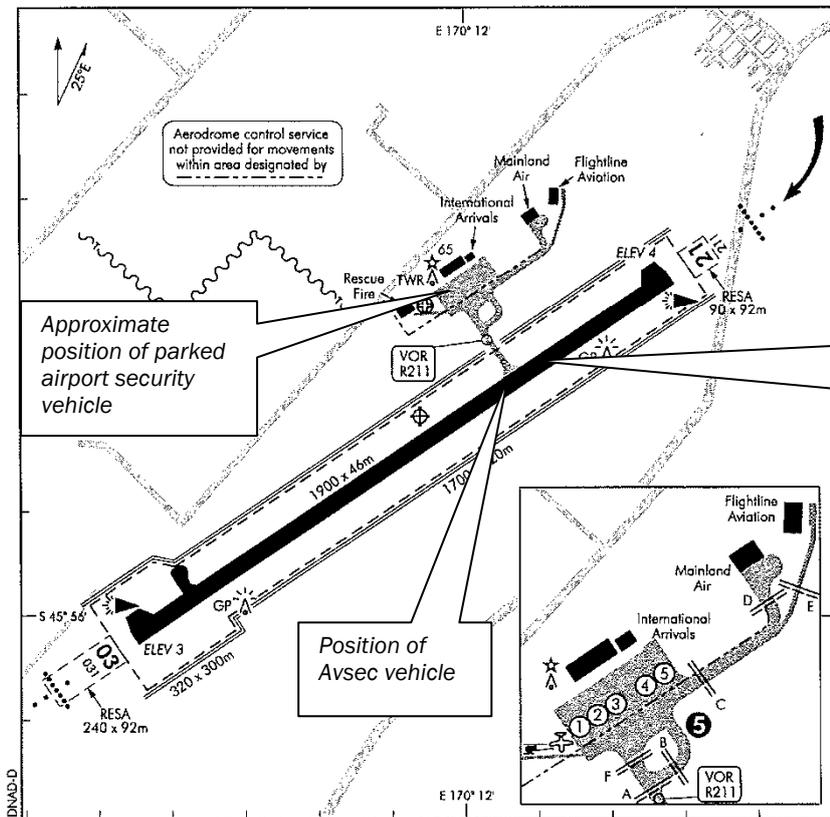
Figure 4  
 Dunedin International Airport

- 3.1.11. The airport CCTV recording showed that the Avsec officer drove past the night security agent's vehicle parked near Gate One by the terminal just after 0608, and proceeded straight to the taxiway, entering the runway approximately 25 seconds later (see Figure 4). The vehicle lights and rotating beacons were seen to be on and reflecting off the rain and standing water on the apron. The night security agent said that the Avsec officer waved to him as he drove past and that the vehicle travelled quickly along the taxiway and was not seen to stop before it entered the runway. The aeroplane was not identifiable on the CCTV recording because of scattered light in the heavy rain.

- 3.1.14. The Avsec officer said that as he turned right from the taxiway onto the shoulder of the runway he stopped quickly, because the reflection of the vehicle lights and rotating beacons off the rain were making it difficult for him to see. He was about to turn back and leave the runway when he heard and saw Post 91 overtake him, about 10 metres away.
