Aviation inquiry 10-007:  
Boeing 737-800, ZK-PBF and Boeing 737-800, VH-VXU, airspace incident,  
near Queenstown Aerodrome, 20 June 2010

# Final Report

10-007  
Boeing 737-800, ZK-PBF and  
Boeing 737-800, VH-VXU  
airspace incident  
near Queenstown Aerodrome  
20 June 2010

Approved for publication: 13 March 2012

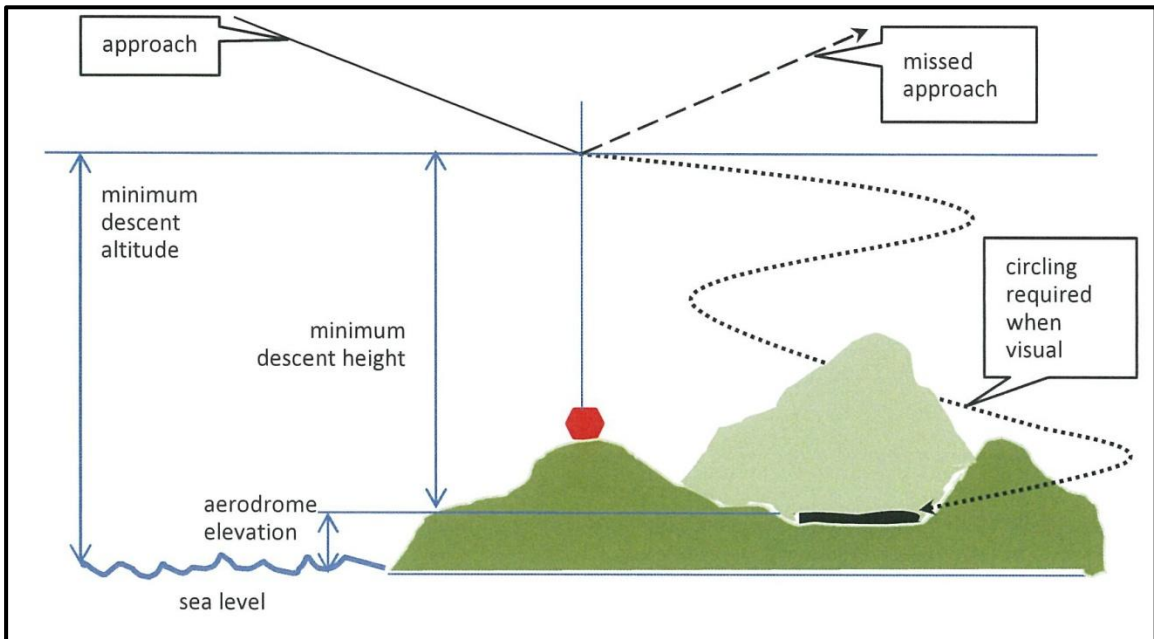
Figure 2  
Example of instrument approach in mountainous terrain

- 3.1.6. For a particular type of approach procedure, the minimum descent height above an aerodrome varies according to the height and proximity of the terrain and obstacles surrounding the aerodrome. For example, an approach to an aerodrome located on an extensive Tibetan plateau will have a higher minimum descent altitude, because Tibet is well above sea level, but could have a much lower minimum descent height than a similar type of approach to an aerodrome like Queenstown, which is closer to sea level but closely surrounded by high mountains (see Figure 2).

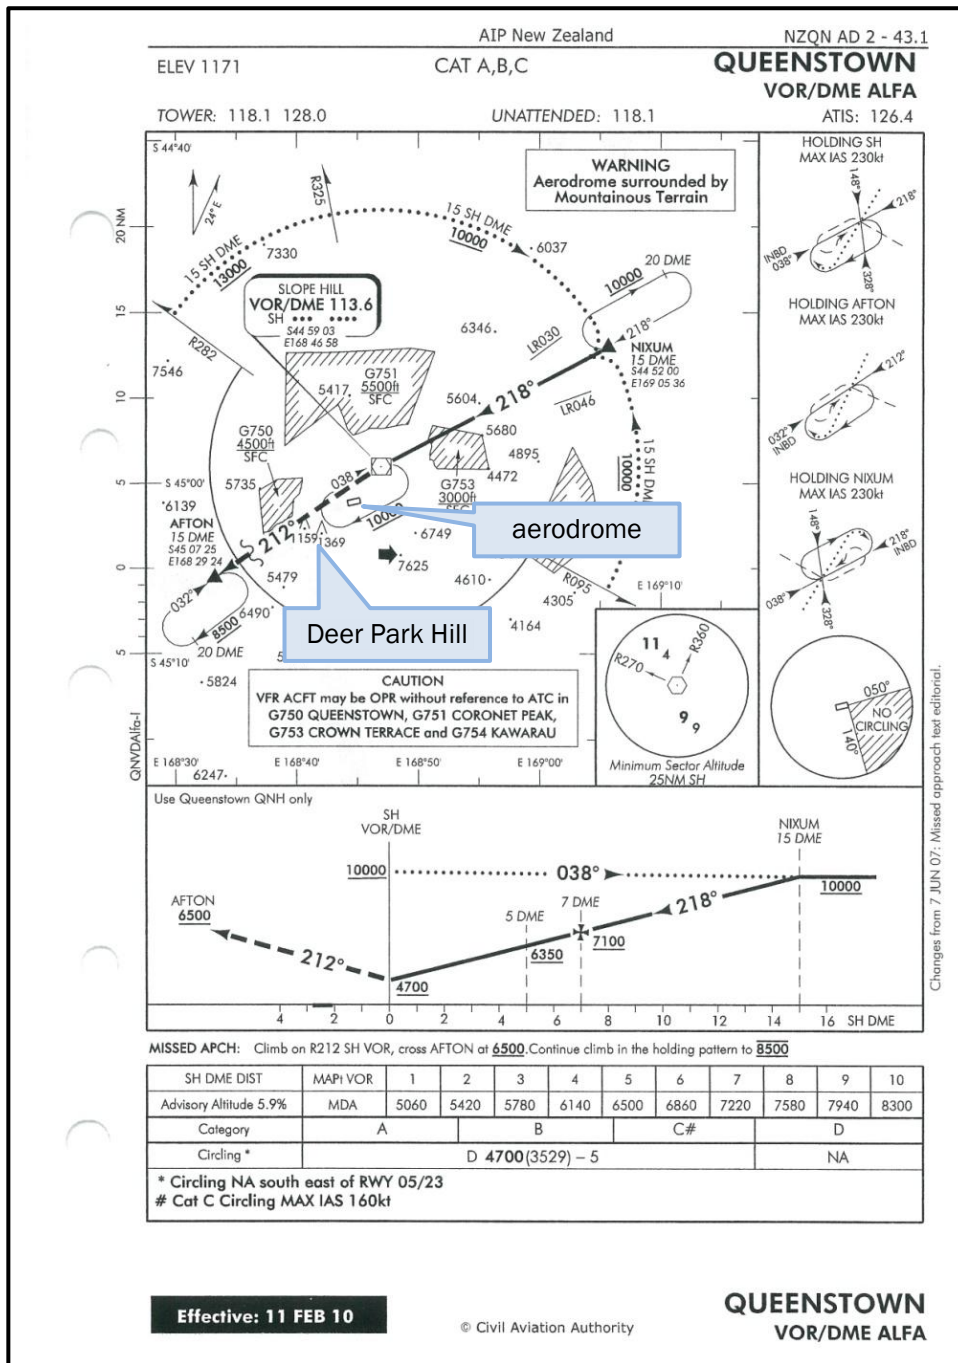
**Figure 3**  
Approach flown by Pacific Blue

- 3.2.8. Twenty seconds later, Pacific Blue advised it would now track overhead the aerodrome and 'try' an approach to runway 05. It did not request a revised clearance to the different runway, as it should have done, and ATC did not explicitly re-clear it. The pilots then asked ATC about the cloud to the south and over the Frankton Arm, because they found it difficult to discern the height of the cloud tops, and were told the cloud was quite thick to the south but the Frankton Arm looked clear.

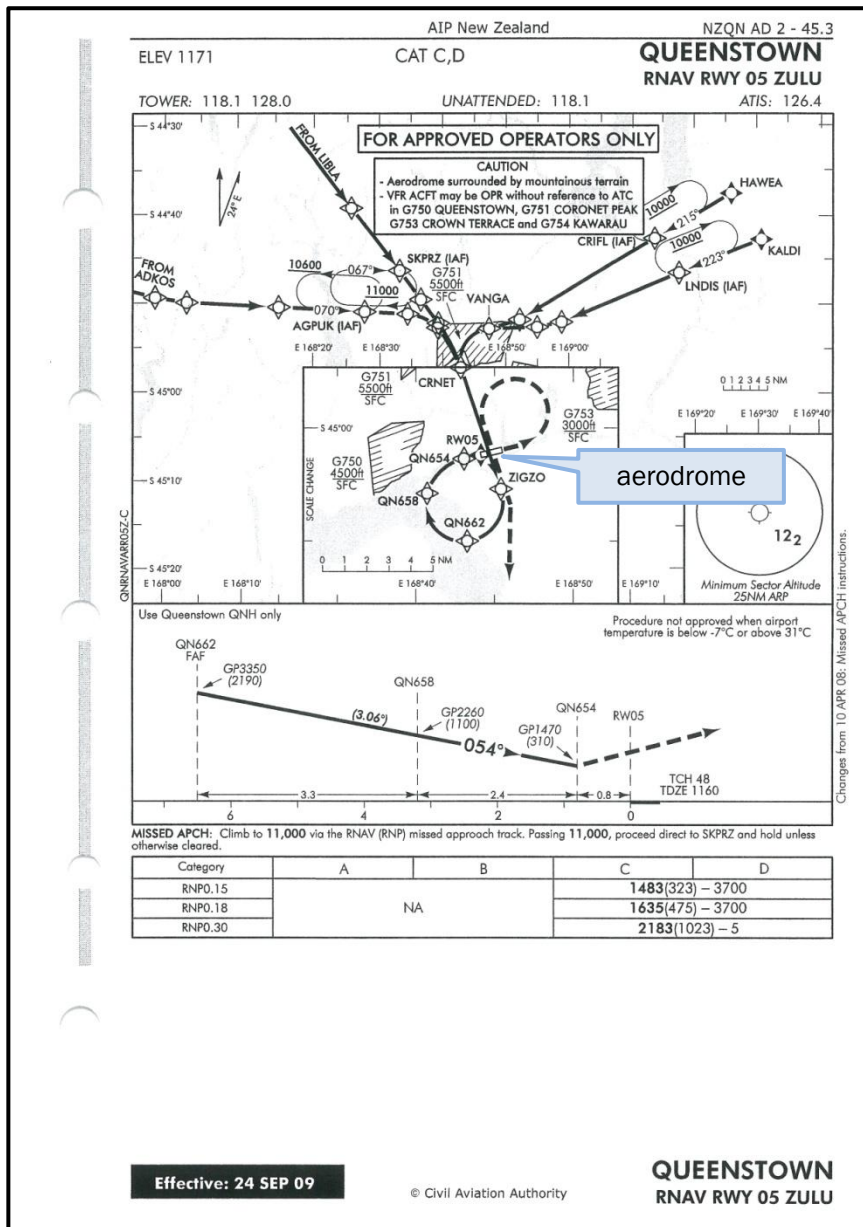
**Figure 5**  
Approach flown by Qantas

- 3.2.14. Pacific Blue was not authorised for the same high-precision approaches as Qantas, so its pilots did not know all of the positions referred to by ATC and Qantas, and were concerned initially that Qantas might be on an approach that came over the lake in the opposite direction to the missed approach track they were flying.<sup>7</sup> At one point the Pacific Blue pilots observed a target on their traffic display, a couple of miles behind and 800 ft or 900 ft above them.<sup>8</sup> The collision avoidance systems fitted to the aeroplanes did not generate any traffic advisories or warnings.

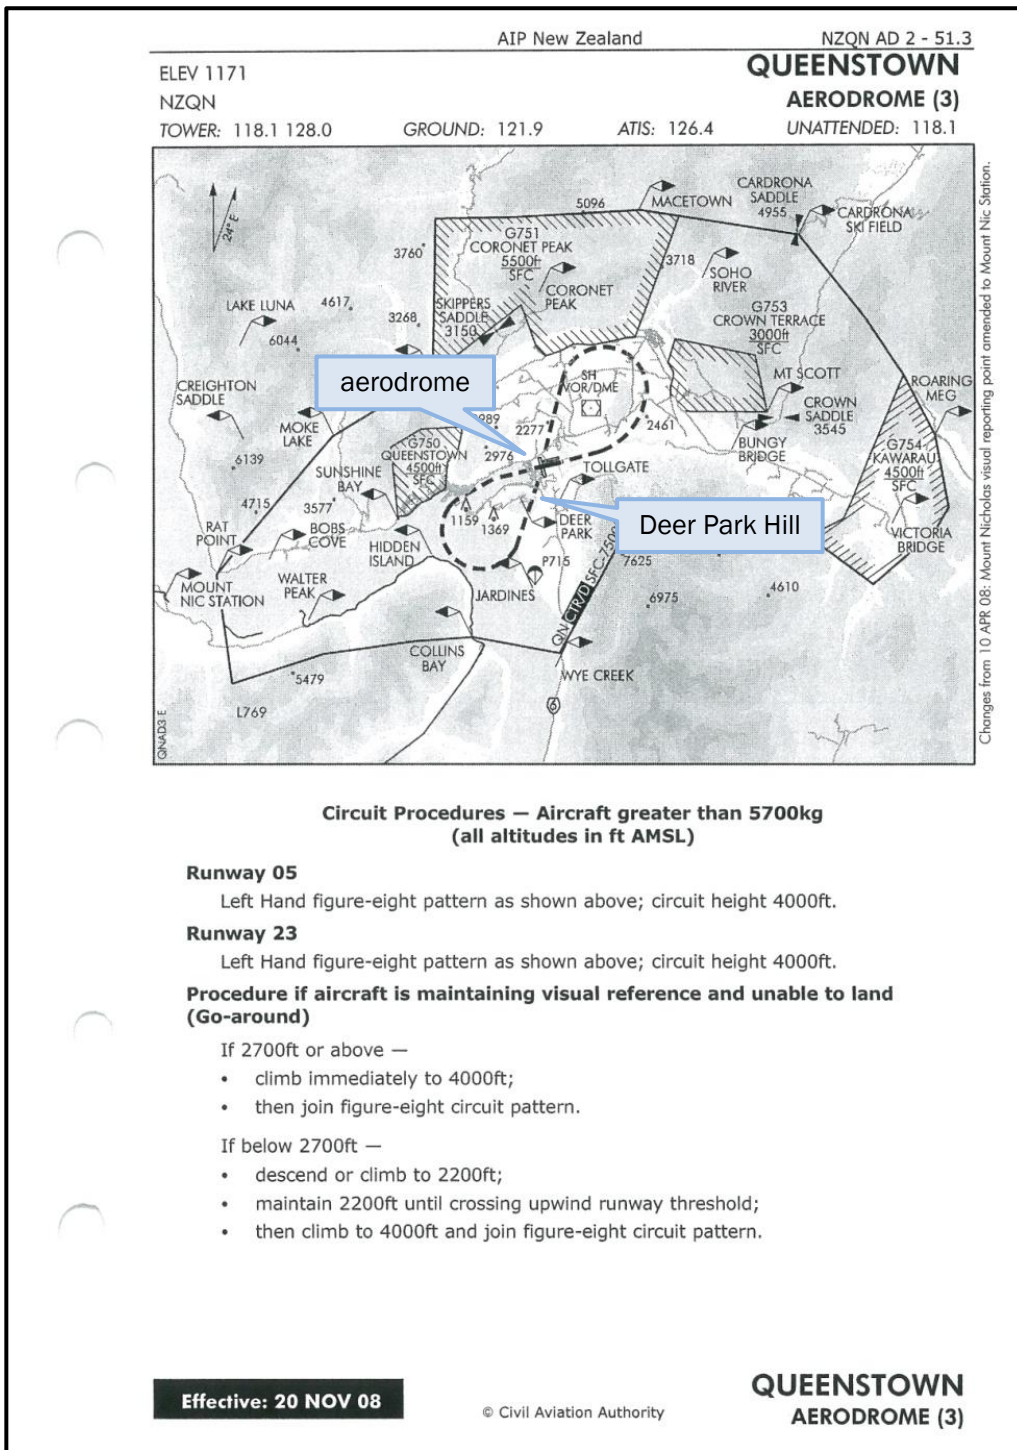
**Figure 6**  
Visual circuit for large aircraft

3.5.4. The different circuit for larger aircraft arose from airline concerns that a jet aeroplane going around from its final approach to the main runway 05/23 could conflict with an aircraft on the downwind leg of the circuit for the crossing grass runway. The internal 'Request for Change' submitted by the aerodrome chief controller noted there was a right-hand circuit for runway 23 promulgated under Civil Aviation Rules<sup>19</sup>, but added 'terrain prohibits large aircraft carrying out [the published] circuits, so the airlines have adopted a figure-8 type circuit pattern.'

- 3.5.9. In response to observations made during this investigation, the chief controller initiated an AIP change to correct the description of the figure-8 circuit and clarify its purpose. On 10 February 2011, the chart sub-title was amended to read, 'Procedure if aircraft is maintaining visual reference or circling from an instrument approach and unable to land.' The supporting documentation for the change request noted that, if the change were not implemented, there was 'a high risk of misinterpretation by pilots unfamiliar with the procedure'. The request also stated that 'no one has been asked to consult on this [change]', and the potential for the procedure to be misinterpreted had not been identified earlier due to the procedure's 'very rare use.'

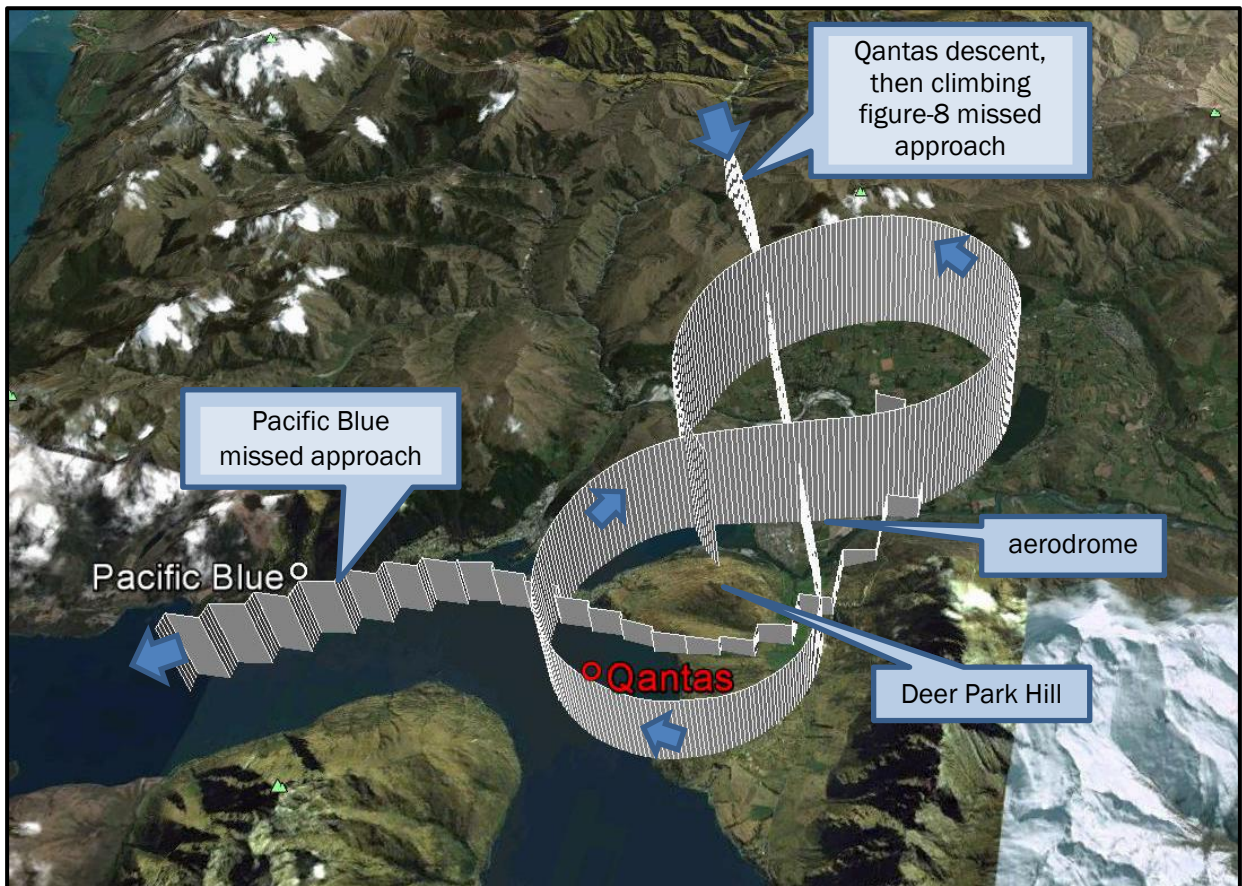
**Figure 7**  
**Flight paths of both aeroplanes**  
 (Image courtesy of the Australian Transport Safety Bureau)

3.3.6. Pacific Blue was climbing through about 6300 ft when the aeroplane intercepted the prescribed missed approach track approximately 7 miles from the VOR/DME, which was the start point for the missed approach procedure. The procedure design minimum altitude at 7 miles was 5528 ft.<sup>13</sup>
