Interim Factual Report 10-008: Cessna C152 ZK-JGB and Cessna C152 ZK-TOD,  
mid-air collision, near Feilding, Manawatu, 26 July 2010

# Interim Factual Report

Aviation Inquiry 10-008: Cessna C152 ZK-JGB  
and Cessna C152 ZK-TOD, mid-air collision, near  
Feilding, Manawatu, 26 July 2010

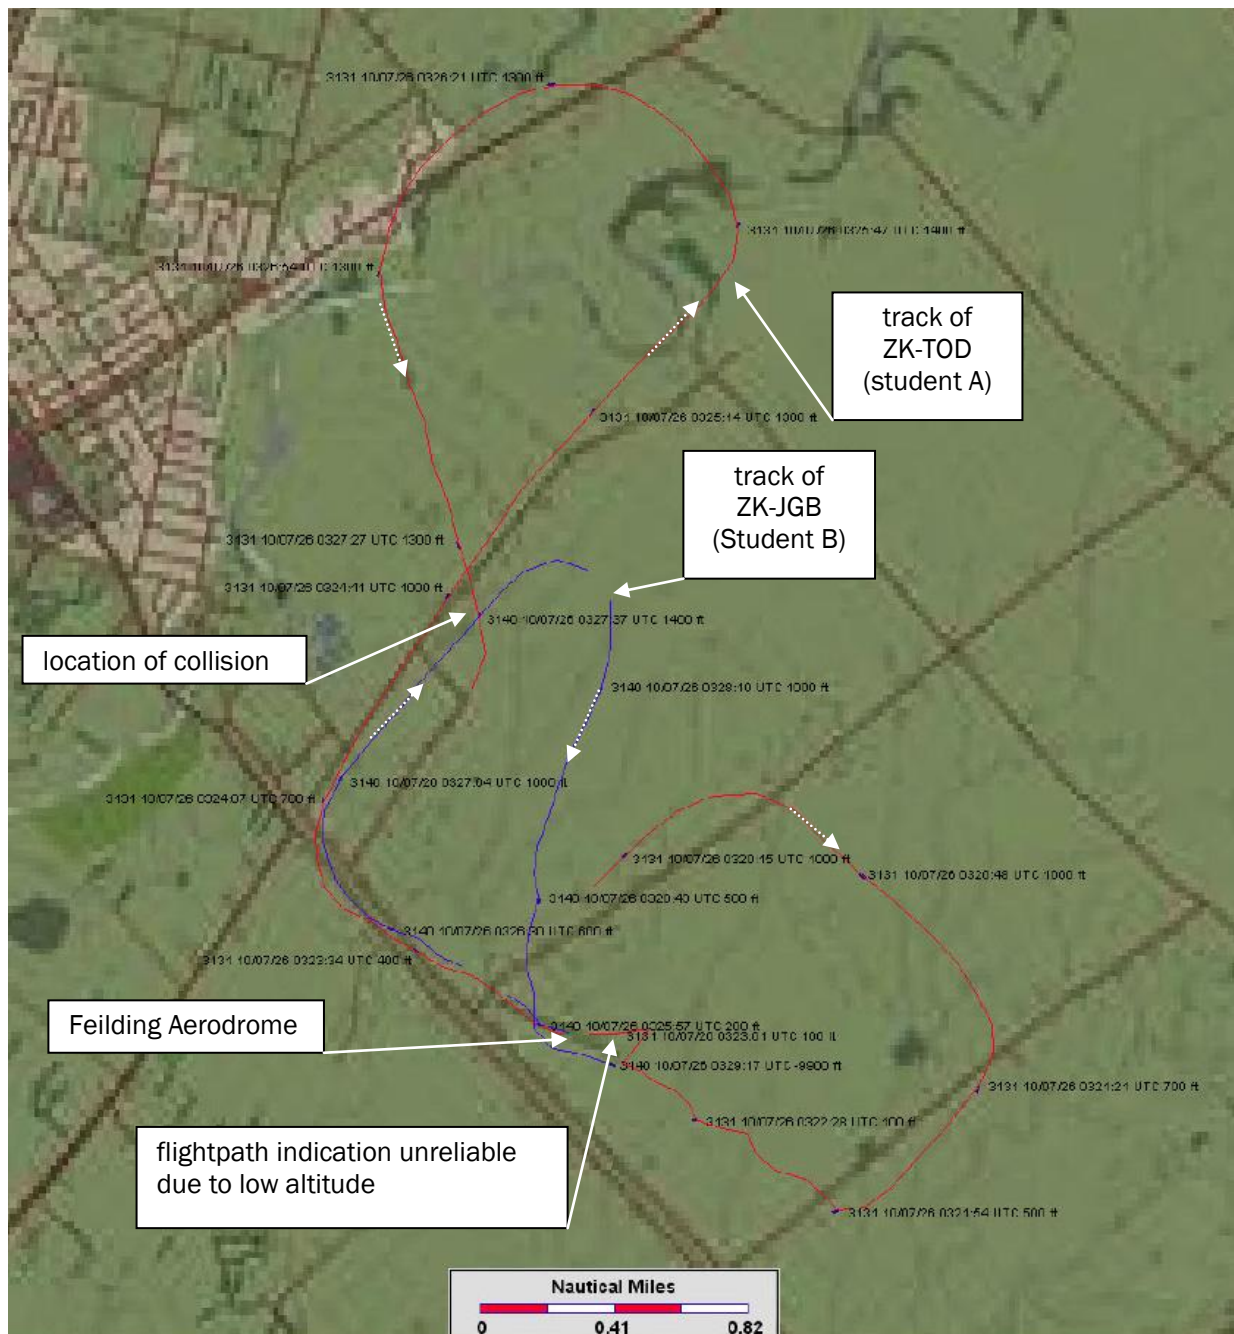
**Figure 1**  
**Radar Recording**  
(Courtesy of Airways New Zealand)

- 1.1.7. At 1526:59, ZK-TOD was 3 nautical miles to the north-west of the aerodrome, near the eastern boundary of Feilding township, having just completed a left turn. The radar data showed the aircraft was now tracking directly towards the aerodrome, with a recorded altitude of 1300 feet, having descended from 1400 feet during the left turn (see Figure 1). At the same time, ZK-JGB had turned right onto a crosswind leg and was climbing through 900 feet. Student B was heard to have transmitted that ZK-JGB was crosswind and vacating to the training area to the north.

- 1.1.8. The radar recording showed ZK-TOD and ZK-JGB continued to maintain constant tracks as they closed on each other, with ZK-TOD maintaining 1300 feet and ZK-JGB climbing steadily. At 1527:36 the 2 aircraft collided. Student B later reported that he heard a loud noise and the aircraft nose then pulled down. The engine stopped soon after. ZK-TOD was seen to enter a steep descending spiral dive before impacting the ground, fatally injuring the 2 occupants. As a result of the collision the engine on ZK-JGB stopped. However, student B was able to glide back to the aerodrome and landed on the side of runway 10 with the nose wheel trailing rearwards. Student B was not injured.

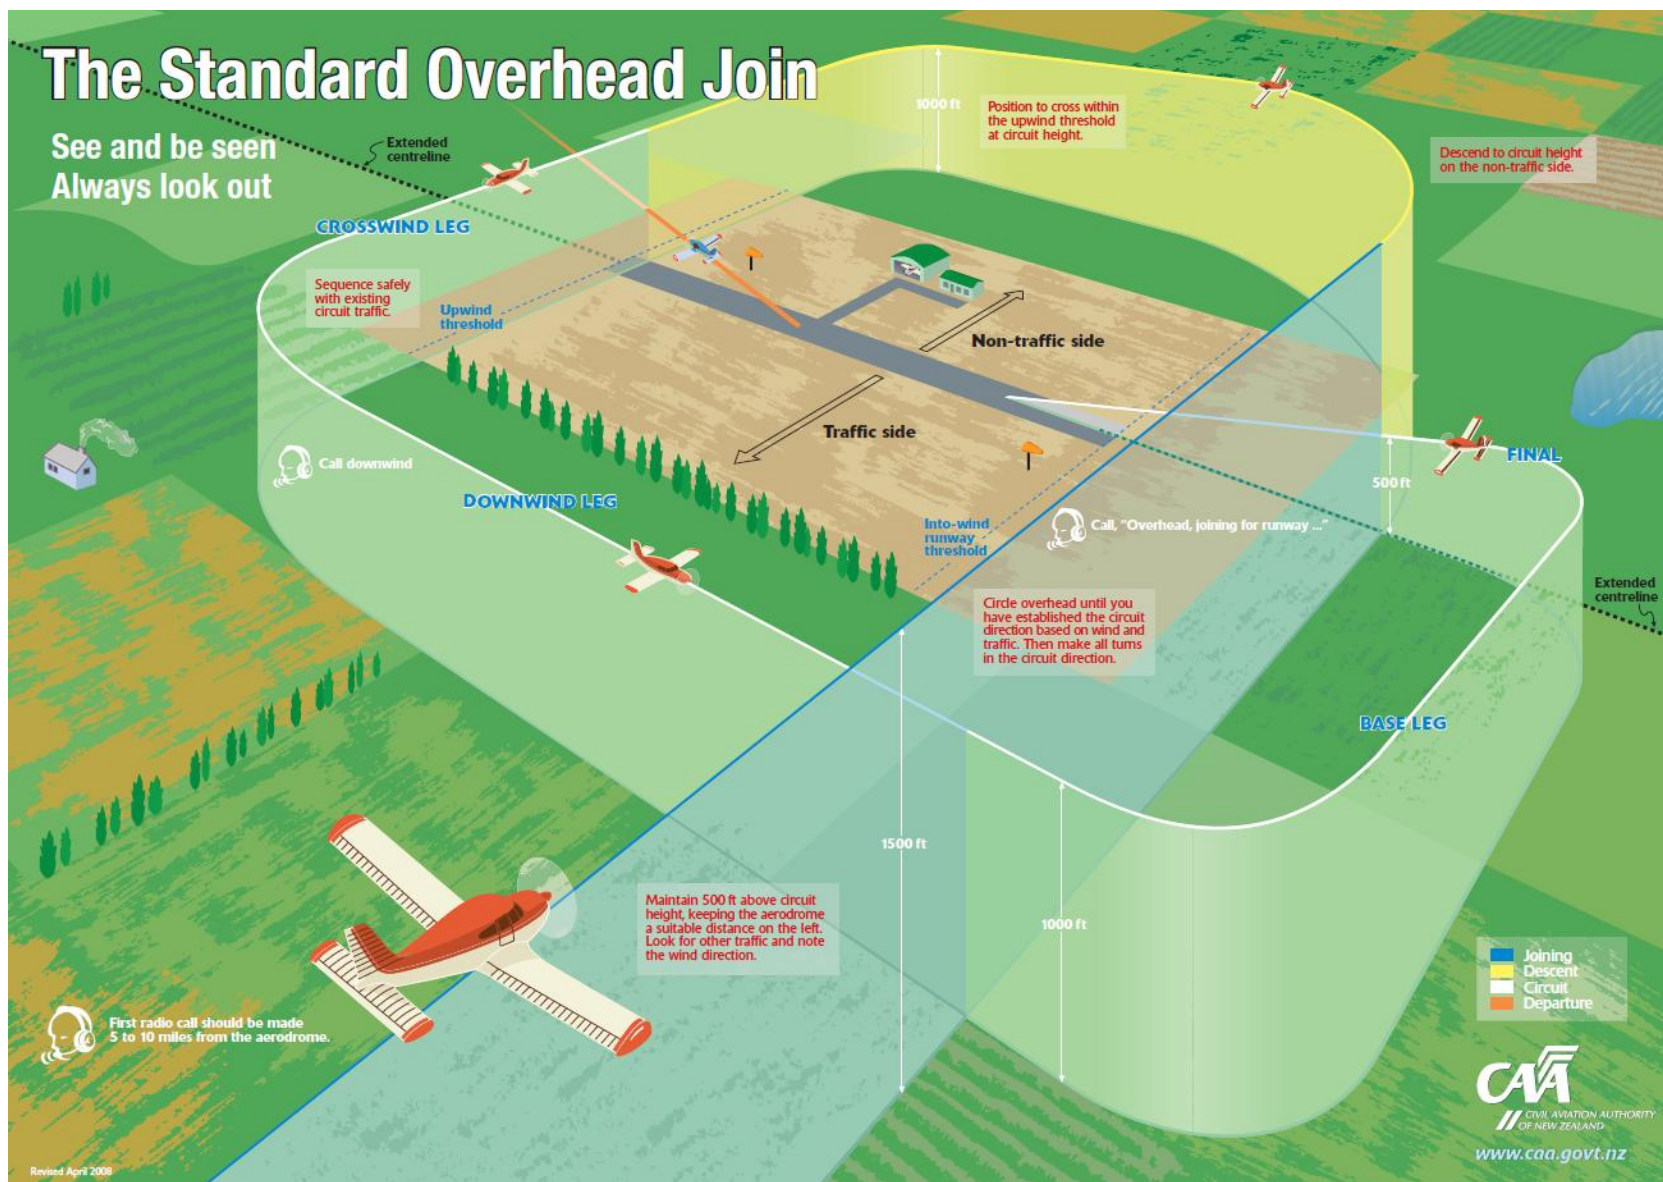
Figure 2  
Standard overhead joining procedure  
(Courtesy of the CAA)

- 1.3.1. Feilding Aerodrome was located 3 nautical miles to the south east of Feilding. It consisted of a single sealed runway surrounded by a grass verge. The runways were aligned 280/110° magnetic. Local procedures required aircraft to circuit to the north of the runway, resulting in runway 28 being a right-hand circuit and runway 10 left-hand.
- 1.3.2. The aerodrome was 214 feet above mean sea level, resulting in a normal circuit altitude of 1200 feet. Local procedures stated an initial overhead joining altitude of 1500 feet, due to this being the lower limit of controlled airspace above the aerodrome.
- 1.3.3. The overhead join was a common means of joining the aerodrome to land. Aircraft would join overhead the aerodrome at 500 feet above the circuit altitude before descending to join the circuit.
