Addendum to Final Report AO-2010-009: Walter Fletcher FU24, ZK-EUF
loss of control on take-off and impact with terrain,
Fox Glacier aerodrome, South Westland, 4 September 2010

Addendum to Final Report

Aviation inquiry 10-009
Walter Fletcher FU24, ZK-EUF
loss of control on take-off and impact with terrain
Fox Glacier aerodrome
South Westland
4 September 2010

Approved for publication: September 2015

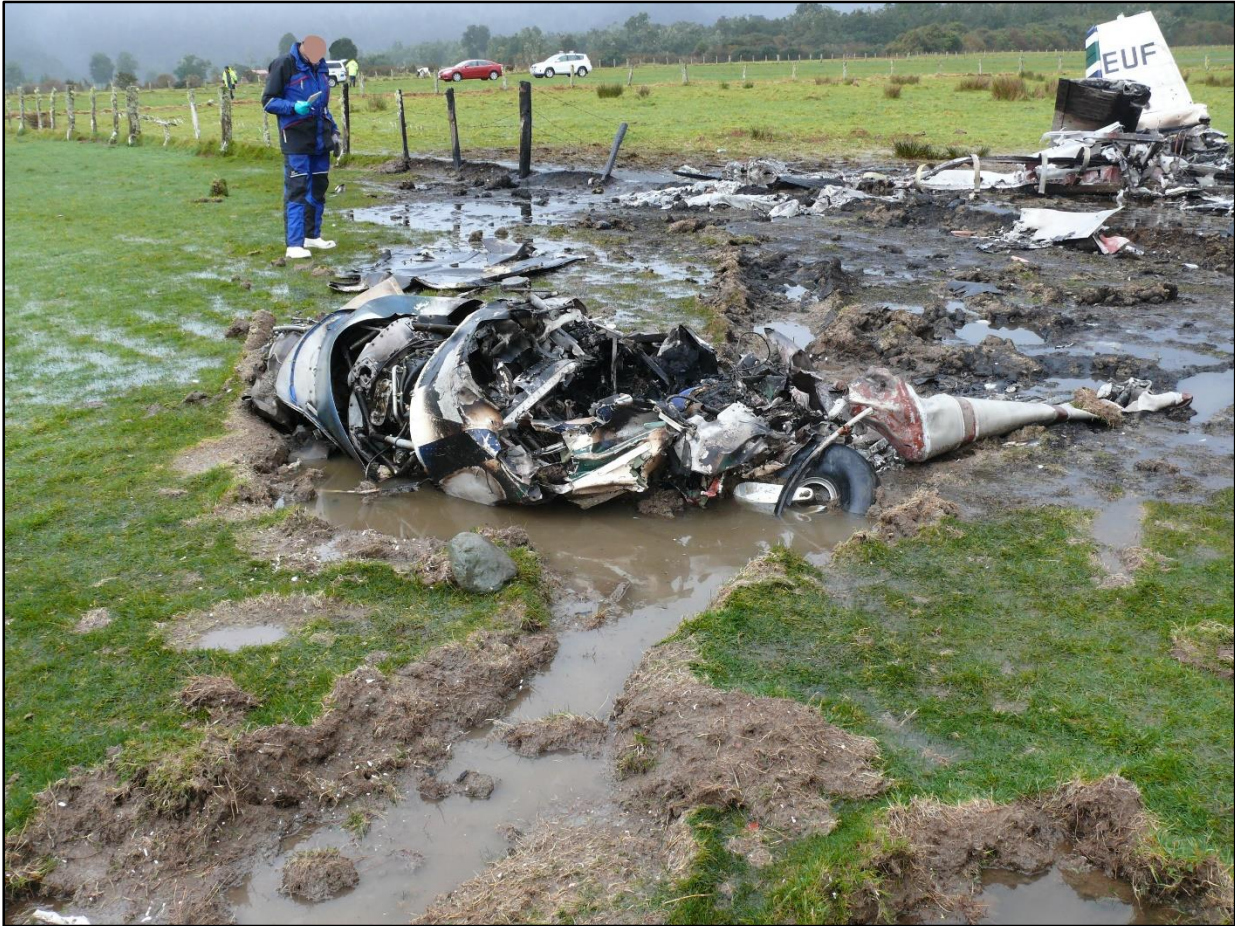
- it was not possible to recreate accurately the layout of the wreckage as it was at the scene of the accident, although photographs of the wreckage in situ were available (see Figure 1)
- most of the aeroplane was affected by the fire, which destroyed some components
- it was very likely that some components were damaged further when the wreckage was moved (three times since the accident) and/or as a result of it being buried for three and a half years
- the aeroplane owner had disconnected some components in order to transport and store the wreckage
- not all of the components were located.

Figure 1
Photograph of wreckage at original accident site (taken 5 September 2010)

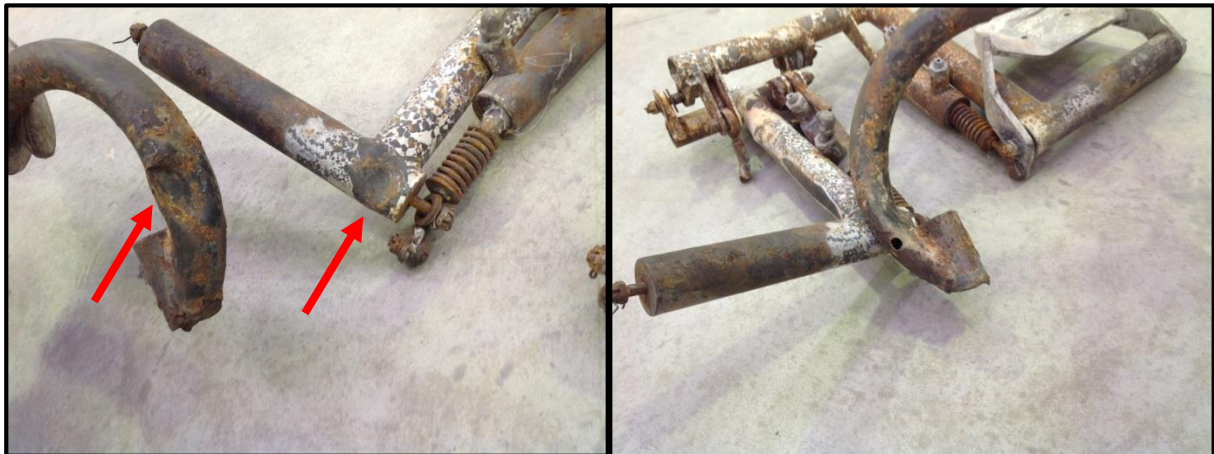
3.1.4. At the accident site, the investigator in charge determined by visual examination of the fracture surfaces that the control stick had broken in the crash, but that conclusion was omitted from the final report. An independent metallurgist who examined the control stick as part of the review determined that the failure was typical of "tensile overload"⁷ and was "consistent with damage occurring as a result of the accident". He found that the fracture "did not occur as a result of fatigue or any other pre-existing defect" (see Appendix 2). The wreckage re-examination showed that the control stick had struck the rudder pedal assembly during the crash (see Figure 2).

Figure 2
Relative positions of base of control stick and rudder pedal at impact

- 8.2.4. An independent metallurgist confirmed the conclusion, originally reached at the accident site, that the control stick had fractured as a result of impact damage. The wreckage re-examination showed that the control stick had struck the rudder pedal assembly. Therefore the control stick fracture did not occur before the impact and it was not a factor in the accident.

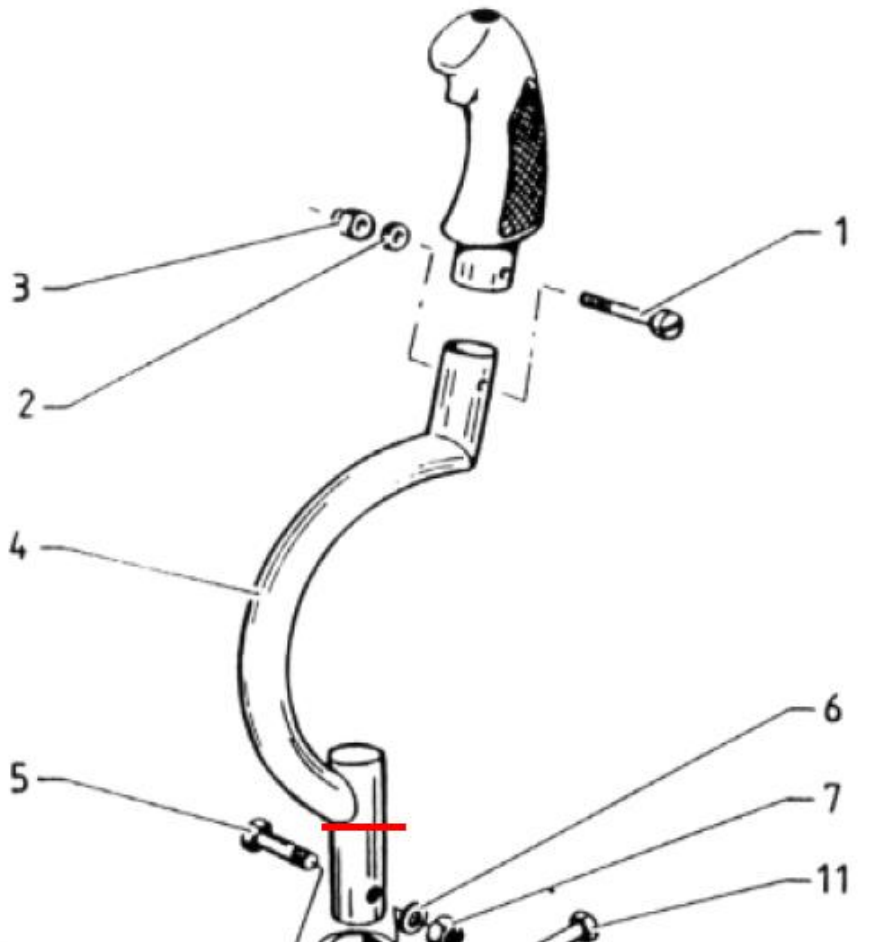
The control stick failed as a result of overload and likely occurred at the same time as the significant indent in the curved tube as a result of a single significant impact loading. This is consistent with damage occurring as a result of the accident.

Figure 1: Schematic diagram showing control column and fracture location (red line).

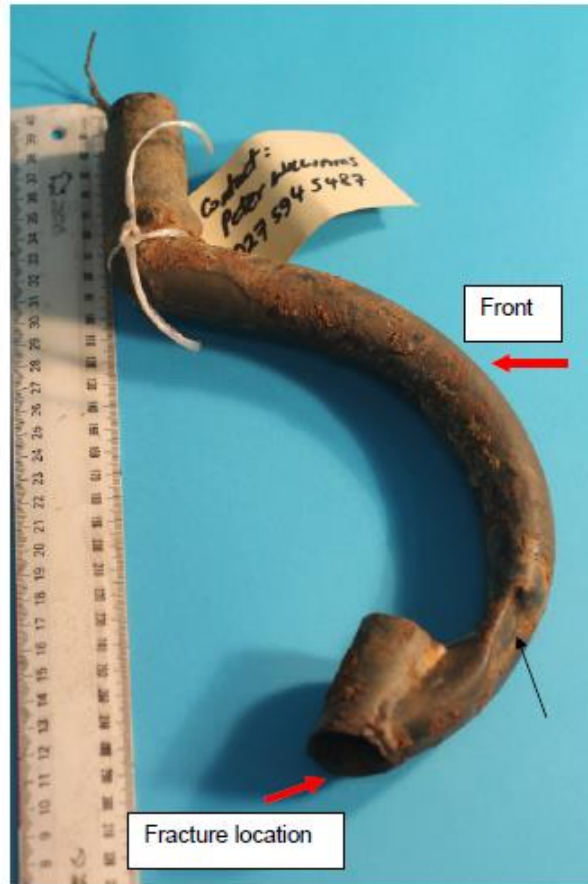
Figure 2: Control Column as supplied. Photomicrograph shows the fractured bottom tube that was welded to the curved tube. The side on the right of the picture was marked F (front). The black arrow shows the probable direction of the impact force which generated damaged found on the curved section of tubing.

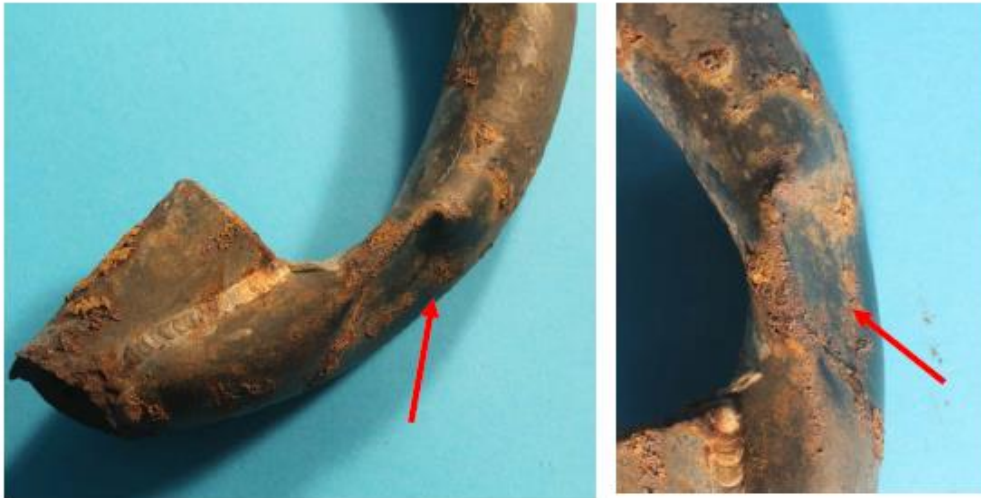
Figure 3: Close up of the indentation / impact damage in the curved tube section. The arrows show the probable direction of the impact force.

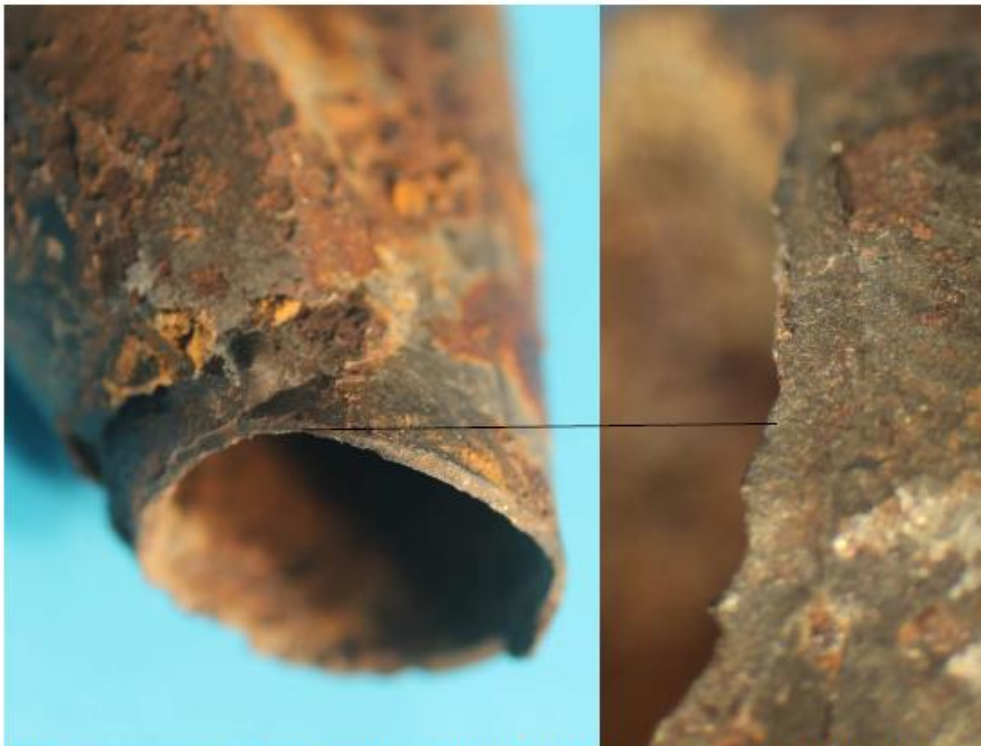
Figure 4: Fracture Surface on bottom tubing, 45 degree shear lip / overload fracture clearly visible.
