Report 10-102: collision between 2 metro passenger trains
after one struck a landslide and derailed between Plimmerton and Pukerua Bay,
North Island Main Trunk, 30 September 2010

Final Report

Rail inquiry 10-102
collision between 2 metro passenger trains after
one struck a landslide and derailed between
Plimmerton and Pukerua Bay,
North Island Main Trunk
30 September 2010

Approved for publication: May 2012

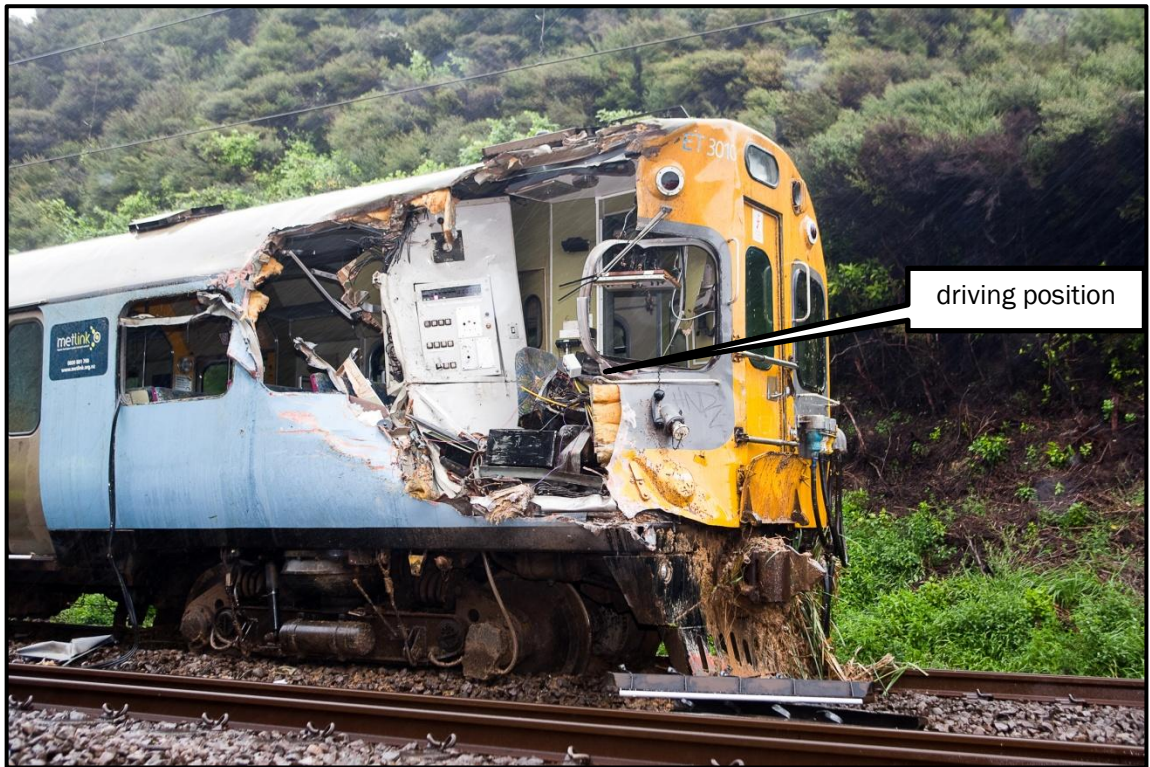
Figure 1
Driving compartment of derailed Train 6250 after being struck by Train 6247

- 3.1.9. At 1503:30 Train 6247 was travelling at 54 km/h when it struck the then stationary Train 6250 (see Figure 1).
- 3.1.10. After the collision, the driver and passenger operator of Train 6250 walked through the train and asked the passengers whether they had suffered any injury. After being told that there were no serious injuries, the crew brought all passengers together in the rear passenger car. The crew told the passengers that the overhead line was considered to be live and they were to wait on the train until the overhead line had been isolated.

The driving compartments on Trains 6250 and 6247 were damaged during the collision sequence to such an extent that had the drivers not vacated their driving positions before impact they would likely have been fatally injured.

- inspect and restore the structural integrity of the mounting points
- fit a “face mask” kitset of increased material thickness on the driving end to provide greater resistance to tearing and rupture, and increase the strength of the connections between the driving cab and the under frame
- fit an anti-climb device to the driving cab at a height consistent with anti-climb devices already fitted to locomotives.

The Commission recommends that the Chief Executive of the NZ Transport Agency monitor the development of current prototype improvements in crashworthiness for the Ganz Mavag rail fleet and requires that such improvements be adopted for any trains that are to remain in service for an appreciable time. (022/12)

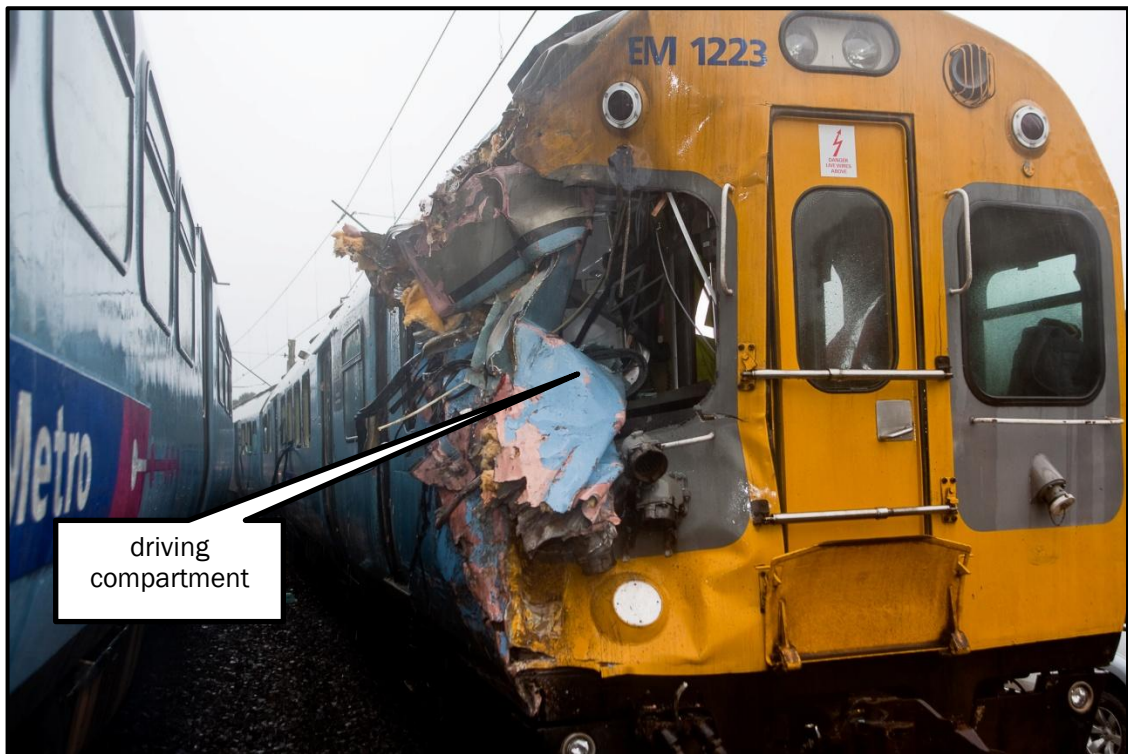
Figure 2
Driving compartment of Train 6247 after impact

- 3.1.11. Train 6247 was a 2-car set and had a crew of 3 and 14 passengers on board. It did not derail during the collision sequence. The train stopped about 74 m past the point of impact (see Figure 2). After the collision, the pantograph on EM1223 automatically retracted from the overhead contact wire. The back-up battery system was damaged in the collision, so the train was left with no electrical power.
- 3.1.12. As soon as Train 6247 came to a stop, the driver and the train manager asked the passengers whether any of them had been hurt during the collision. After determining that none of the passengers had suffered any serious injury, they were directed to the Wellington end of the train where they waited to be assessed by ambulance staff.

- 4.4.8. The Tranzlog event recorders from the leading and trailing ends of Train 6247 shut down 0.6 seconds after the collision. The driving compartment on EM1223 was damaged to such an extent that the train radio equipment was unusable, and because the battery supply failed, all electrical power was lost throughout the train. With no electrical power, the radio equipment in the **undamaged** driver’s cab at the trailing end was also unusable.

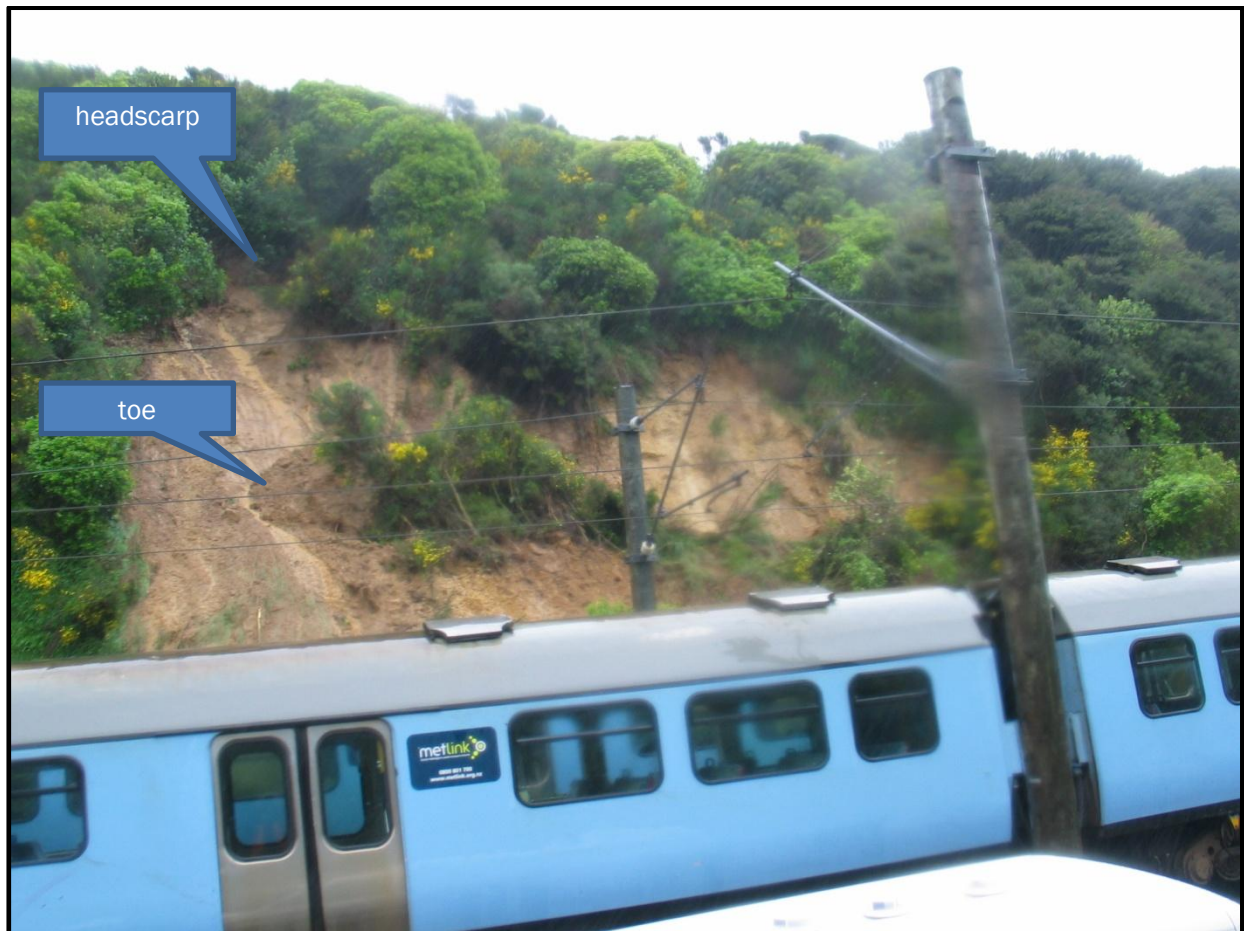
Figure 4
Extent of the landslide

- 3.5.3. The 20 m wide landslide was centred at the 26.887 km mark with the headscarp⁷ about 16 m above rail level (see Figure 4). The maximum depth of the landslide was about 2 m below the pre-existing ground surface. The toe⁸ of rupture of the landslide varied between 5 m and 10 m upslope from the base of the slope. Below this level, landslide debris consisting of saturated colluvial soils made from silty sands and clay flowed to cover the Up Main line.

3.5.6. KiwiRail confirmed that there had been previous slips and slumps within the cutting. An examination of historical aerial photographs showed that in 1977 there had been recent benching earthworks at the head of the cutting on which this landslide occurred. Again, on 14 September 1996, the track was closed temporarily when slip material covered the Up Main line near the 26.9 km mark.

- 4.2.6. As a result of this accident KiwiRail has given some priority to the 324 m long cutting where the landslide occurred, and remedial work is well underway to stabilise the slope, which means the Commission has not needed to make a recommendation for it to do so.
