Report 10-201: Bulk carrier TPC Wellington, double fatality resulting from enclosed space entry,  
Port Marsden, Northland, 3 May 2010

Marine inquiry 10-201  
Bulk carrier TPC Wellington, double fatality resulting from  
enclosed space entry,  
Port Marsden, Northland, 3 May 2010

Approved for publication: May 2011

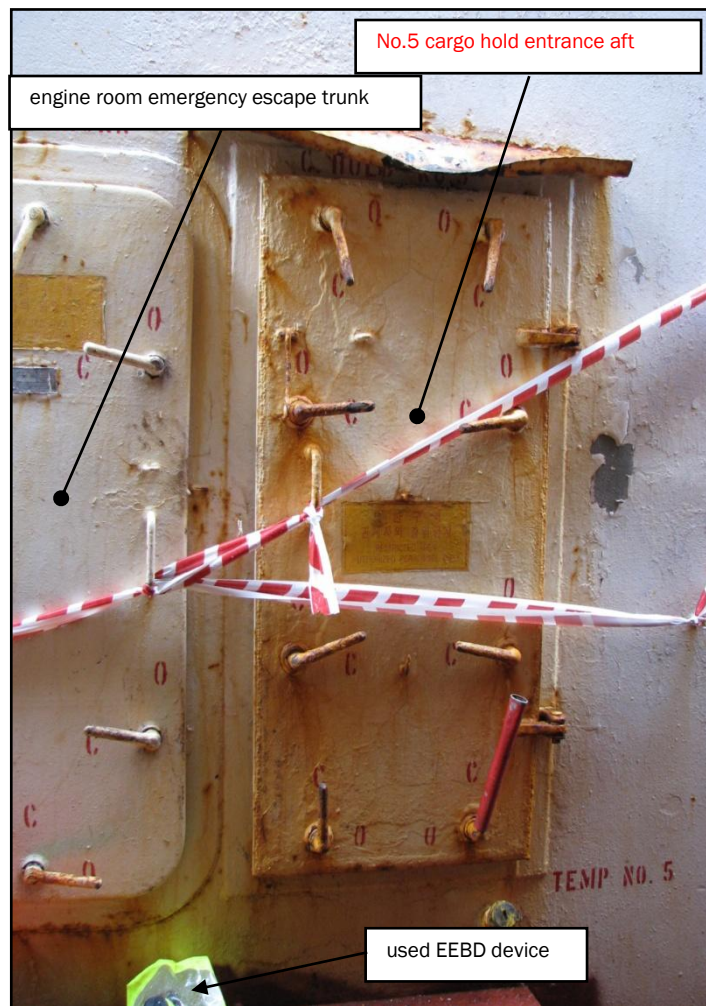
Figure 2  
Entrance door to No.5 Cargo Hold aft

- 3.1.10. The chief officer and bosun opened the access hatch, then the chief officer took his torch and climbed on to the ladder to make his way down into the hold. The bosun said that the chief officer said “OK, no problem” and started to descend. The bosun made an attempt to follow him into the hold but after the chief officer had descended only a short distance, estimated to be about 5 or 6 steps down the ladder he fell onto the logs below that were protruding into the access way.
- 3.1.11. The bosun immediately shouted for help from the crew members at the gangway (see Figure 1) that the chief officer had fallen down the hold. Once he had got the attention of the crew at the gangway the bosun made his way to the aft mooring station to get a rope suitable for hauling the chief officer out of the hold access.

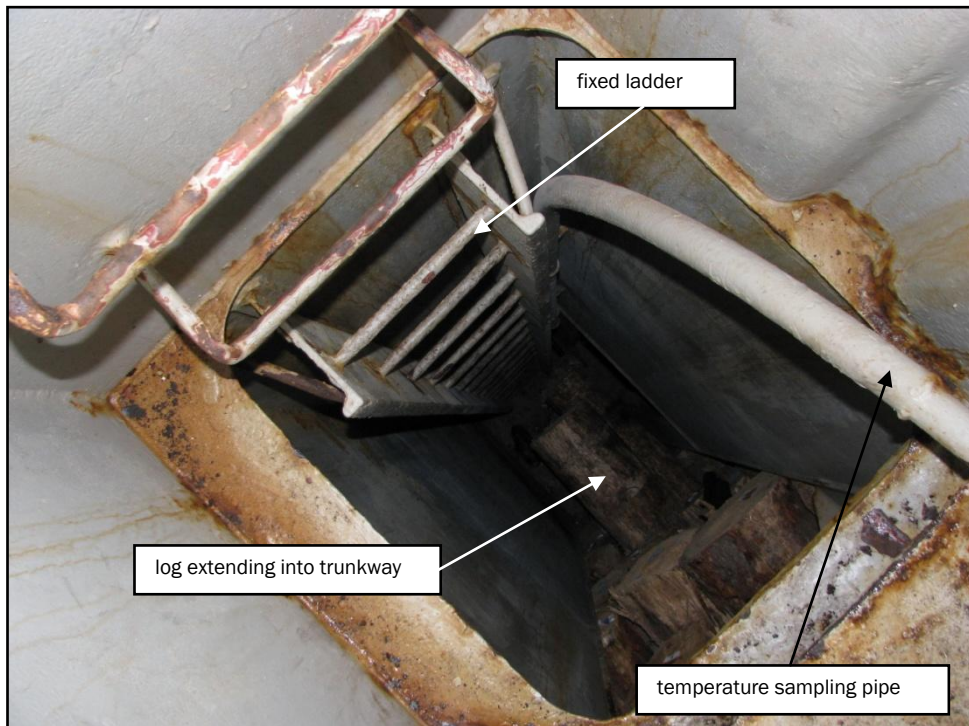
**Figure 3**  
**No.5 aft hold ladder from inside hold entrance door**

the crew member away from the access he heard the sound of the other crew member falling down the access. The bosun then looked down the access and saw him lying on top of the chief officer in what appeared to be an unconscious state.

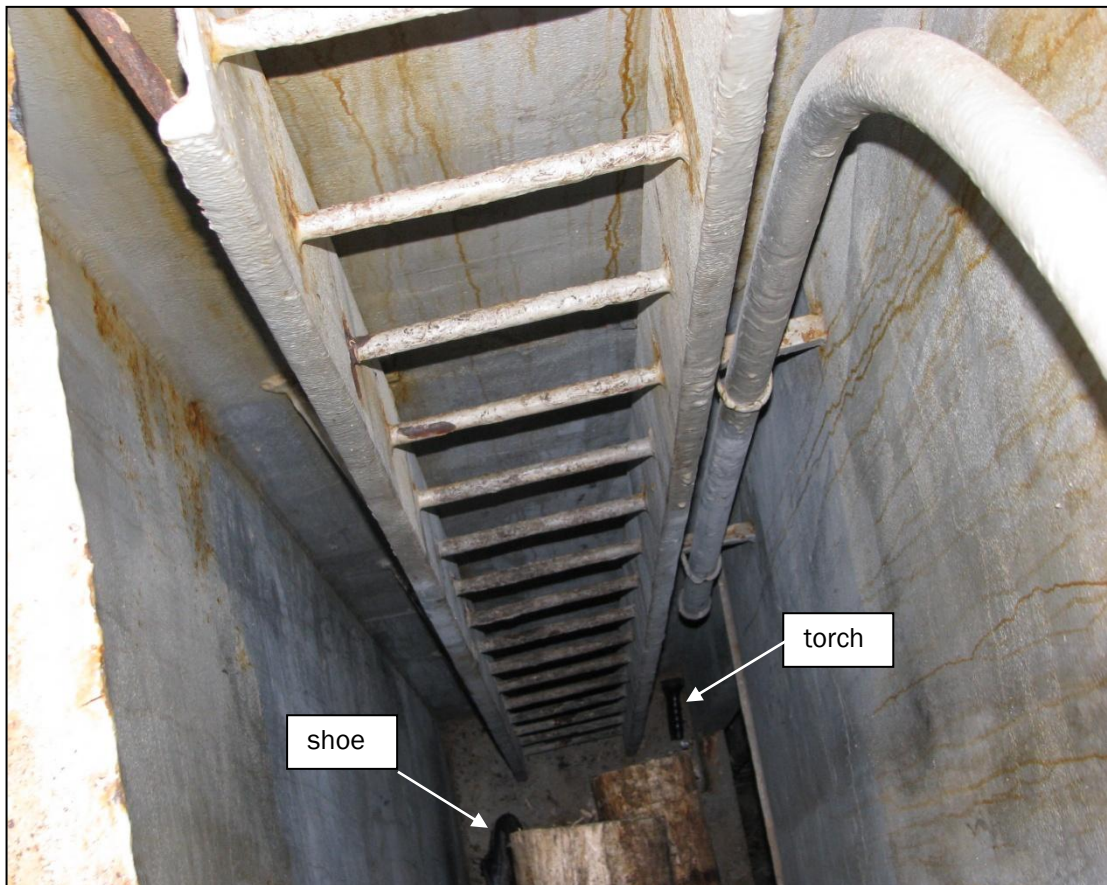
**Figure 4**  
**No.5 hold aft access showing shoe and torch unable to be recovered due to foul atmosphere**

- 4.3.3. The organic cargo, logs, in cargo hold number 5 had depleted the amount of oxygen available in the access trunk to the hold, as measured after the event, to such a degree that anyone entering the hold without wearing breathing apparatus would have been affected virtually as soon as they entered the hold. The Occupational Health and Safety Administration in the United States of America has a standard of 20.8% to 21.0 % as the normal oxygen level in the atmosphere, and 19.5% or below is considered a low oxygen level. The National Institute for Occupational Safety and Health in the United States of America produced a technical report on respiratory protection that noted the following signs and symptoms were observable when a human body experienced oxygen deficiency (see below):

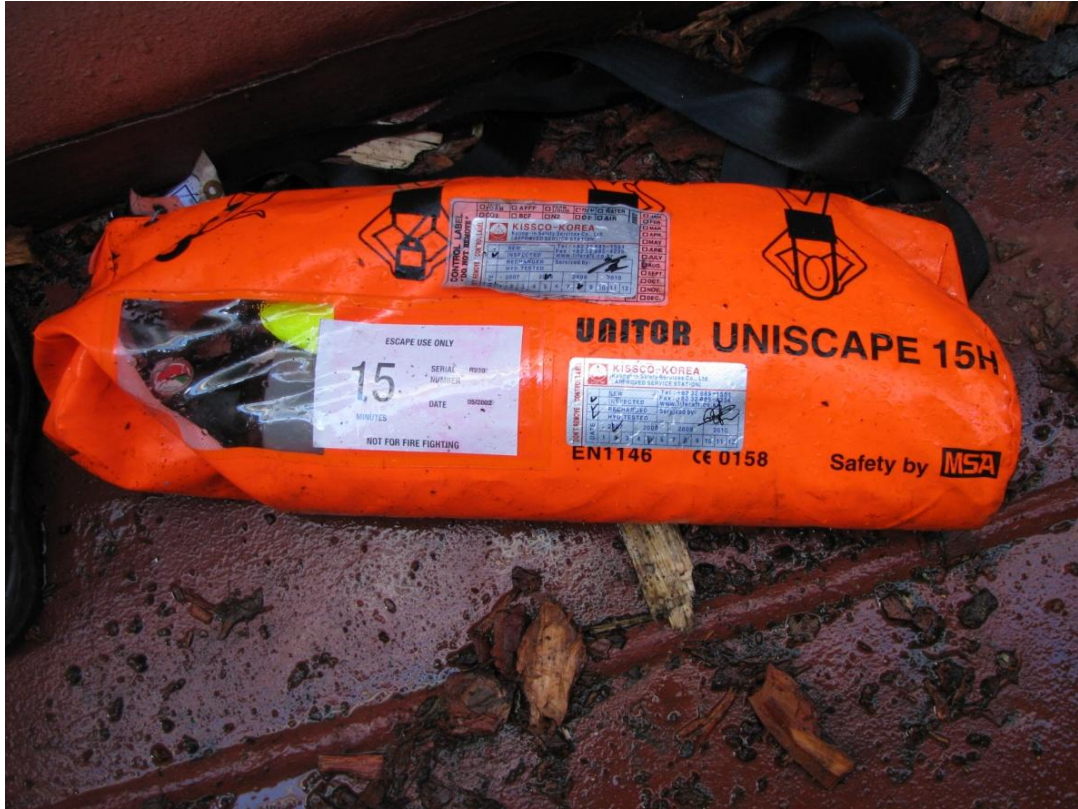
Figure 5 EEBD used in the rescue

was hauled out. When the first engineer heard that one other crew member was still trapped in the hold he donned the other breathing apparatus and entered the access. But the breathing apparatus prevented him manoeuvring past a log that was protruding into the access. The first engineer exited the hold and took off the breathing apparatus, then found and donned an emergency escape breathing device<sup>2</sup> (EEBD) that was of smaller dimensions.

- 4.5.5. Both breathing apparatus sets were brought to the scene and one set was used effectively by the third officer to recover the chief officer. The second set proved too bulky for its wearer to reach the second victim. The EEBD was only meant as an “escape” device so the first engineer using it to enter the hold, while laudable, was considerably risky. The air supply from the EEBD was luckily sufficient for the first engineer to carry out the retrieval of the deck crew member, but only just. The first engineer was on the point of collapse as he exited the hold and if he had not been close enough to the exit to be hauled clear by his colleagues he too could have become a casualty.
