**Inquiry 10-202: M.V. *Anatoki*, grounding, off Rangihaeata Head,
Golden Bay, South Island, 6 May 2010**

Final Report

Marine inquiry 10-202
M.V. *Anatoki*, grounding, off Rangihaeata Head, Golden Bay,
South Island, 6 May 2010

Approved for circulation: March 2012

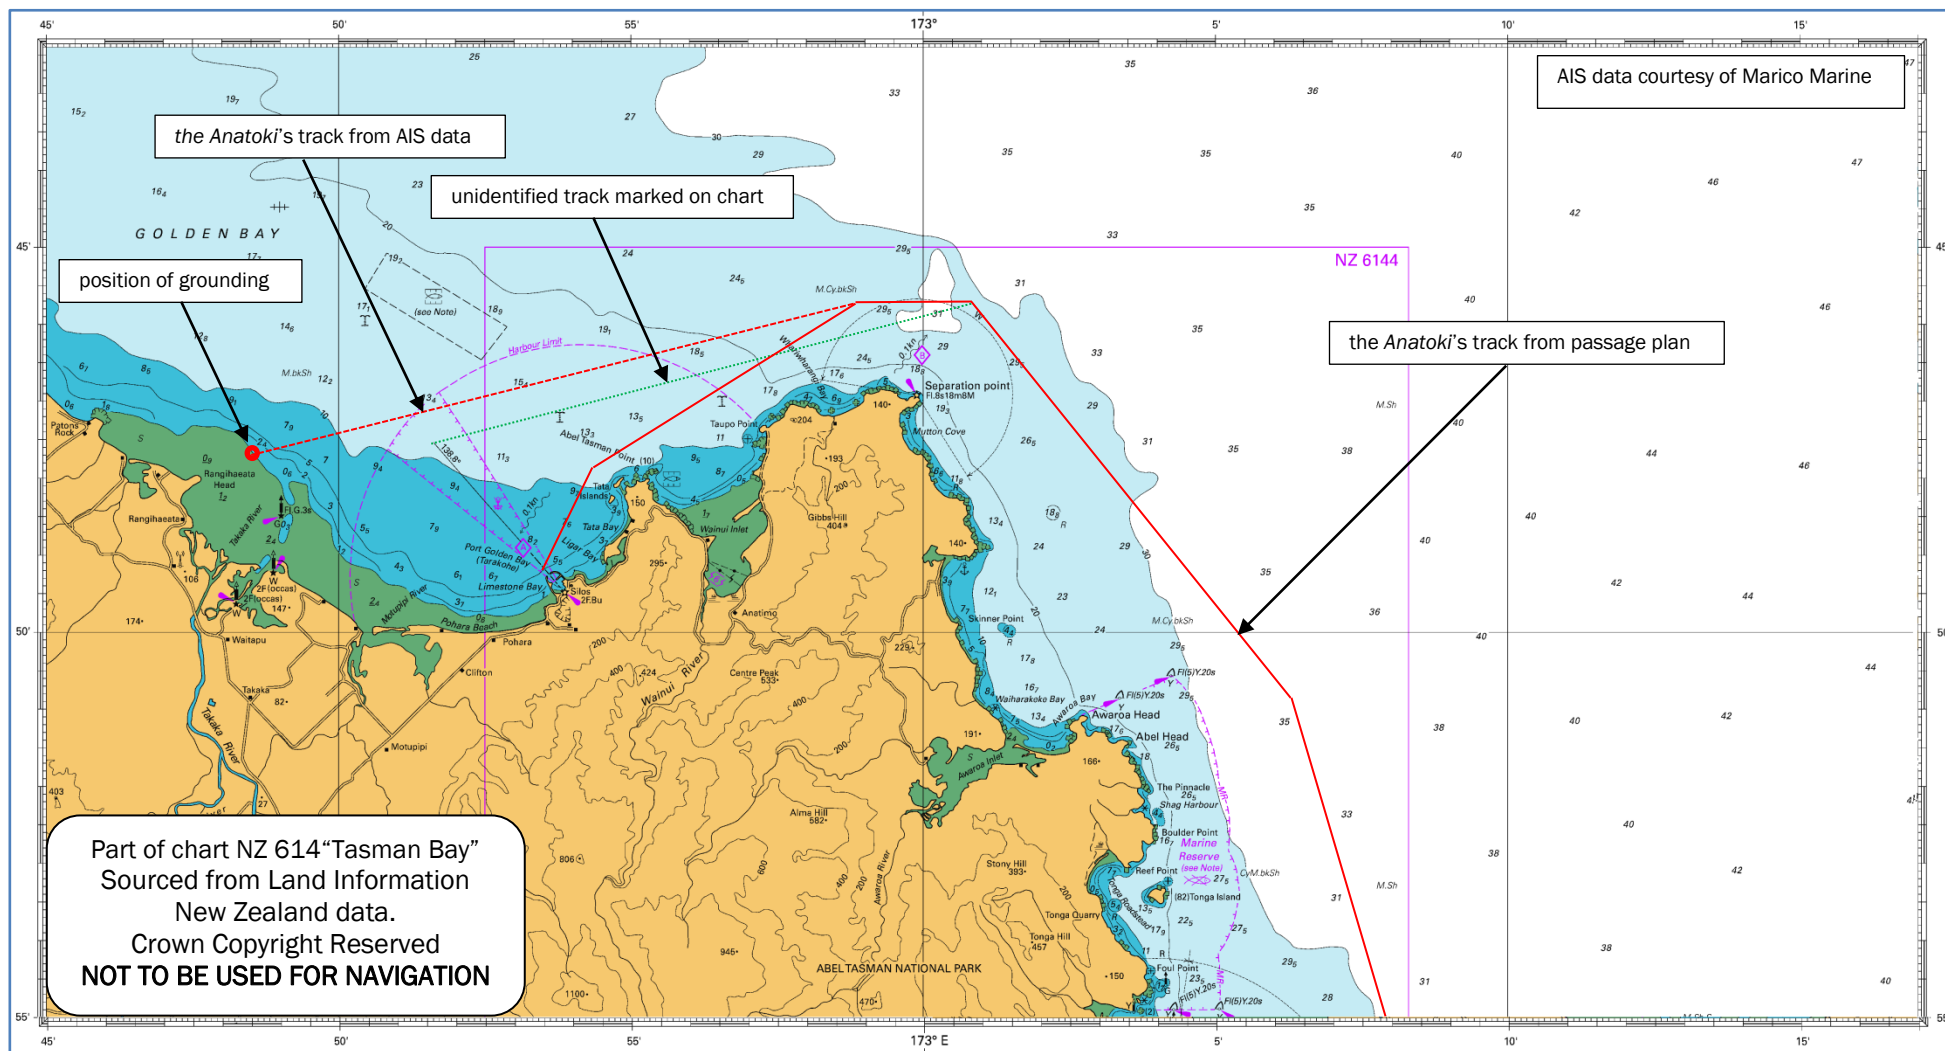
Figure 2
Chart of the *Anatoki*'s planned, intended and actual tracks

- 3.1.12. The watchkeeper maintained the vessel on its designated track, regularly plotting the vessel's position on the chart and altering course at about 0300 off Abel Head (see Figure 2) and again at about 0350 off Separation Point (see Figure 2).

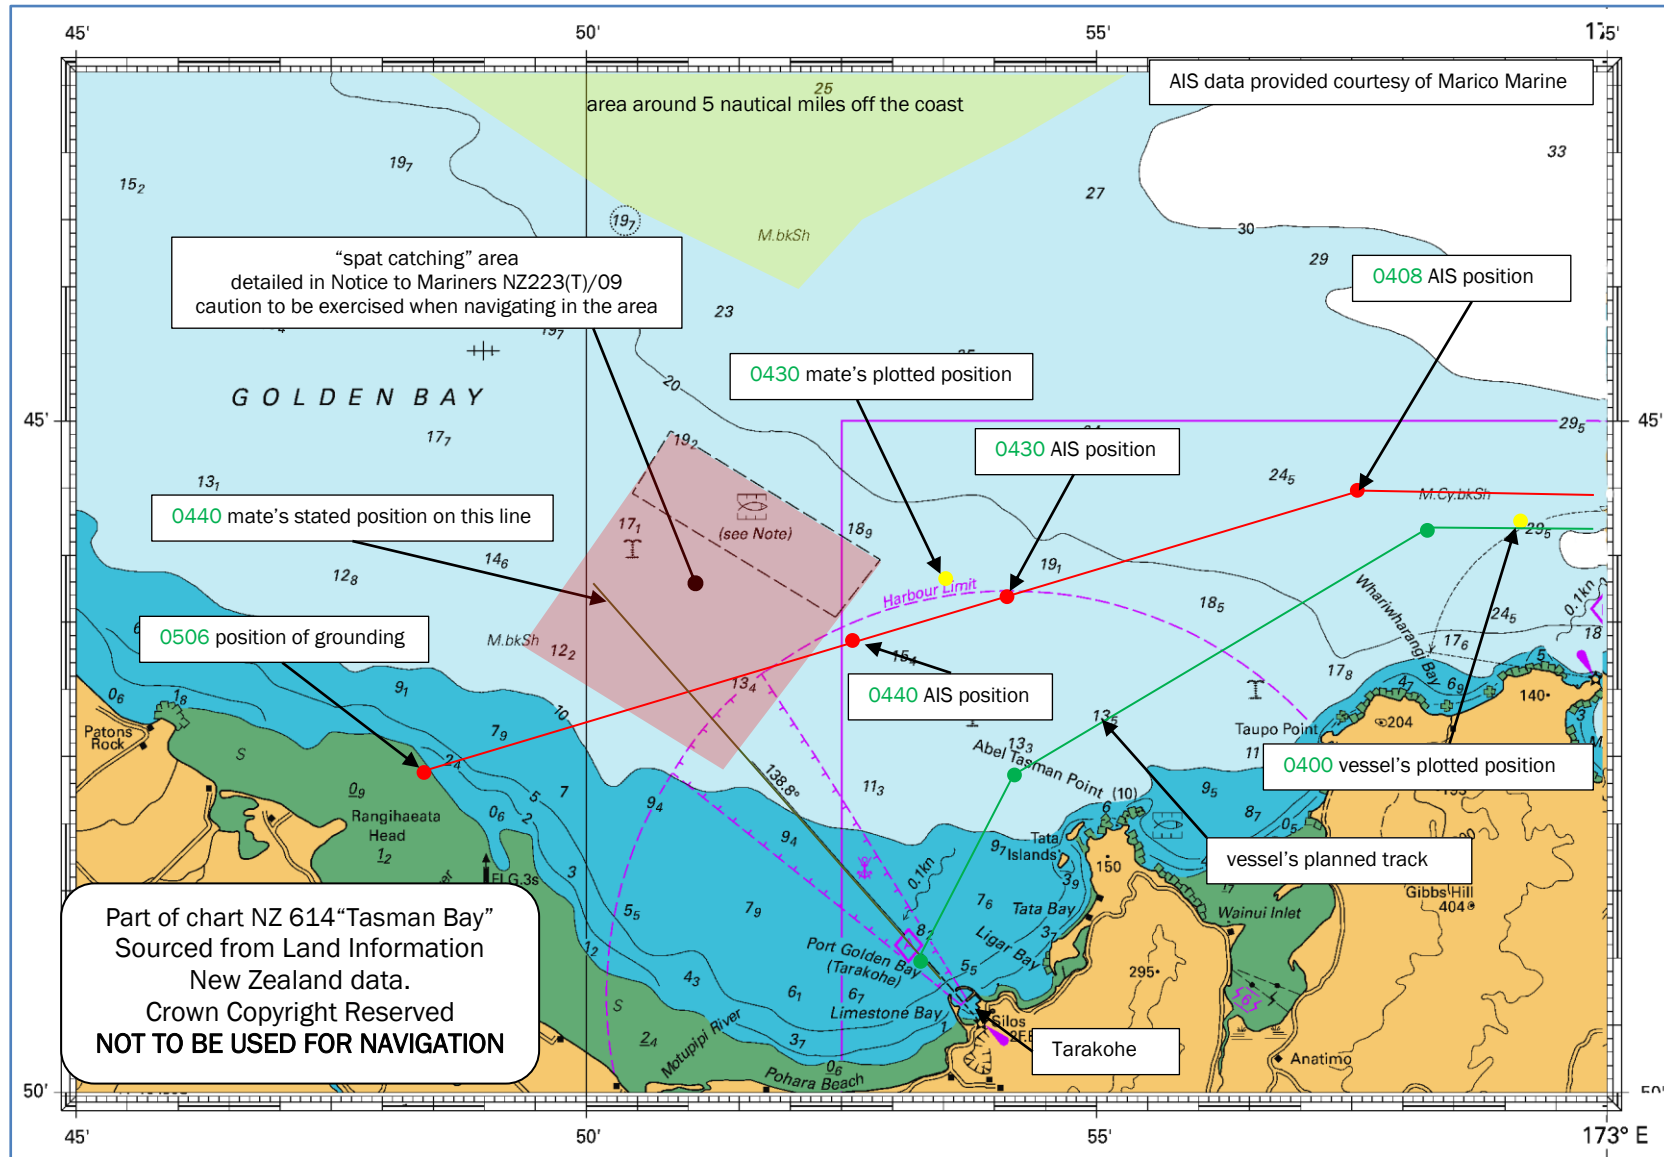
Figure 3
Larger scale chart of eastern Golden Bay

- 3.1.16. The AIS data shows that the *Anatoki* ran aground approximately 0.7 nautical miles off Rangihaeata Head at about 0506 (see Figure 3).
- 3.1.17. At about 0515, the mate used a buzzer to call the engineer to change from the shaft generator to the harbour generator. As the engineer was getting out of bed he was again "buzzed" by the mate. The engineer went to the engine room and changed the generators over. He noted that the engine sounded different but was operating normally.

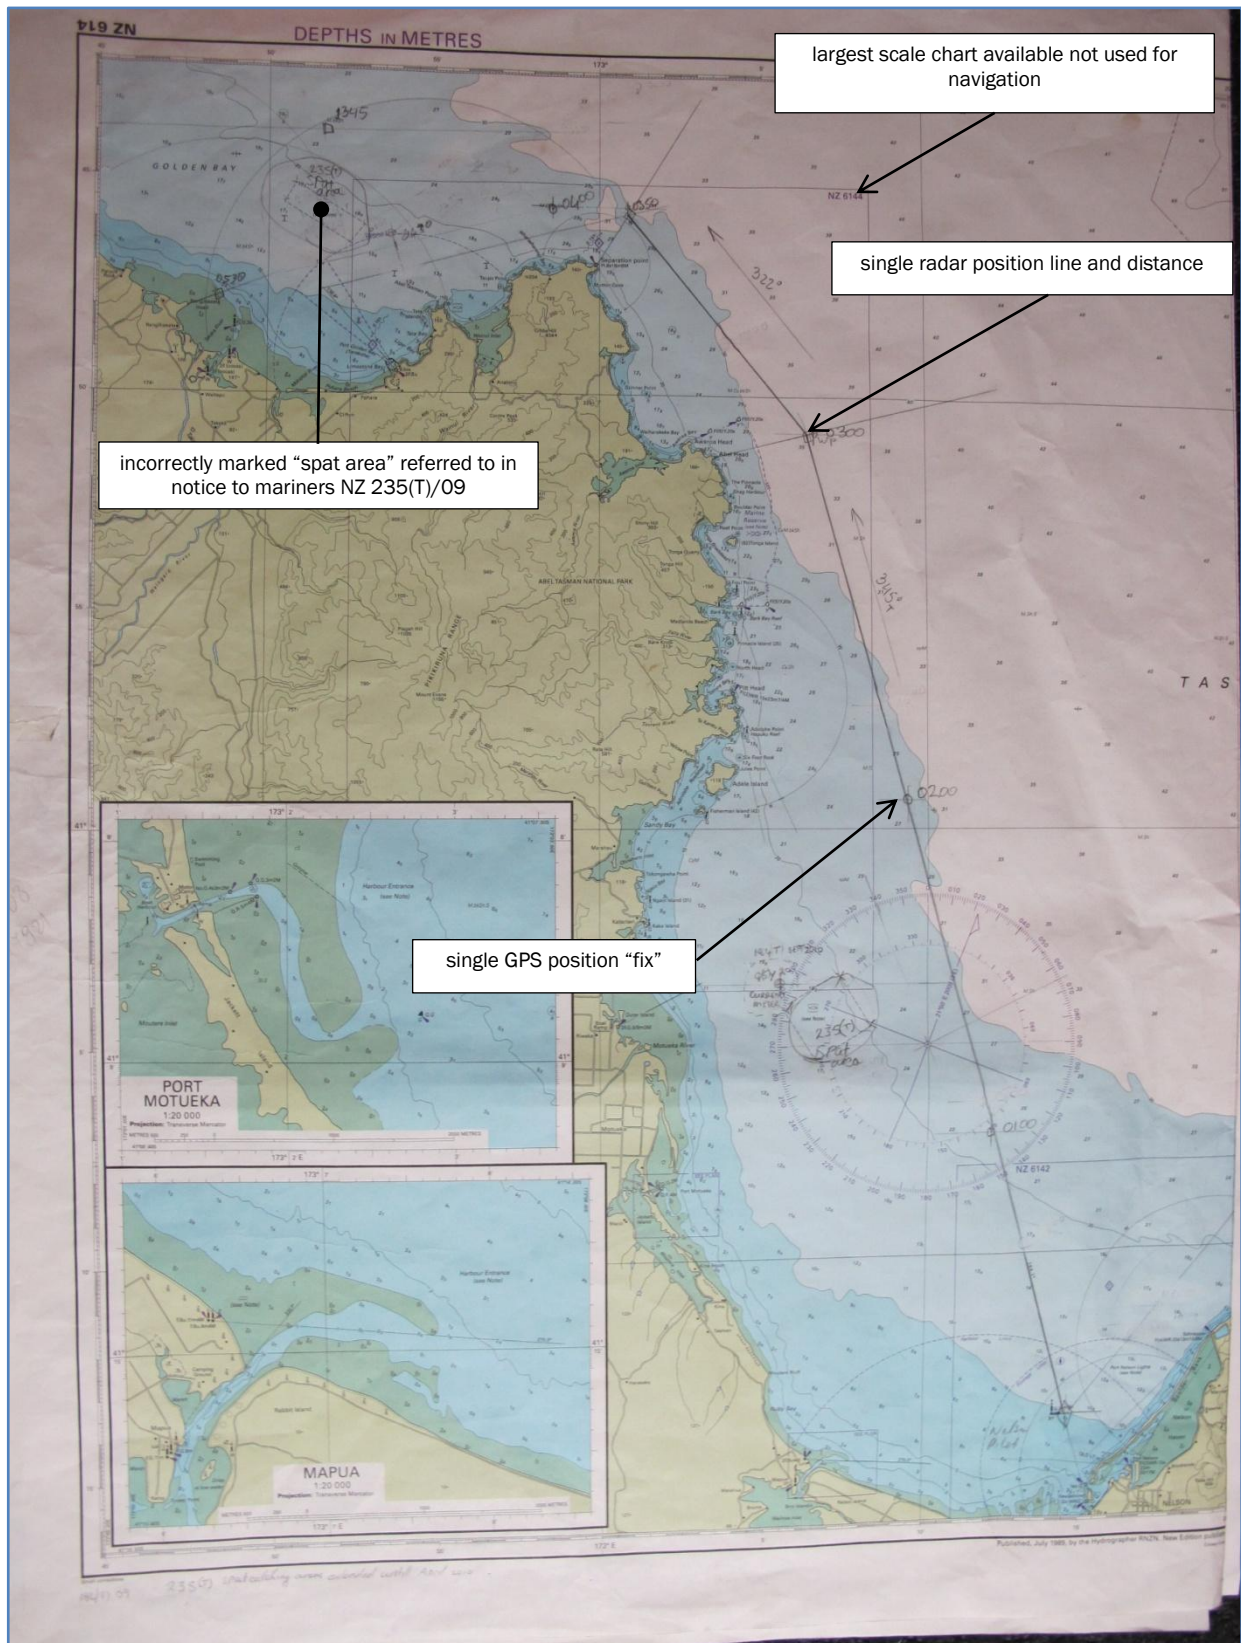
Figure 4
Photograph of chart in use by the *Anatoki* at the time of the accident

- 4.2.3. The course the vessel travelled missed the spat catching area permanently marked on the chart, but the area had been enlarged as contained in the notice to mariners NZ 235(T)/09 and the vessel encroached on this area. Fortunately the obstructions in the area had been removed a few days earlier but the notice to mariners was still in force and was not cancelled until 28 May 2010. Although the master noted in his night orders to watch for "M. farm and M. barges" the mate would not have been aware of the extended precautionary area as this had not been marked on the chart (see Figure 4).
