Report 10-203: *Marsol Pride*, uncontrolled release of fire-extinguishing gas into engine room, Tui oil and gas field, 27 May 2010

Final Report

Marine inquiry 10-203
Marsol Pride, uncontrolled release of
fire-extinguishing gas into engine room,
Tui oil and gas field, 27 May 2010

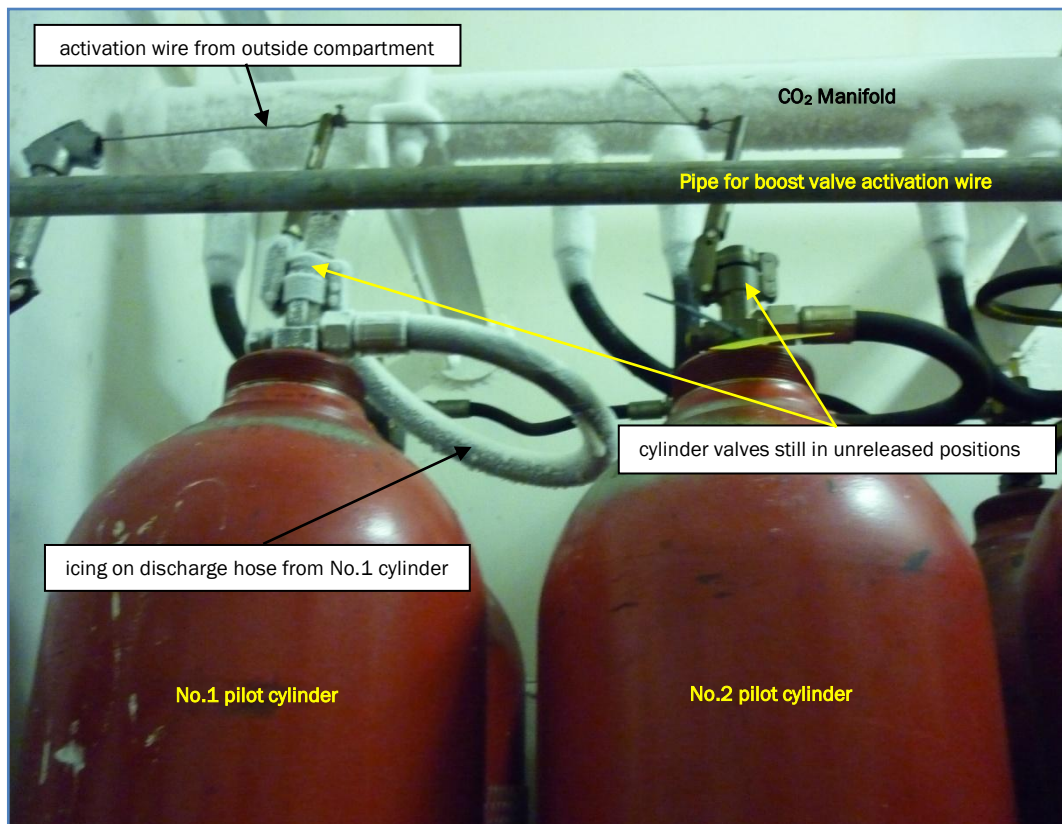
Figure 4
CO₂ pilot cylinders after release, one showing tell-tale icing

- 4.2.3. The No.1 pilot cylinder had been leaking. The frosting around its discharge valve and hose connection to the pressure manifold (Figure 4) was typical of what occurs when CO₂ gas is released under pressure.

- 4.2.4. The Commission has not been able to determine why the pilot cylinder leaked. The laboratory examination showed that the valve was in good condition with no defects. By the time the Commission took possession of the valve:

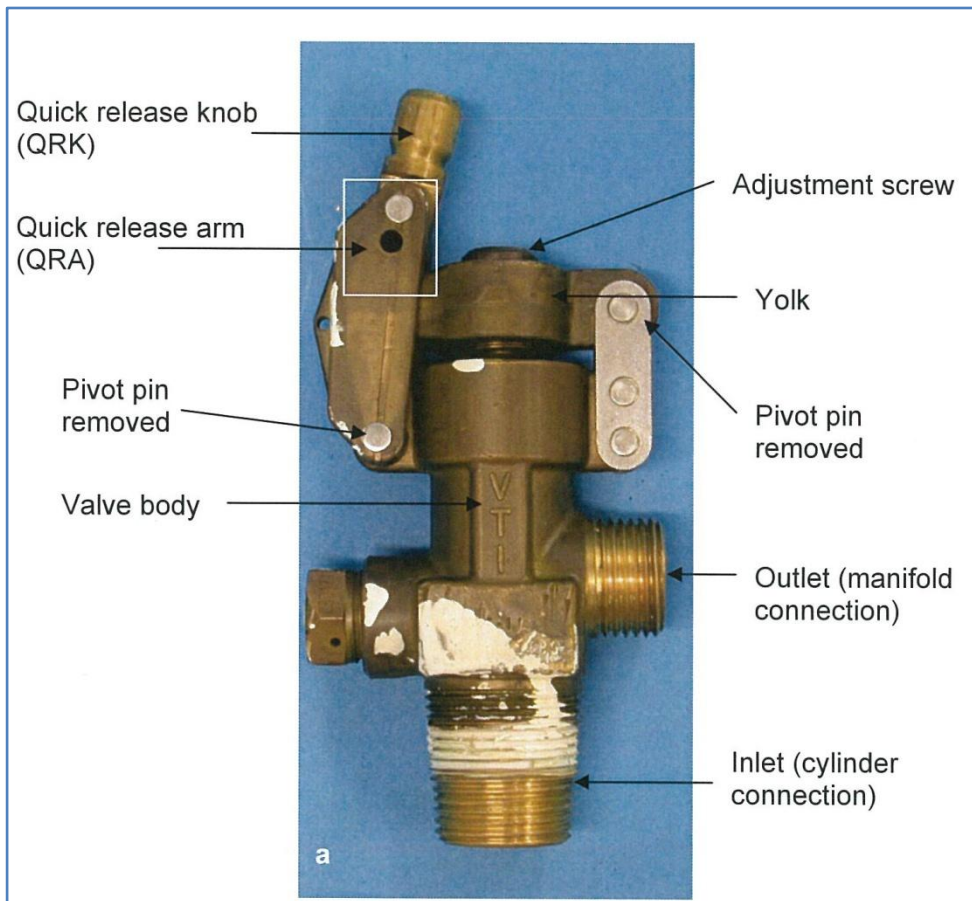
Figure 5
Boost valve in closed position

- Considerable debris was found in the boost valve, including some in the recess beyond the valve seat. This debris is most likely to have been deposited when the valve was open or partially open, as may occur in a leaking valve. In contrast, the seals and recesses in the pilot valves were very clean.
- The debris contained particles resembling brass swarf, corroded or oxidised brass, oxidised zinc, corrosion or oxidation products of iron-based material, fibres, dust/dirt particles and what appeared to be a liquid residue.
- Microscopic assessment and chemical analysis confirmed that the brown areas on the boost valve piston and on the valve seat had suffered attack of the brass, in the form of de-zincification.
- The boost valve seal had a raised rim whereas the pilot valve seals did not.
- Brass particles were embedded in the boost valve seal.

- It is very likely that the boost valve leaked gas
- It is most likely that the leak was caused by debris on the valve seat
- The origin of the debris could not be precisely established but two possible sources have been identified and further investigation is recommended
- It is likely that once leaking occurred, acidification of moisture around the seat and piston caused de-zincification. – this would have exacerbated the propensity for leaks

- 4.2.7. The laboratory inspection of the booster valve showed that it was not in good condition and that it was “very likely” that it had leaked gas. CO₂ gas leaking past the booster valve would and did eventually cause the “gang release” of the other 18 CO₂ cylinders, then 30 seconds later, opened the main valve, which then allowed the contents of the entire CO₂ system to discharge into the engine room.

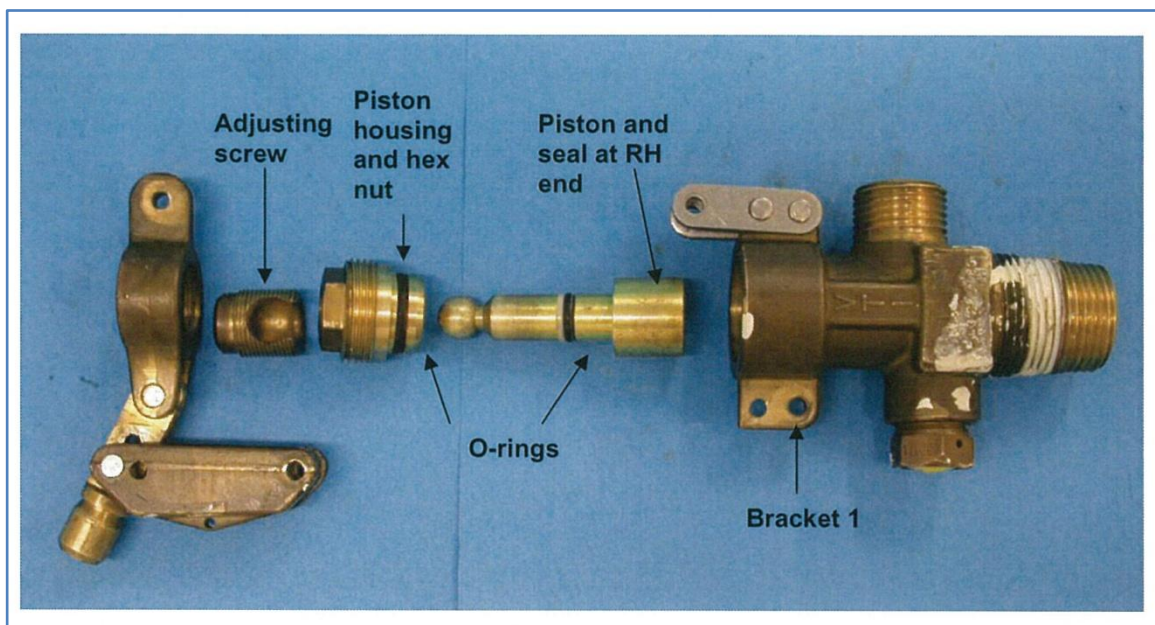
Figure 6
Boost valve disassembled

- 4.3.6. The laboratory examination revealed that the brass booster valve piston and valve seat had been attacked by corrosion in the form of de-zincification, a process where the zinc component in brass preferentially corrodes or oxidises. The report said also that CO₂ dissolving in moisture formed carbonic acid, a substance known to attack the zinc inclusion in standard brass.

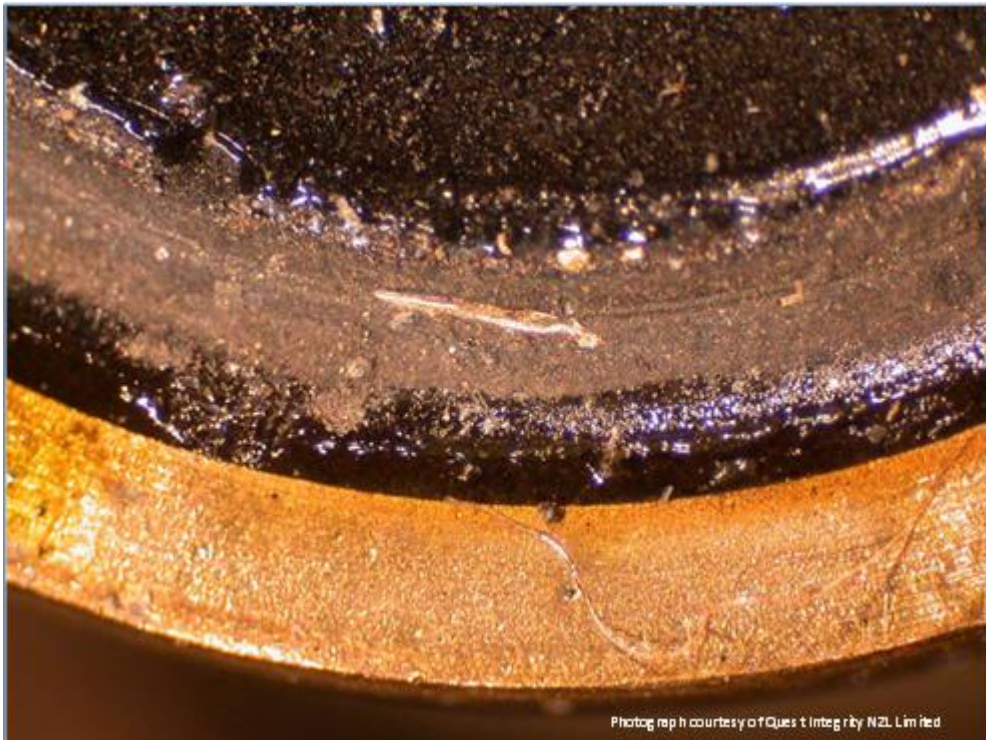
Figure 8
Boost valve, close-up of a portion of the seal

- 4.3.7. The de-zincification around the valve seat would have exacerbated the propensity for the valve to leak past debris trapped within the valve seal. The condition in which this booster valve was found justifies a regular inspection and cleaning of the booster valve or any control valve in other fixed CO₂ systems that are critical to the integrity of the whole system.
