Inquiry 10-204: Bulk carrier *Hanjin Bombay*, grounding,
Mount Maunganui, 21 June 2010

Final Report

Marine inquiry 10-204
Bulk carrier *Hanjin Bombay*, grounding,
Mount Maunganui, 21 June 2010

Transport Accident Investigation Commission

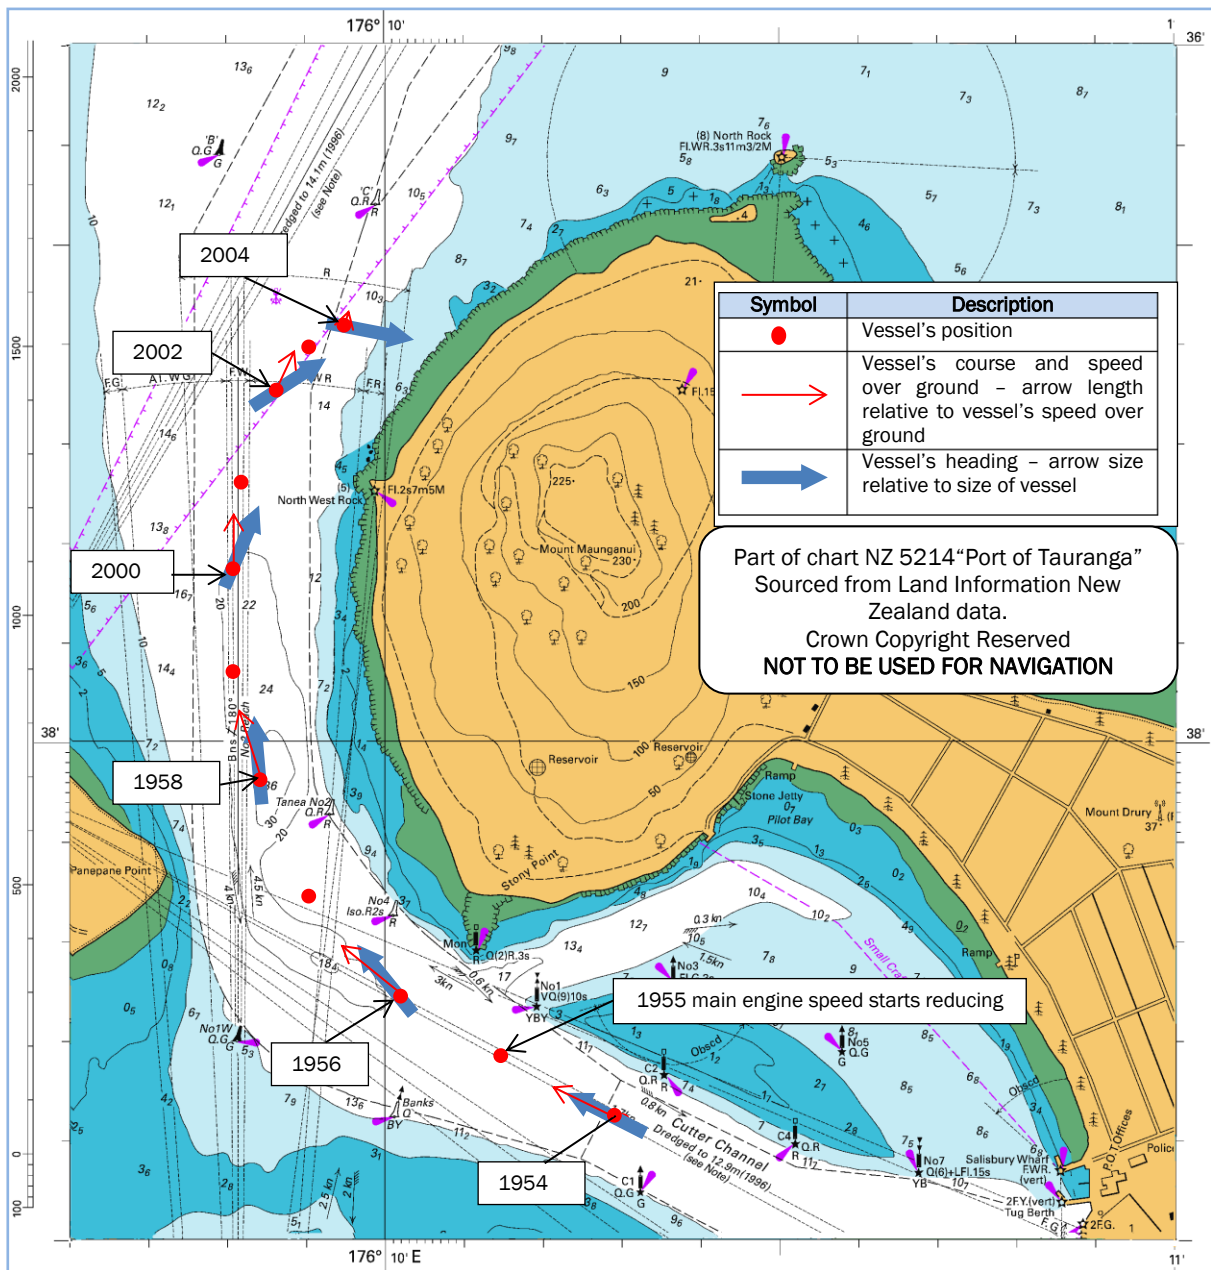
Figure 2
Chart of the entrance to Tauranga Harbour detailing the *Hanjin Bombay's* track

- 3.1.11. The engine was still turning ahead on reduced revolutions, so the pilot ordered port helm to stop the vessel turning and steady the course to No.2 Reach. The *Hanjin Bombay* was reacting slowly to the helm, so the pilot requested the master to get the engine going as soon as he could, otherwise the vessel was going to run aground.

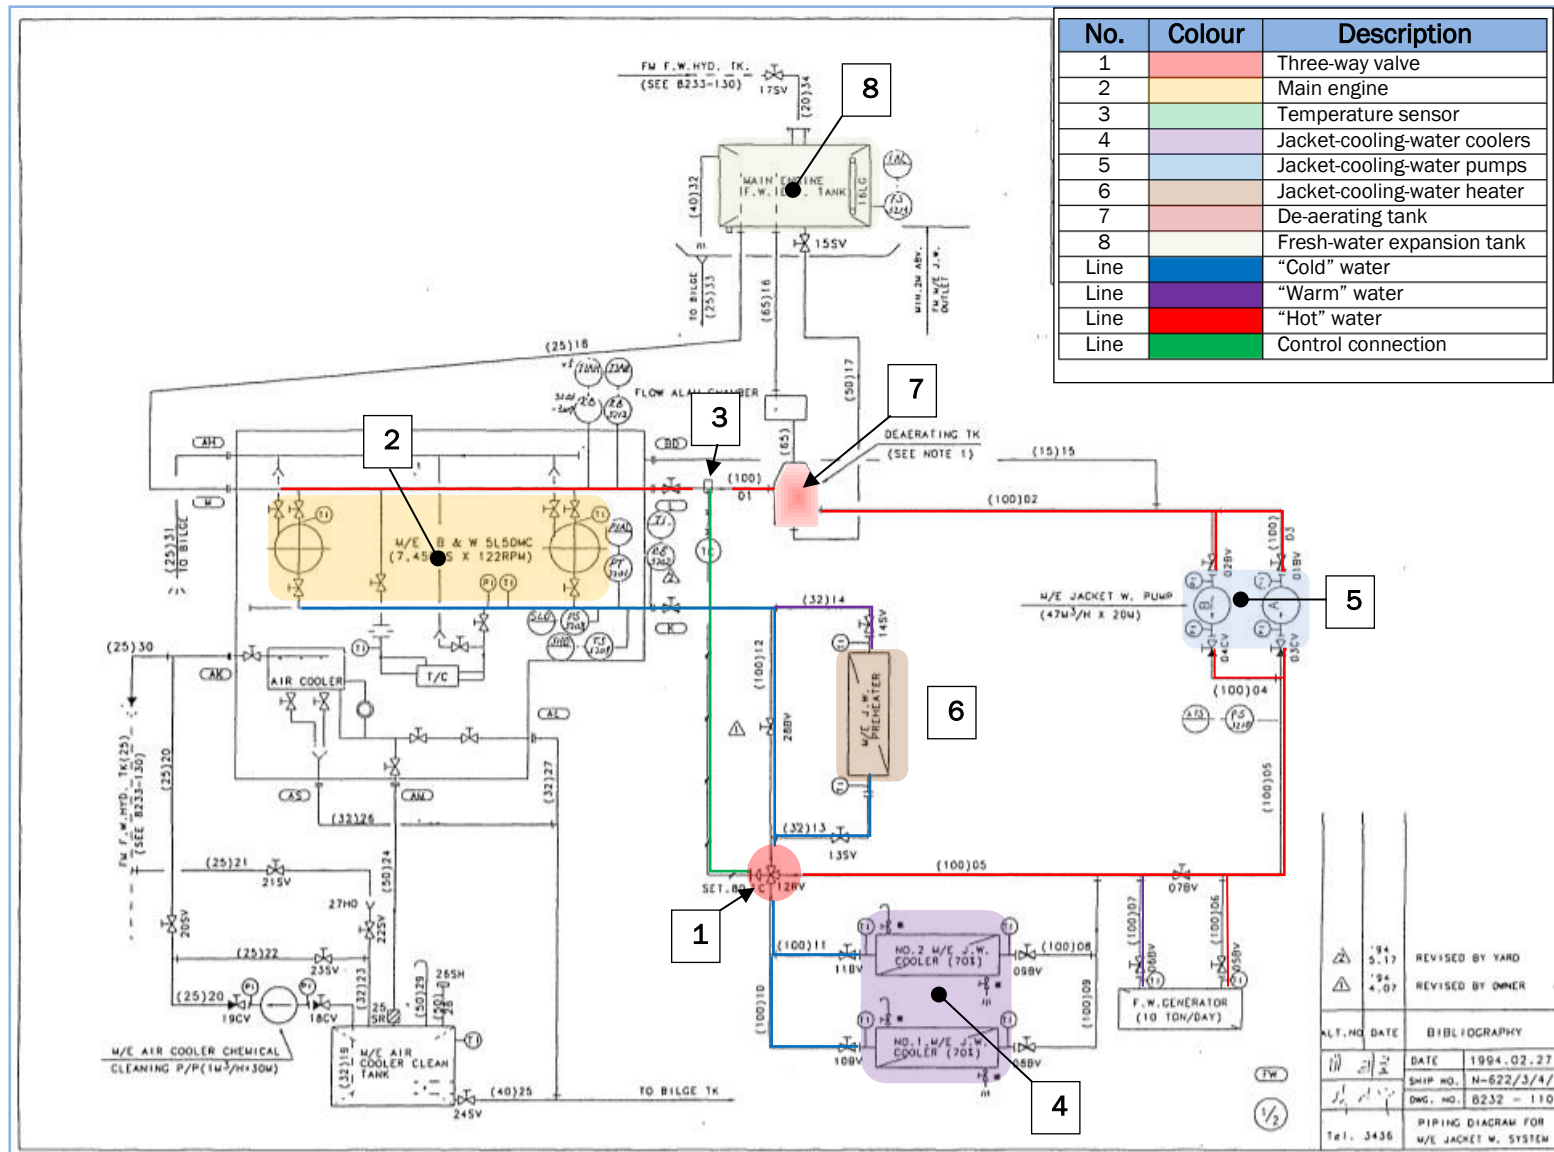
Figure 3
Main-engine-cooling water system diagram

- 3.5.3 With reference to Figure 3, the 3-way valve was in turn controlled by a temperature sensor (3) located in the return line of the cooling water from the main engine (2). The water was pumped around the system by the main engine jacket-cooling-water pumps (5) and could, through the operation of the 3-way valve, be sent through the main engine jacket water coolers (4). Also located in the system after the 3-way valve and before the main engine was the jacket-cooling-water heater (6), which when the main engine was running was isolated from the system. In the event of the system getting air or gas into it from either a leak or the water boiling, the de-aerating tank (7) would allow this to escape through the main engine fresh-water expansion tank (8).

- 3.5.4 When the vessel was ready to depart the engineers would isolate the jacket-cooling-water heater. The temperature sensor would send a signal through a pneumatic control unit to the 3-way valve. The valve would automatically open and close to regulate the cooling water temperature. When the engine was not running the 3-way valve would typically be closed. When the engine was running, the 3-way valve would open to varying degrees to regulate the

flow of the fresh water through the water coolers to keep the fresh water at the optimum pre-set temperature.

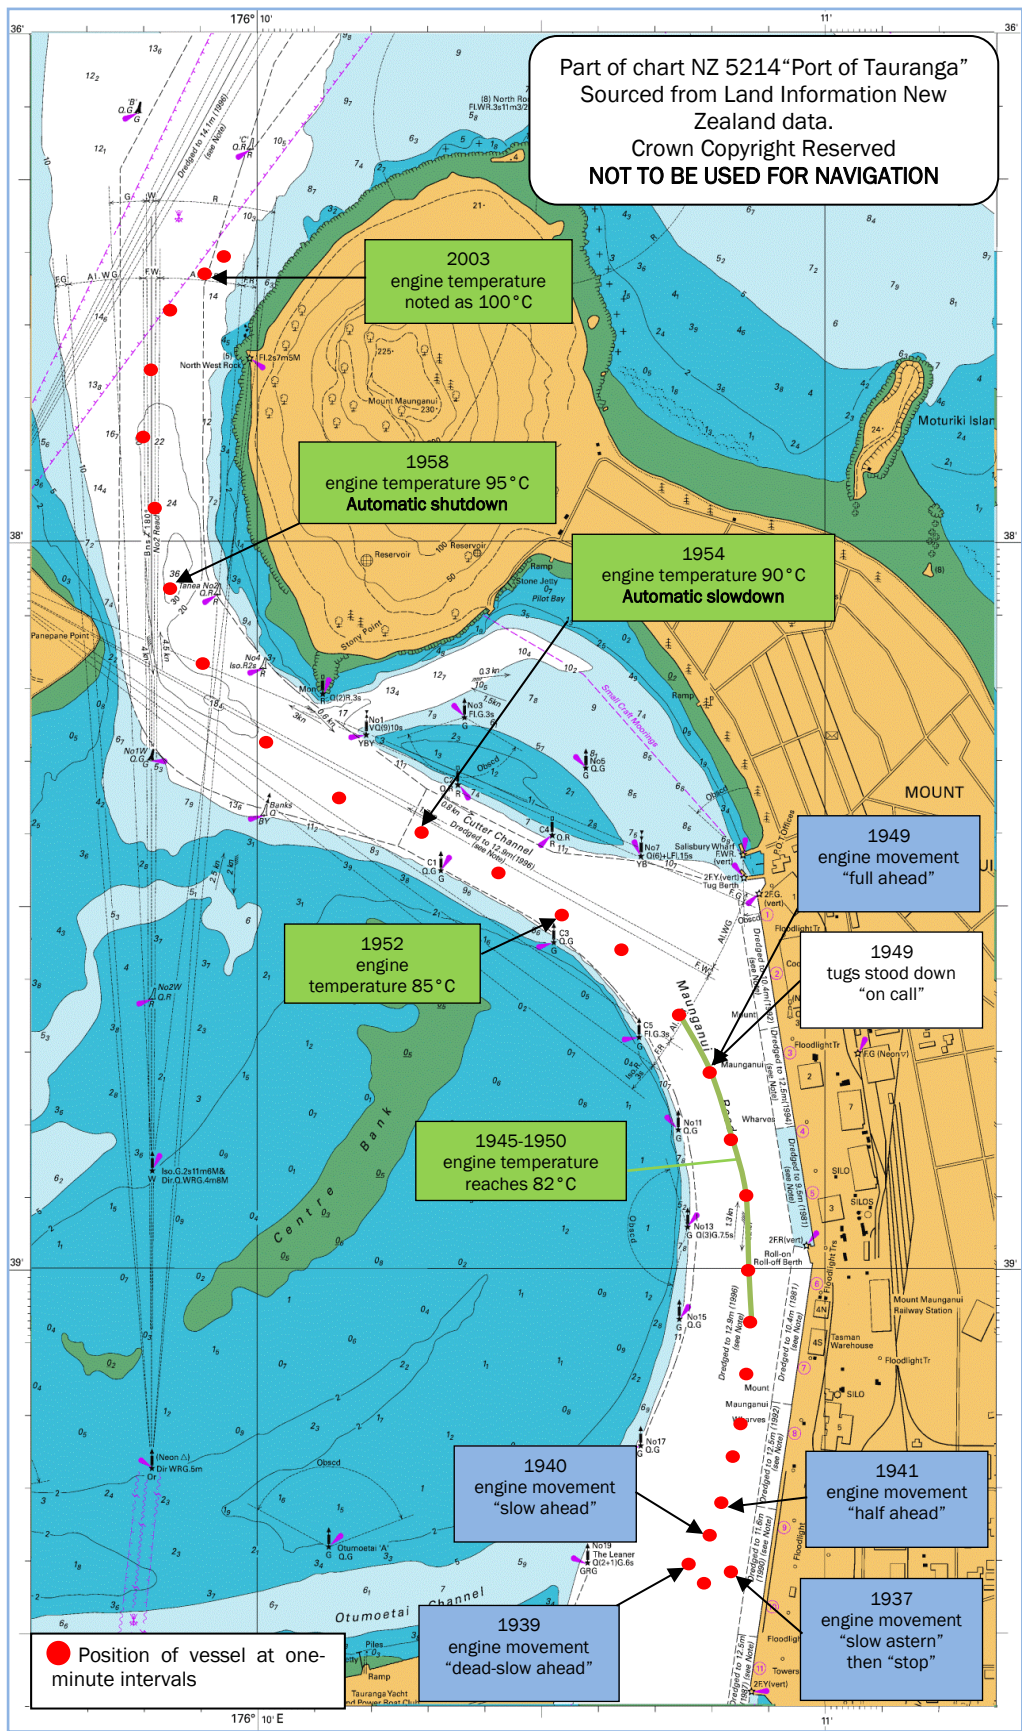
Figure 5
Diagram showing engine movements and temperatures against time

- 4.3.6 Figure 5 shows the progress of the *Hanjin Bombay* as the events unfolded. When the chief engineer first noted that the cooling-water temperature had risen above normal (82°C), the tugs were still in attendance. By the time the temperature had risen to 85°C the tugs were returning to their berth, less than half a nautical mile away. A precautionary phone call to the bridge at that time could have allowed the tugs to be back in attendance. It also could have delayed the 'full-ahead' engine movement from the bridge, which would have slowed the rise in cooling-water temperature and given the engineers more time to resolve the issue before the engine shut down.

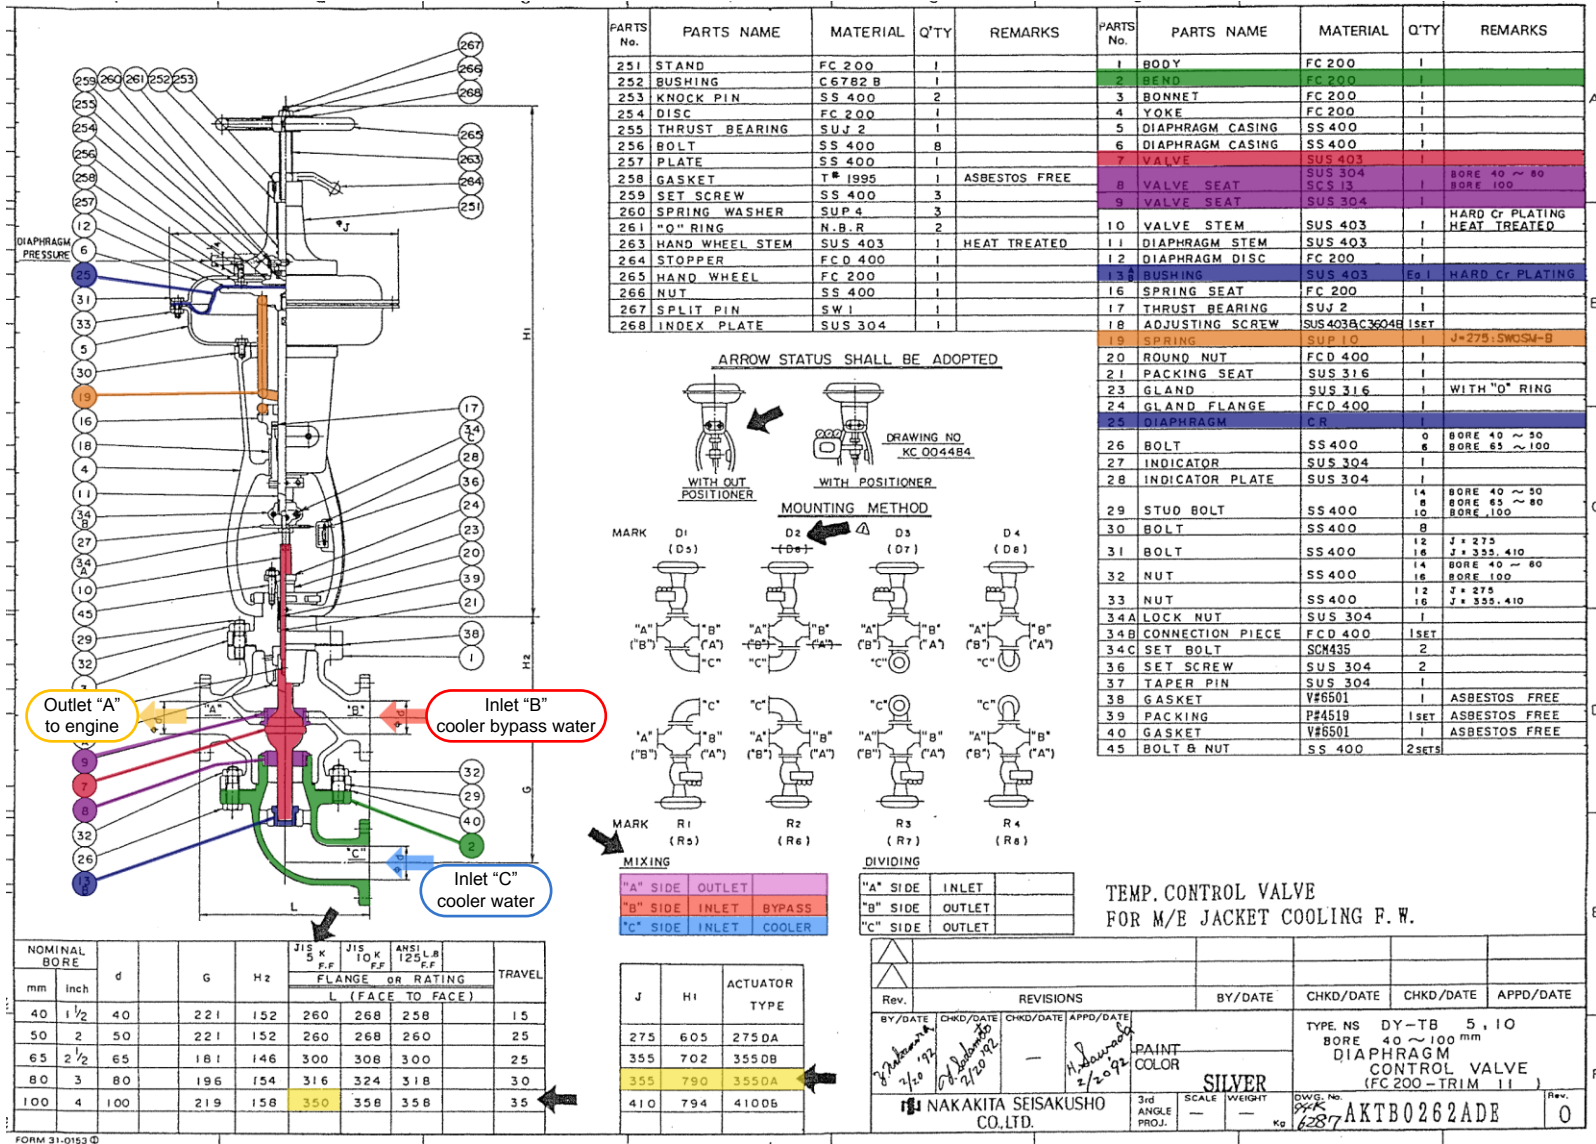
Figure A1-1
Diagram of 3-way control valve for main engine jacket-cooling fresh water

- The lower bend (2) was removed and the stainless valve trim was found to be in good condition.
 - There was no evidence of wear in the lower bushes (13b) or any signs of binding.

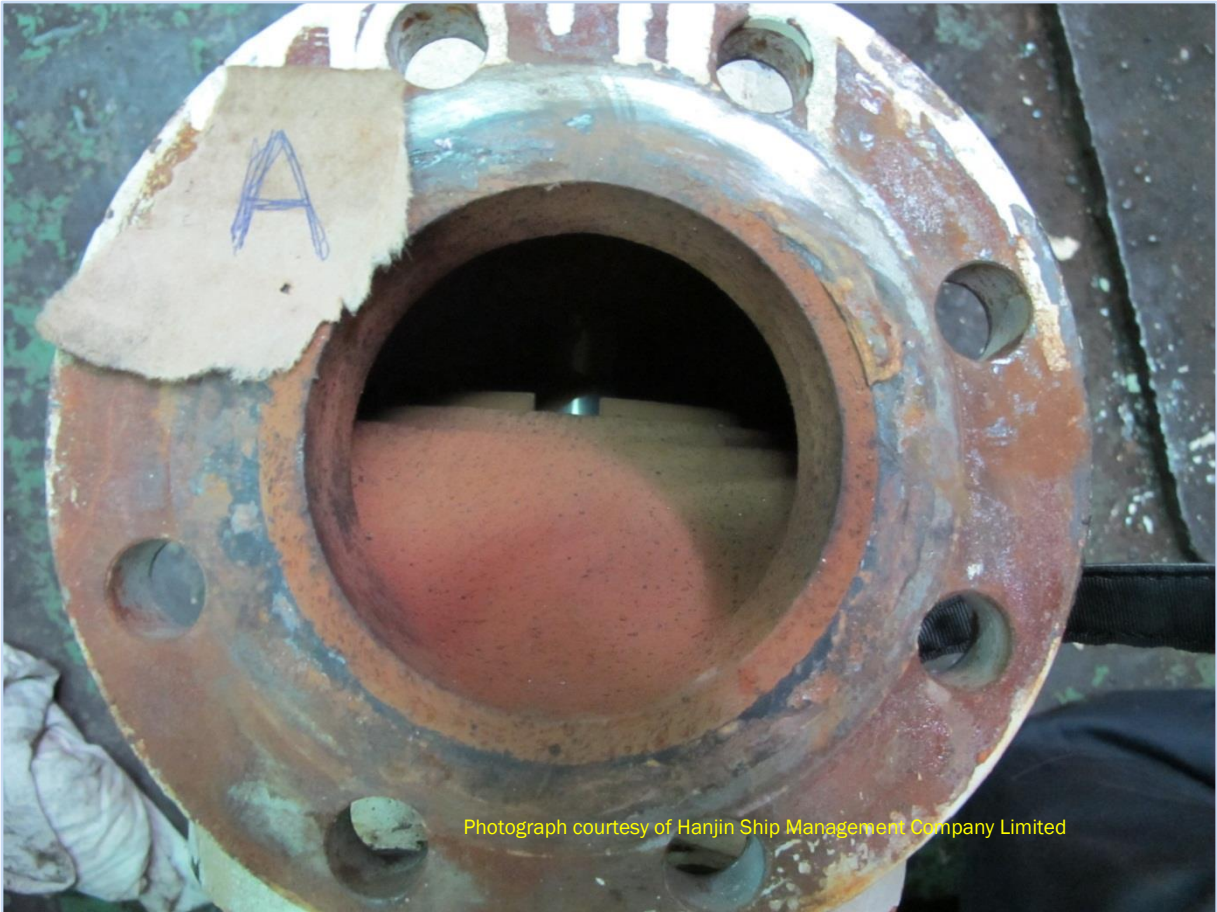
- 4.2.5 The fourth possibility is that the valve stem became temporarily jammed with debris such as detritus. Evidence of detritus was not found jammed around the valve spindle, but detritus was found in the cooling water system (see figures A1-2 and A1-3). The chief engineer succeeded in starting to move the valve by hammering on the valve casing. This would indicate that something was jamming the valve. By the time the valve was dismantled for inspection, it had been operating to cool the main engine when it was used to re-float the vessel, to take the vessel out to the anchorage and then to re-enter the port again. Any debris lodged around the valve spindle would not necessarily have remained there, which could

explain why the valve spindle was found in a clean condition when the valve was dismantled for inspection.

Figure A1-2
View into 3-way valve through bypass inlet showing detritus build-up and “clean” valve stem

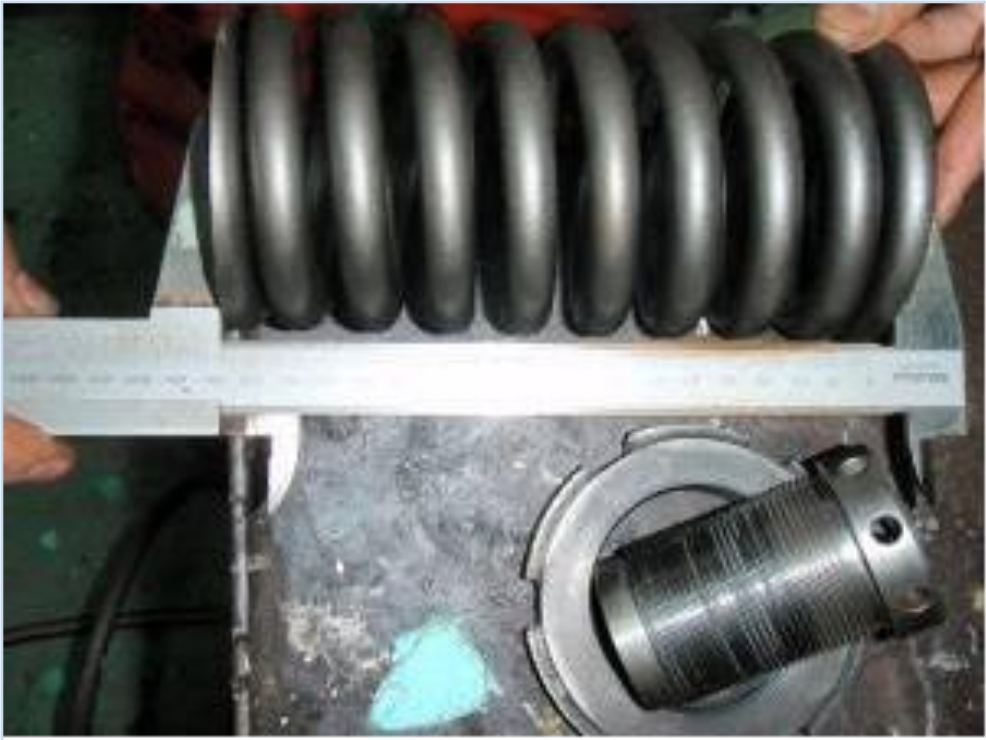
- 4.2.4 The third possibility is that the spring that normally opened the valve was faulty, but it was found in good condition with no signs of corrosion.

Figure A1-3
Photograph of spring showing condition on disassembly
