Inquiry MO-2010-206: Coastal container ship *Spirit of Resolution*  
grounding on Manukau Bar, Auckland, 18 September 2010

Marine inquiry 10-206  
coastal container ship *Spirit of Resolution*  
grounding on Manukau Bar, Auckland  
18 September 2010

Approved for publication: July 2015

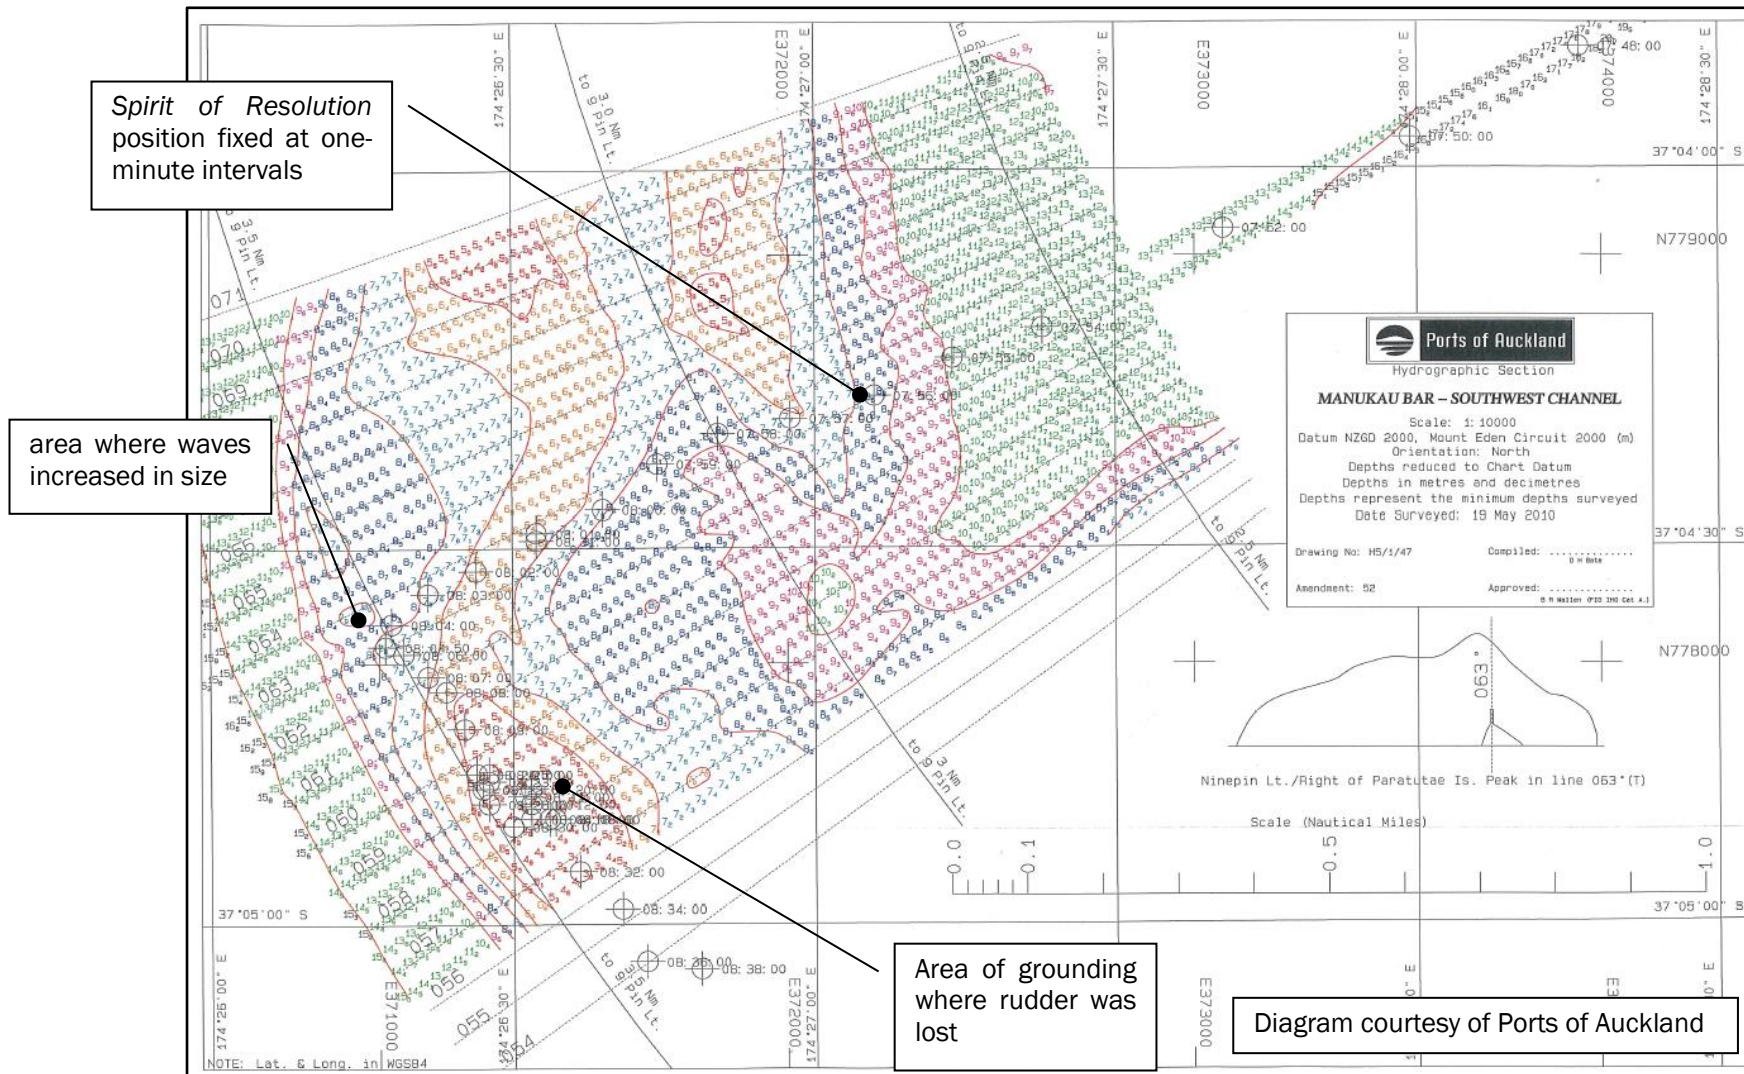
- 3.1.12. For the next 30 minutes the ship drifted southwards into shallower water under the influence of a strong southerly set<sup>7</sup> across the Manukau Bar. Figure 2 shows the progress of the *Spirit of Resolution* with Automatic Identification System (AIS) position fixes overlaid on the then recent soundings diagram, initially at two-minute intervals and then at one-minute intervals as it was reaching shallower water.

Figure 2  
Diagram showing latest depth survey of the Manukau Bar – southwest channel with Spirit of Resolution AIS data overlaid

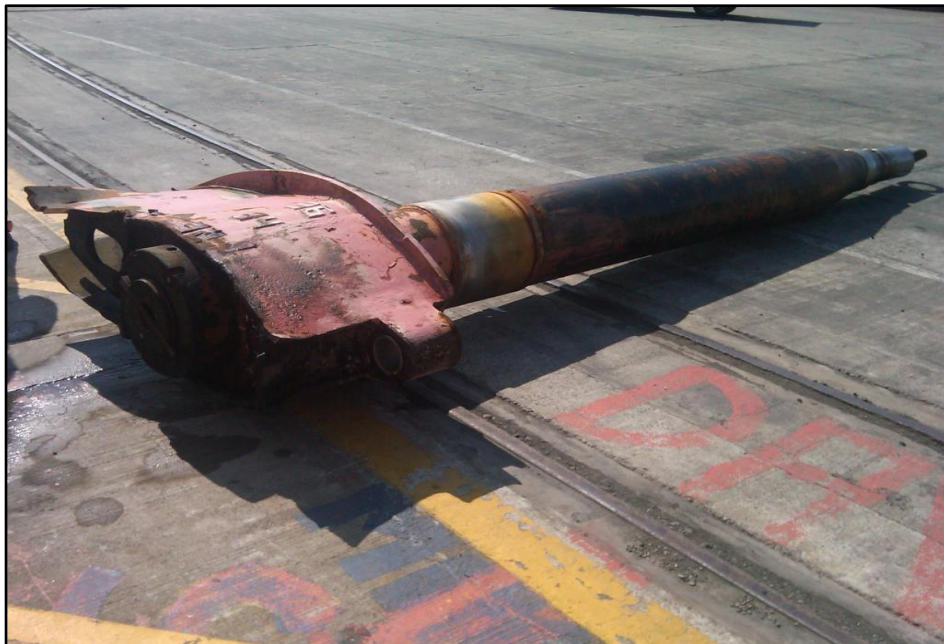
- 3.2.1. The *Spirit of Resolution*'s rudder sheared off near the bottom pintle<sup>10</sup>, with the bottom three metres and the trailing flap being lost to the sea.
- 3.2.2. A number of containers that were carried on deck were damaged or displaced by waves, with one refrigerated container breached.
- 3.2.3. The 'soft nose' structure at the bow of the *Spirit of Resolution* was damaged, with the bulwarks<sup>11</sup> being pushed in.

**Figure 3**  
Rudder stock and remaining top part of rudder after removal from ship  
(Photograph courtesy of Pacifica Transport Group)

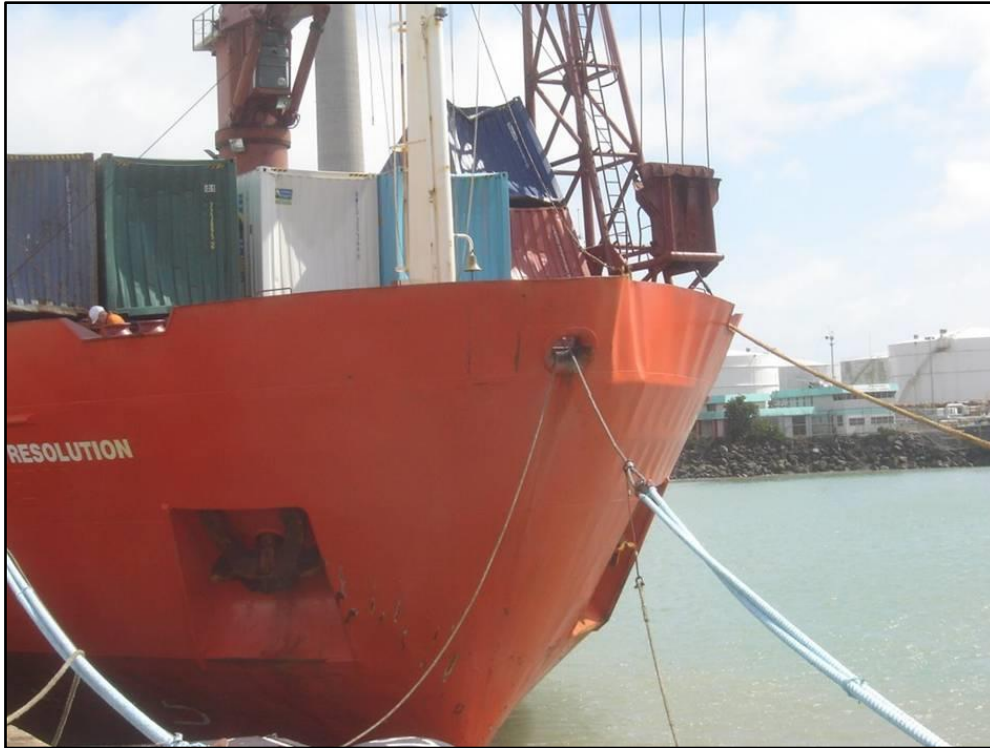
**Figure 4**  
Damage to bulwarks and containers  
(Photograph courtesy of Pacifica Transport Group)

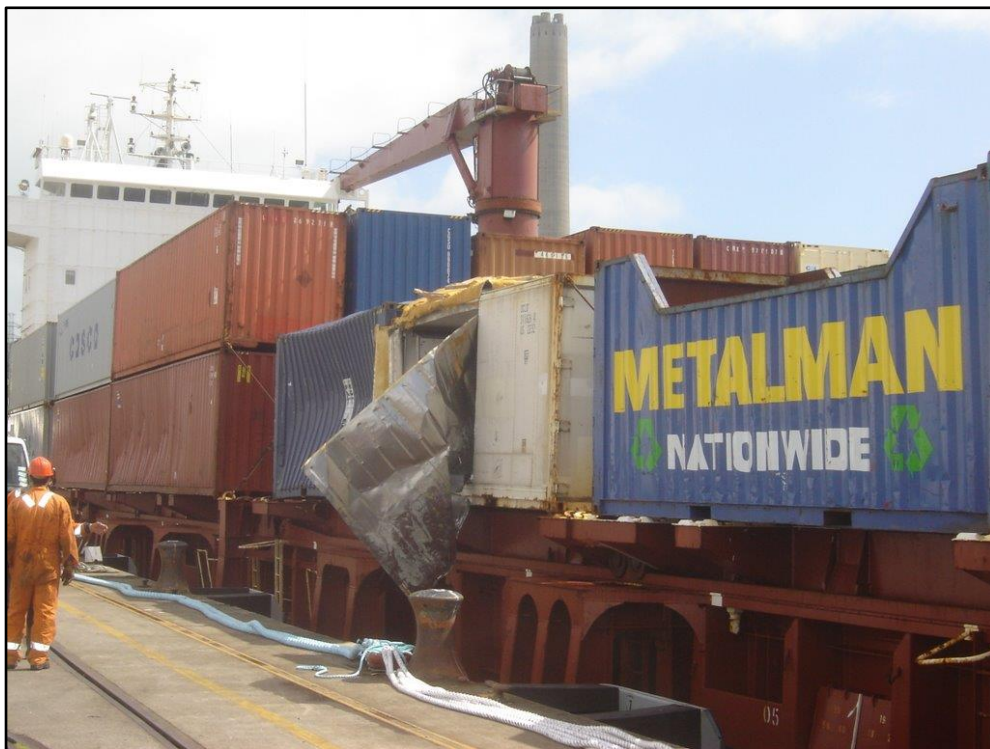
**Figure 5**  
Damage to containers on starboard side  
(Photograph courtesy of Pacifica Transport Group)
