Inquiry 11-003: In-flight break-up ZK-HMU, Robinson R22,
near Mount Aspiring, 27 April 2011

Final Report

Aviation inquiry 11-003
In-flight break-up ZK-HMU, Robinson R22,
near Mount Aspiring,
27 April 2011

Approved for publication: February 2014

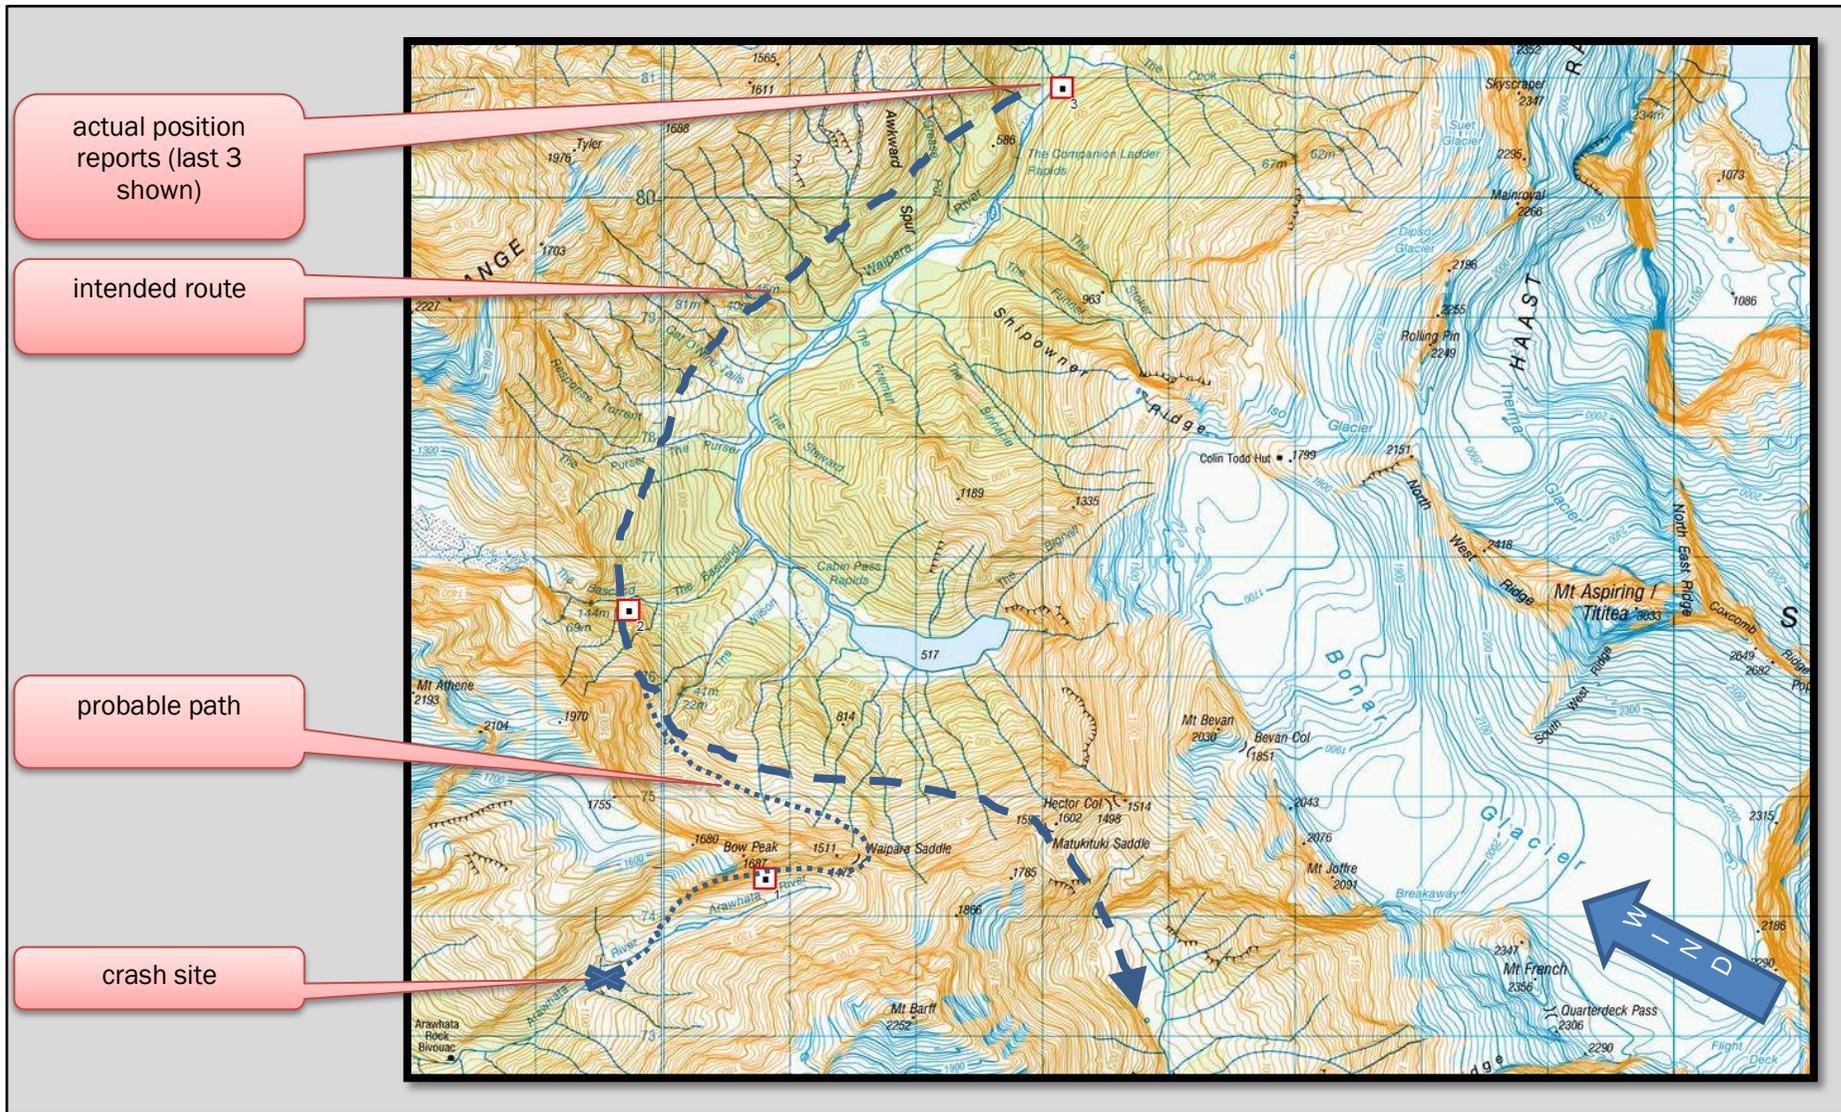
Figure 1
Flight path

- 3.1.5. The flight tracking log showed that the helicopter followed the outbound leg of the intended route through to Haast, then landed at Neils Beach airstrip in Jackson Bay at 1115 (about 35 km south of Haast). The weather conditions at Neils Beach were calm. The local helicopter operator based at Neils Beach spoke with the pilots. The pilots told the local helicopter operator that they had only expected 10 knots wind en-route but estimated it to have been closer to 30 knots. The instructor also told the local helicopter operator that they might have to divert on the way back due to the weather conditions. They said that they intended to fly up the Arawhata River (which meets the sea at Neils Beach).

- 3.1.8. Pilots broadcast regular radio position reports while operating in the Southern Alps so that other pilots in the area are aware of their intentions. The last radio position report broadcast from the helicopter was heard by the pilot of another aircraft in the area at about 1220. The pilot who responded recognised the instructor's voice. He said that the instructor did not sound concerned about the conditions and confirmed they were at 2000 feet and intending to cross Matukituki Saddle. The flight tracking log placed the helicopter in the Waipara River basin at that time.

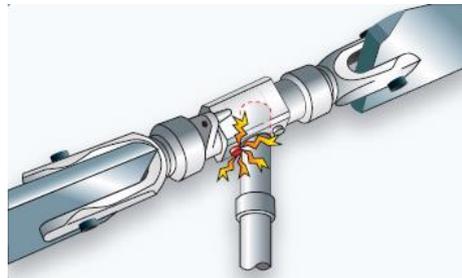
Figure 4
Mast bumping

- 3.2.9. Mast bumping occurs when the main rotor blade exceeds its flapping limits, causing the main rotor hub to “bump” into the main rotor shaft as shown in the diagram below⁶. The condition can lead to complete failure of the hollow main rotor shaft, resulting in the main rotor blade breaking away from the helicopter.

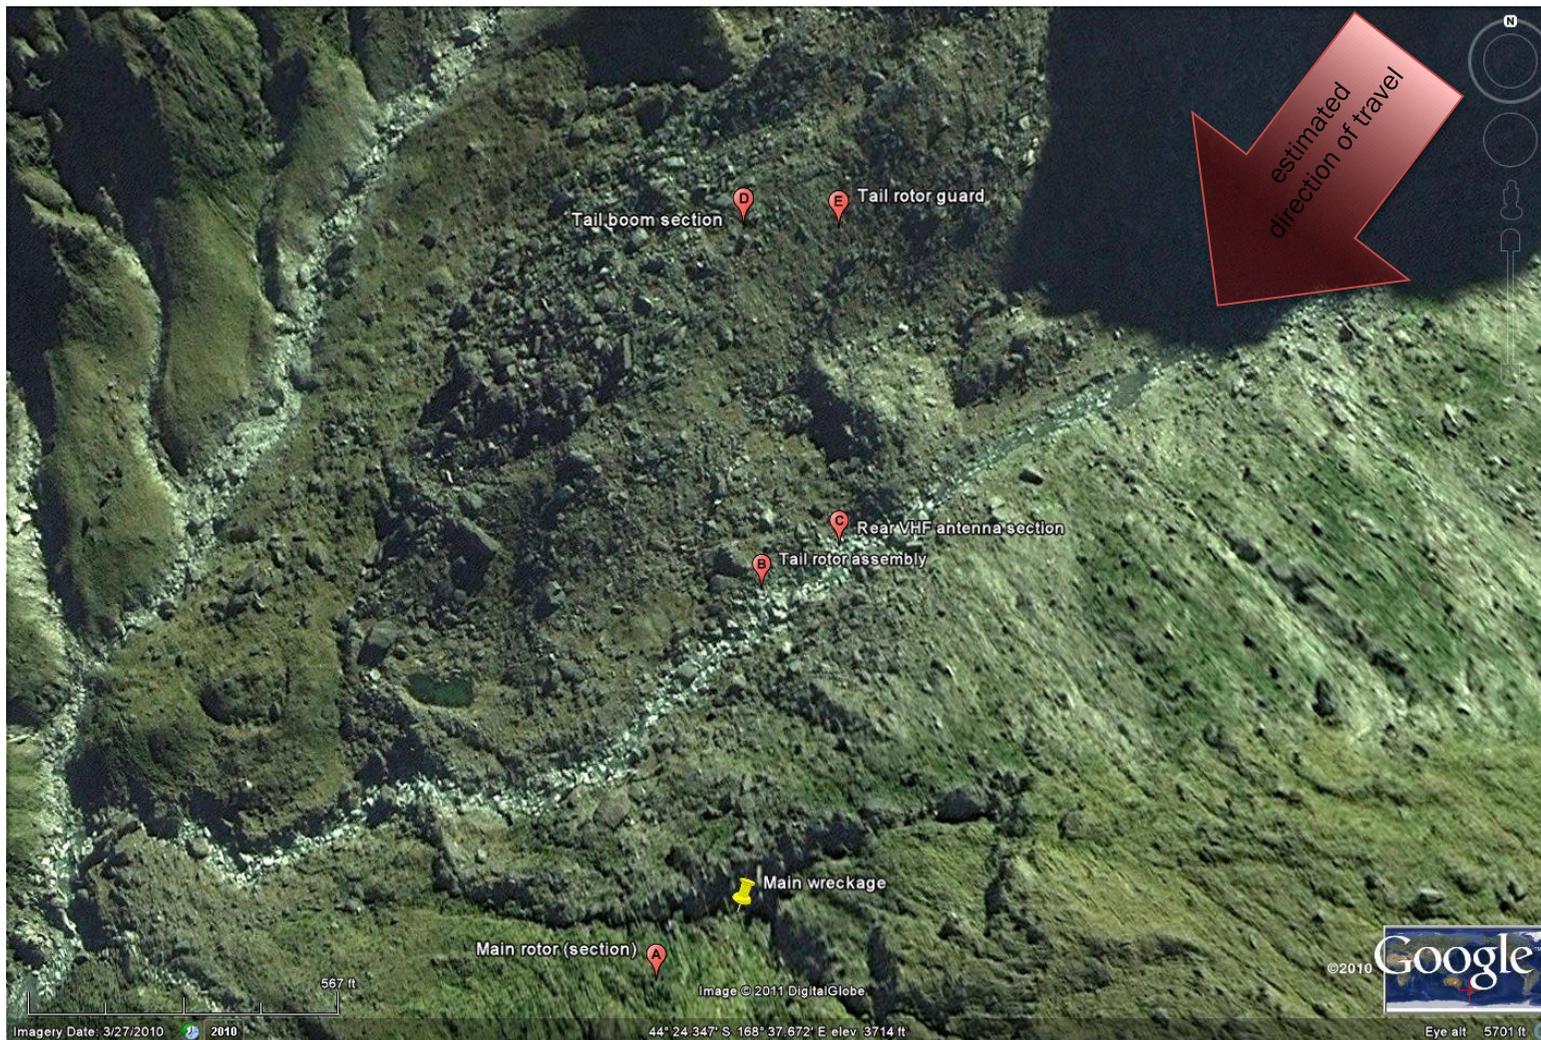
Figure 5
Wreckage spread

- 3.3.1. The main wreckage was located in a narrow, rocky stream bed, with most of the debris strewn 300 metres (m) back along the last known flight path from Waipara Saddle. The exception was the outer section of one main rotor blade, which was found about 50 m ahead of the main wreckage (see Figure 5). The impact damage indicated that the helicopter had struck a large boulder while in an upright position from a near-vertical trajectory. The fuel tanks had burst open upon impact, spilling aviation fuel around the area. There was no fire.

- 3.3.2. The wreckage trail began with the red-and-white tail rotor guard and part of the tail boom. These were found several metres apart about 300 m back from the main wreckage. The complete tail rotor assembly (including the tail fin) were found 145 m back from the main wreckage. Smaller Perspex fragments from the canopy and the red anti-collision beacon were found scattered along this first part of the wreckage trail.

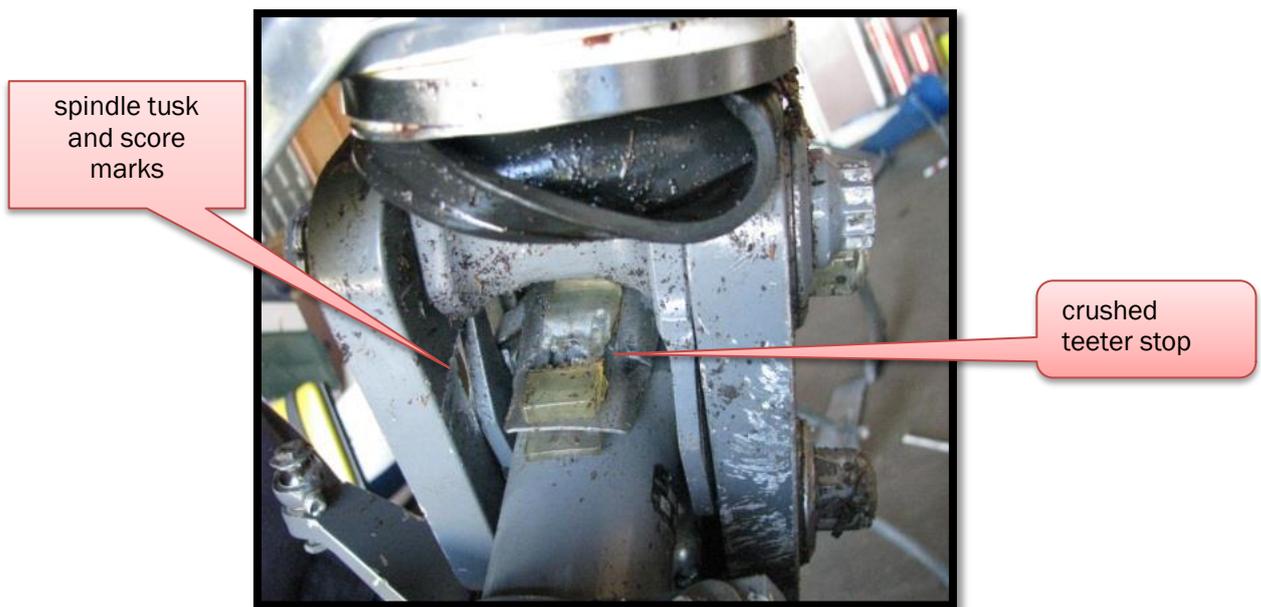
Figure 6
Rotor head and teeter stops

- 3.3.5. One of the main rotor spindle tusks had bent outwards and scored the inside surface of the rotor head (visible in Figure 6). The up-coning stop surfaces both showed evidence of crush damage. Both teeter stops had been crushed by the blade spindle compressing against the main rotor shaft. These are typical indications that excessive rotor blade flapping and mast bumping had occurred.

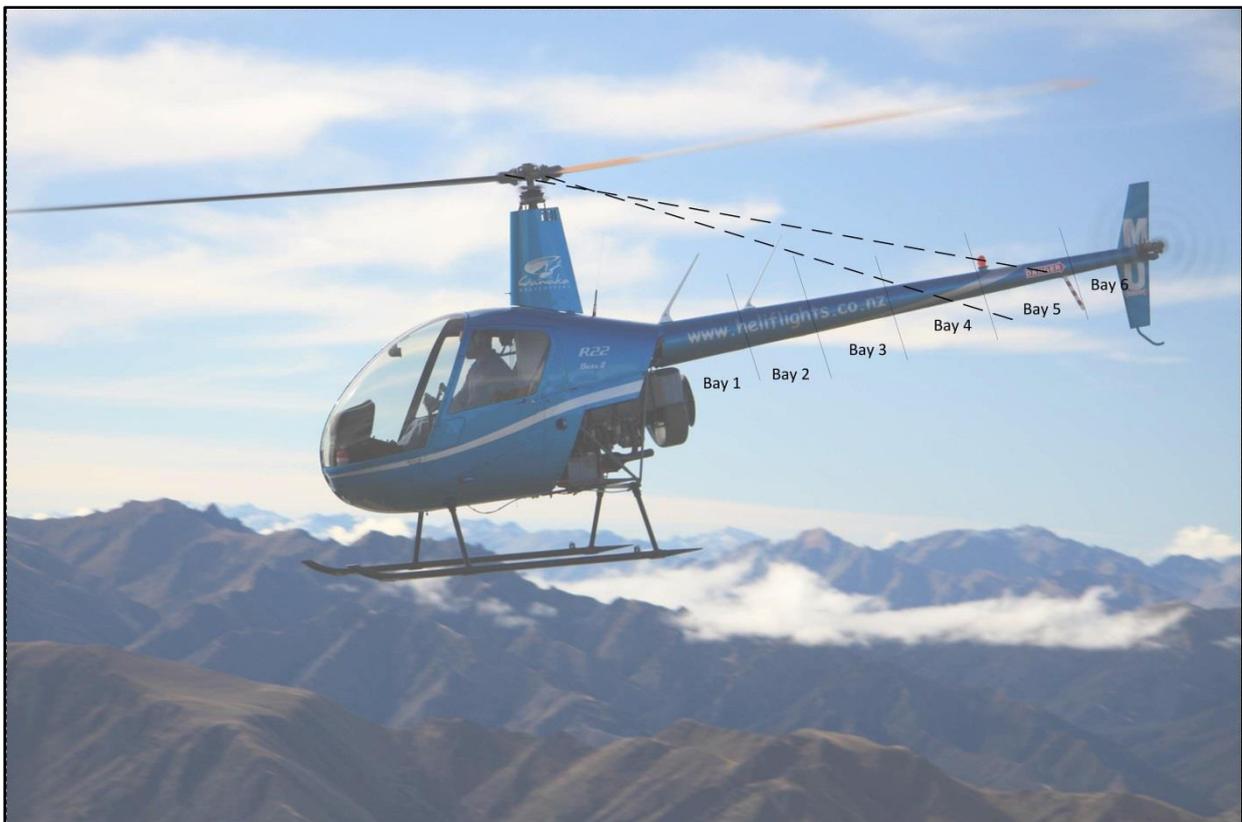
Figure 8
The tail boom impact lines

- 3.3.3. Both main rotor blades had fractured about 700 millimetres out from the hub. One blade had separated at that point and the outer section was found 50 m ahead of the main wreckage. The outer leading edge of both main rotors had paint transfer marks that matched the paint and impact impressions on the tail boom.

4.2.11. The tail rotor section and another section of the tail boom were found near the start of the wreckage trail. This is almost certainly a sign that the tail boom was severed by the main rotor blades and is supported by the paint transfer marks from the tail boom found on both main rotor blades, the impact impressions on the tail boom and the fact that both main rotor blades were bent backwards in the horizontal plane. This rearward bending of the main rotor blades also supports a conclusion that the main rotor blades were being driven at the time they struck the tail boom, meaning the engine was probably still delivering power when the break-up sequence began. With the loss of the tail boom and rotor, the helicopter would have become instantly uncontrollable. Figure 8 shows the angle at which the main rotor blades would have diverged from the main rotor plane in order to strike the tail boom in this way.

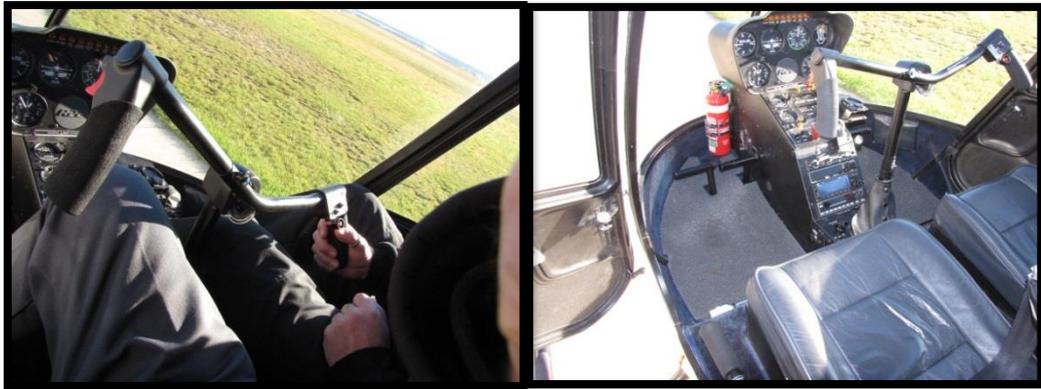
Figure 9
R22 cyclic control

- 4.3.20. The New Zealand situation did not therefore address the FAA's concern about reaction time. An instructor can "guard" the cyclic control against over-controlling by the trainee, but this can be challenging because of the cyclic control design. The cyclic control is pivoted on a central pedestal between the pilots. The pilot who is flying pulls their control handle down to a natural and comfortable flying position, which raises the other pilot's handle. Robinson recommends that in turbulence the pilot steady their right arm against their thigh. This has the effect of further raising the cyclic control for the non-flying pilot and, depending on the height of the pilot flying, putting it beyond comfortable reach (Figure 9).
