Inquiry 11-004: Piper PA31-350 Navajo Chieftain, ZK-MYS
landing without nose landing gear extended
Nelson Aerodrome, 11 May 2011

Final Report

Aviation Report 11-004

Nelson Aerodrome, 11 May 2011

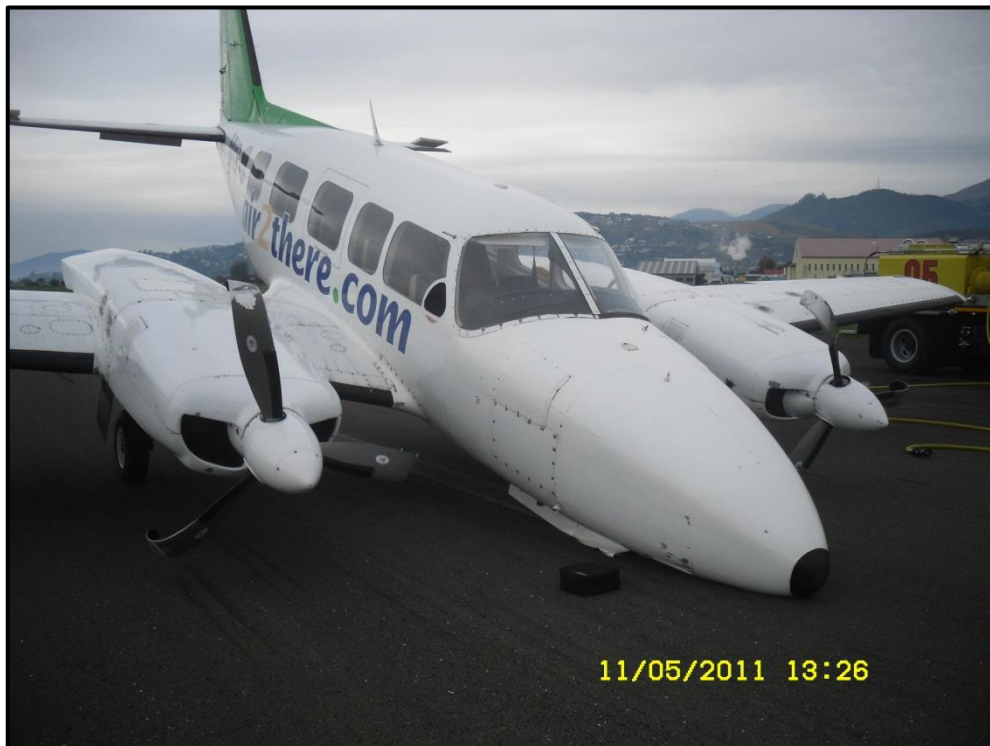
- 3.1.6 At 1247 the pilots declared a “full emergency”. At 1303 the aeroplane landed and the examiner shut down both engines before the nose was lowered to the runway. Neither pilot was injured, but the aeroplane incurred substantial damage to the propellers and underside of the nose cone (see Figure 1).

Figure 1
The aeroplane after landing
(Photo courtesy Nelson Airport Limited)

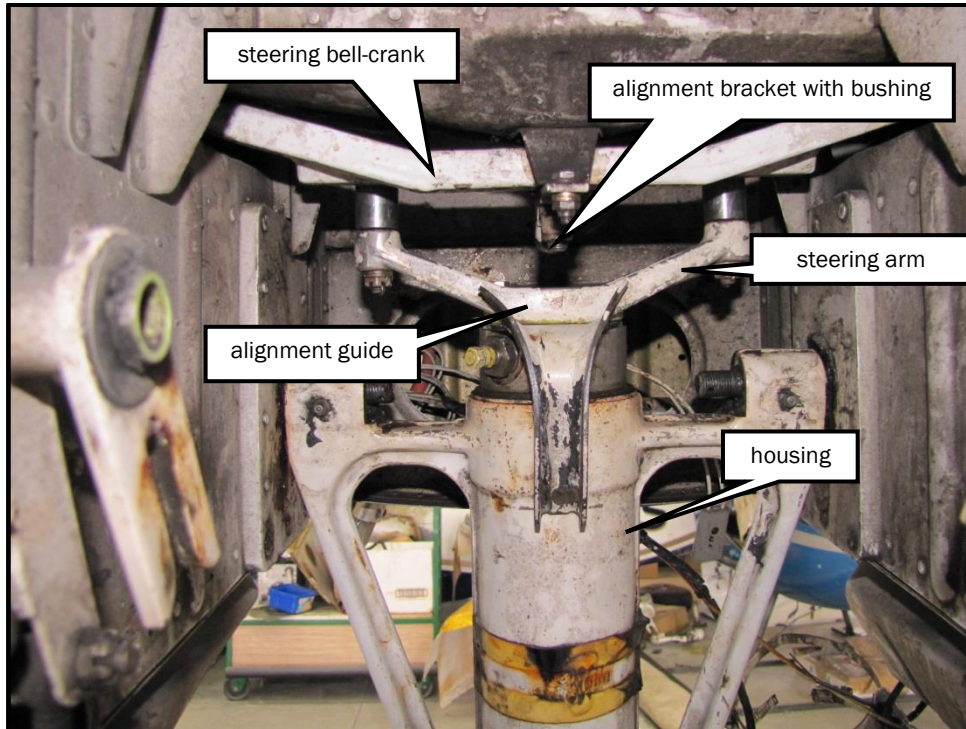
Figure 2
Head of nose landing gear, looking forward

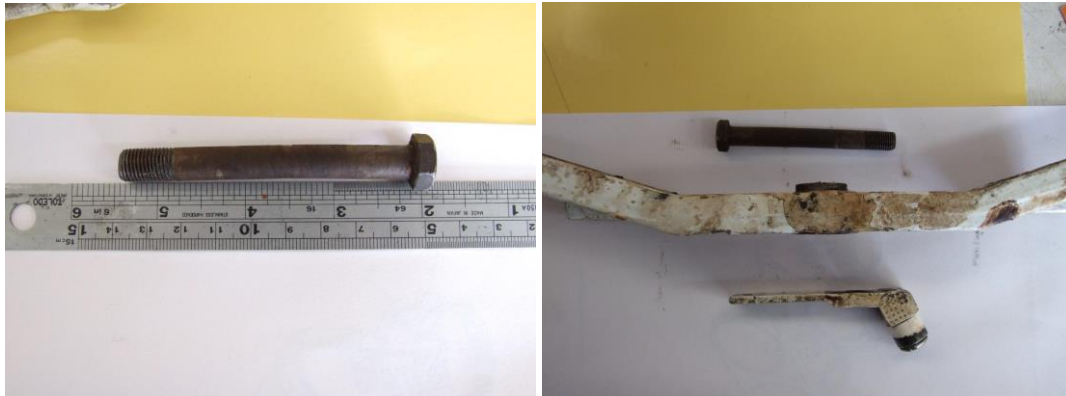
- 3.3.18 The steering arm bushings, which contacted and rolled against the steering bell-crank when the nose landing gear was extended, contacted the bell-crank by less than half of their depth. This small overlap suggested a misalignment or misrigging of the nose landing gear.
- 3.3.19 The pivot bolt¹¹ for the steering bell-crank was found loose and bent (see Figure 3). This caused the alignment bracket bushing to sit about 6 millimetres further above the alignment guide than it would have if the bolt had been tightened and straight. There was supposed to be a washer installed between the steering bell-crank and the alignment bracket, but this washer was missing (see Figure 3).

Figure 3
Bent pivot bolt (left), with bell-crank and alignment bracket (right)

- 3.3.20 The gap between the steering arm bushings and the steering bell-crank exceeded the allowable limit stated in the Maintenance Manual. There were hollows on the face of the bell-crank that looked as if they had been caused by the steering arm bushings striking the bell-crank as a result of this larger gap.

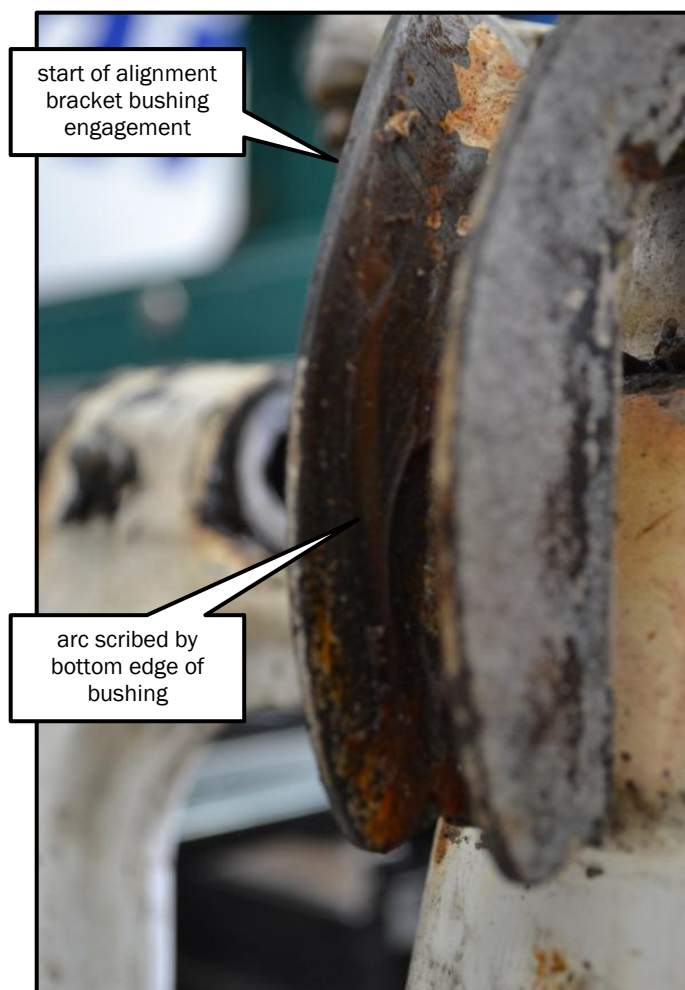
- 3.3.26 On 31 January 2007 the borrowed housing was replaced with one ordered from a United States company. The release certificate for the new housing had the same, incorrect part number as that recorded in the log book when the housing had been removed (45316-03) and the serial number 05332. This was the housing found on the aeroplane on 11 May 2011 after the accident.

Figure 4
Alignment guide witness marks

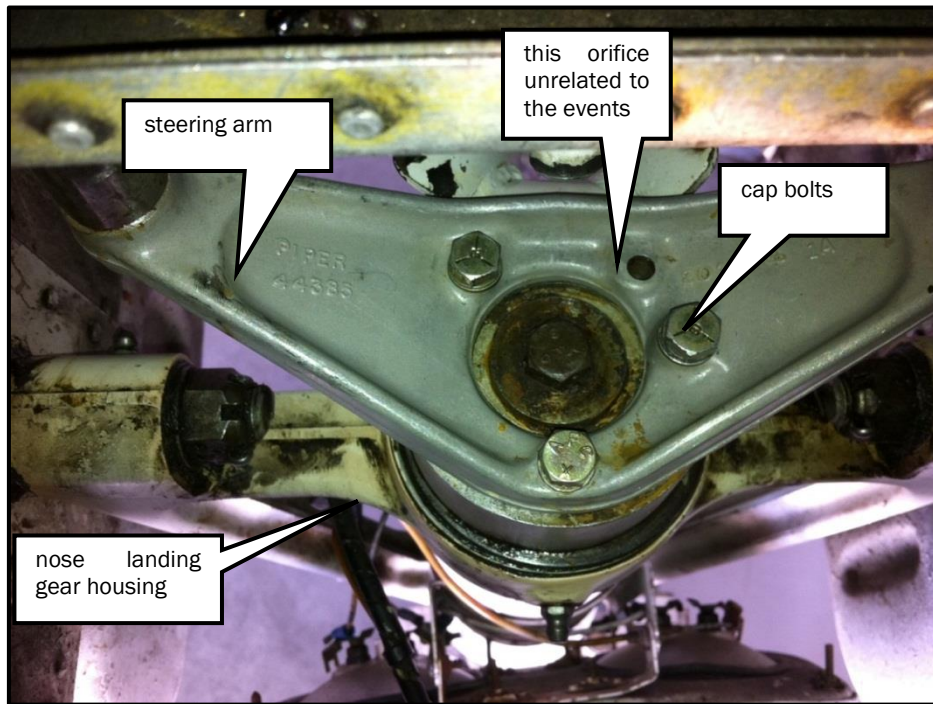
- 3.3.40 The contracted engineer who rectified this defect found that the cap bolts that attached the steering arm and alignment guide to the top of the housing were loose and not the correct parts. The bolts were two ¼-inch coarse-thread bolts and one AN4-6A fine-thread bolt (see Figure 6, which was taken at the time). The bolts were not lock-wired, as required by the Piper Maintenance Manual. The bolt holes in the steering arm, alignment guide and strut inner cylinder had been drilled out to ¼-inch diameter and helical inserts²² put into the cylinder.

Figure 6
Nose landing gear cylinder cap bolts, as found installed, 11 April 2011

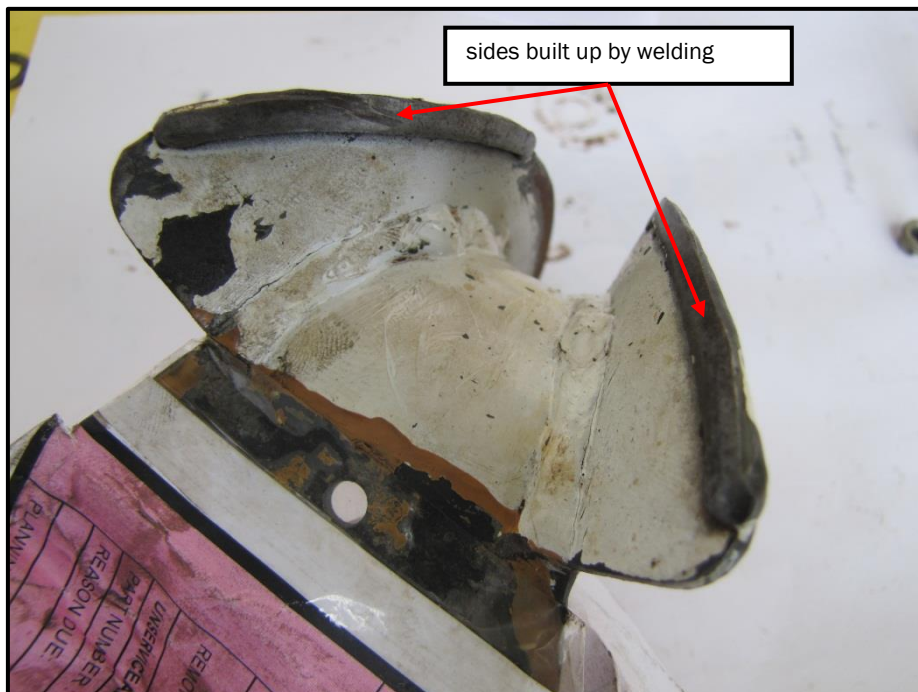
- 3.3.42 The alignment guide was also found to be bent and the sides built up by welding that had left sharp edges on the inside faces of the channel (see Figure 7). The available log books gave no indication of when that repair had been made.
- 3.3.43 None of the Repaircraft and Air West Coast engineers who had worked on the nose landing gear after the December 2010 incident had noticed the sharp, built-up edges on the alignment guide, nor had they noticed that the cap bolts were not lock-wired.
- 3.3.44 The inner cylinder, the steering arm and the alignment guide were replaced, along with the cap bolts. After functional ground and flight checks, the aeroplane was returned to service.

Figure 7
Alignment guide after removal, 11 April 2011, showing built-up sides
