Report 11-103: Track workers nearly struck by passenger train  
near Paekakariki, North Island Main Trunk, 25 August 2011

Rail inquiry 11-103  
Track workers nearly struck by passenger train near Paekakariki,  
North Island Main Trunk  
25 August 2011

Approved for publication: April 2013

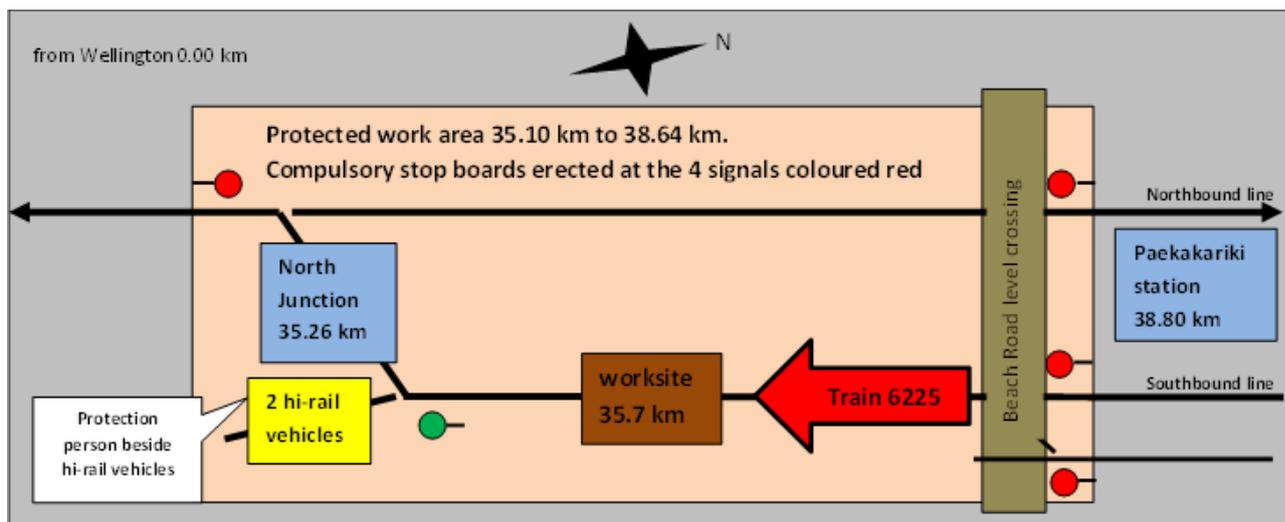
Figure 1  
Diagram of the protected work area (not to scale)

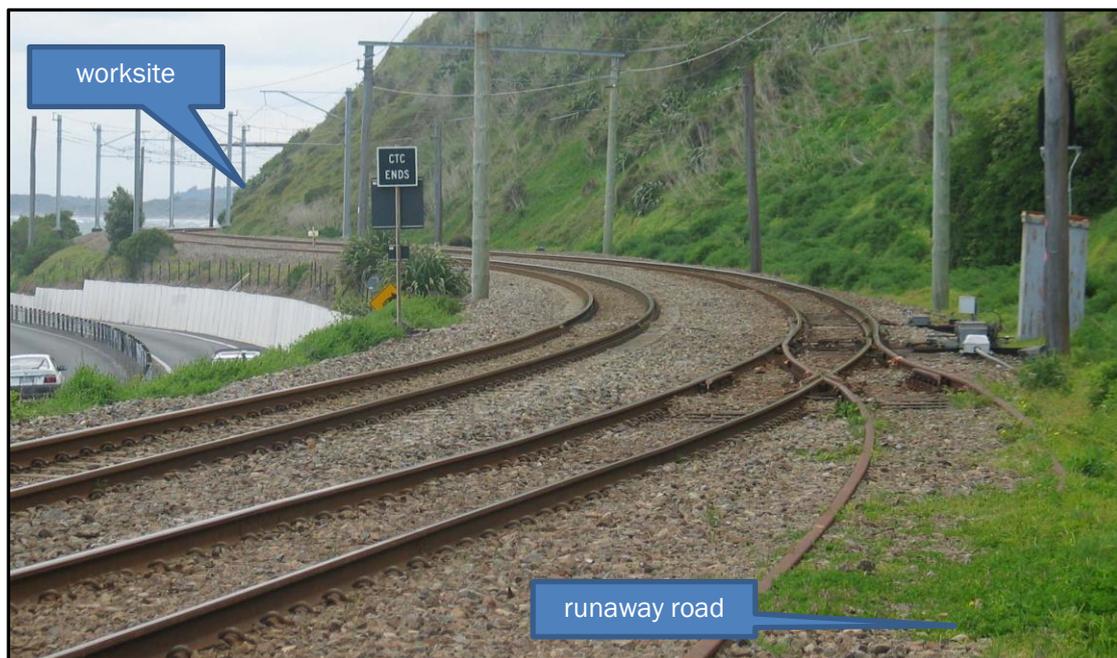
Figure 2  
The protection person’s view line facing north

- 4.2.16. KiwiRail's procedures make no reference to the positioning of the site protector in relation to the worksite that they are protecting. While in some rare cases it might be that the protection person cannot remain in sight of the work gang while still maintaining radio contact with the person in charge, the procedures should make it clear that this should be the exception and stress the importance of the protection person being able to see the work group when making radio contact with the person in charge. Having the work gang in sight will reduce the probability of the system failing, as it did on this occasion.

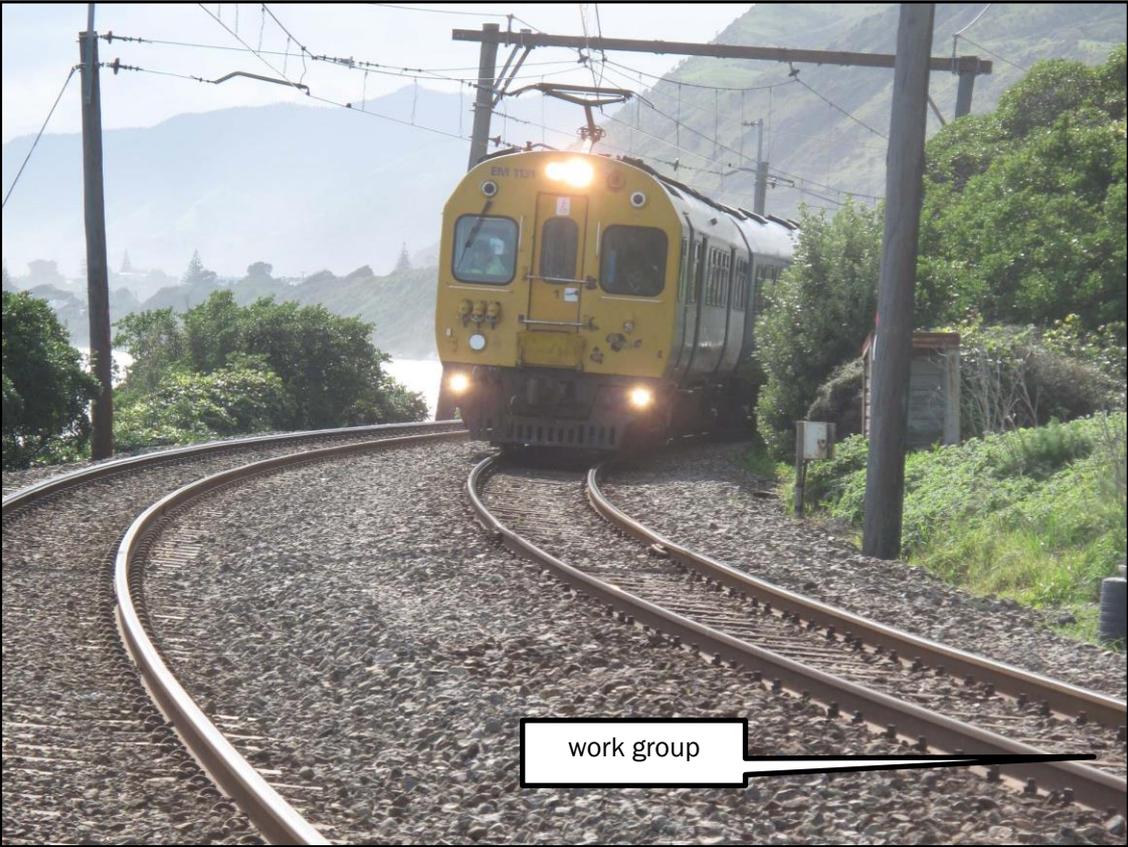
- 3.2.14. The train driver said he was about halfway around the left-hand curve when he first saw 2 track workers wearing hi-visibility clothing about 90 m ahead facing away from his train. He sounded the train horn and applied maximum braking. The track workers turned and saw the train bearing down on them (see Figure 3). They both jumped clear of the track, one towards the adjacent line and the other towards the hillside just before the train passed. The driver said the track workers cleared the track when his train was less than 20 m away.

**Figure 3**  
The work group's view of an approaching passenger train
