Inquiry 11-105: Freight Train 228 wrong-routed, into closed section of track
Wiri Junction, South Auckland, 12 November 2011

Rail inquiry 11-105
Freight Train 228 wrong-routed
into closed section of track
Wiri Junction, South Auckland
12 November 2011

Transport Accident Investigation Commission

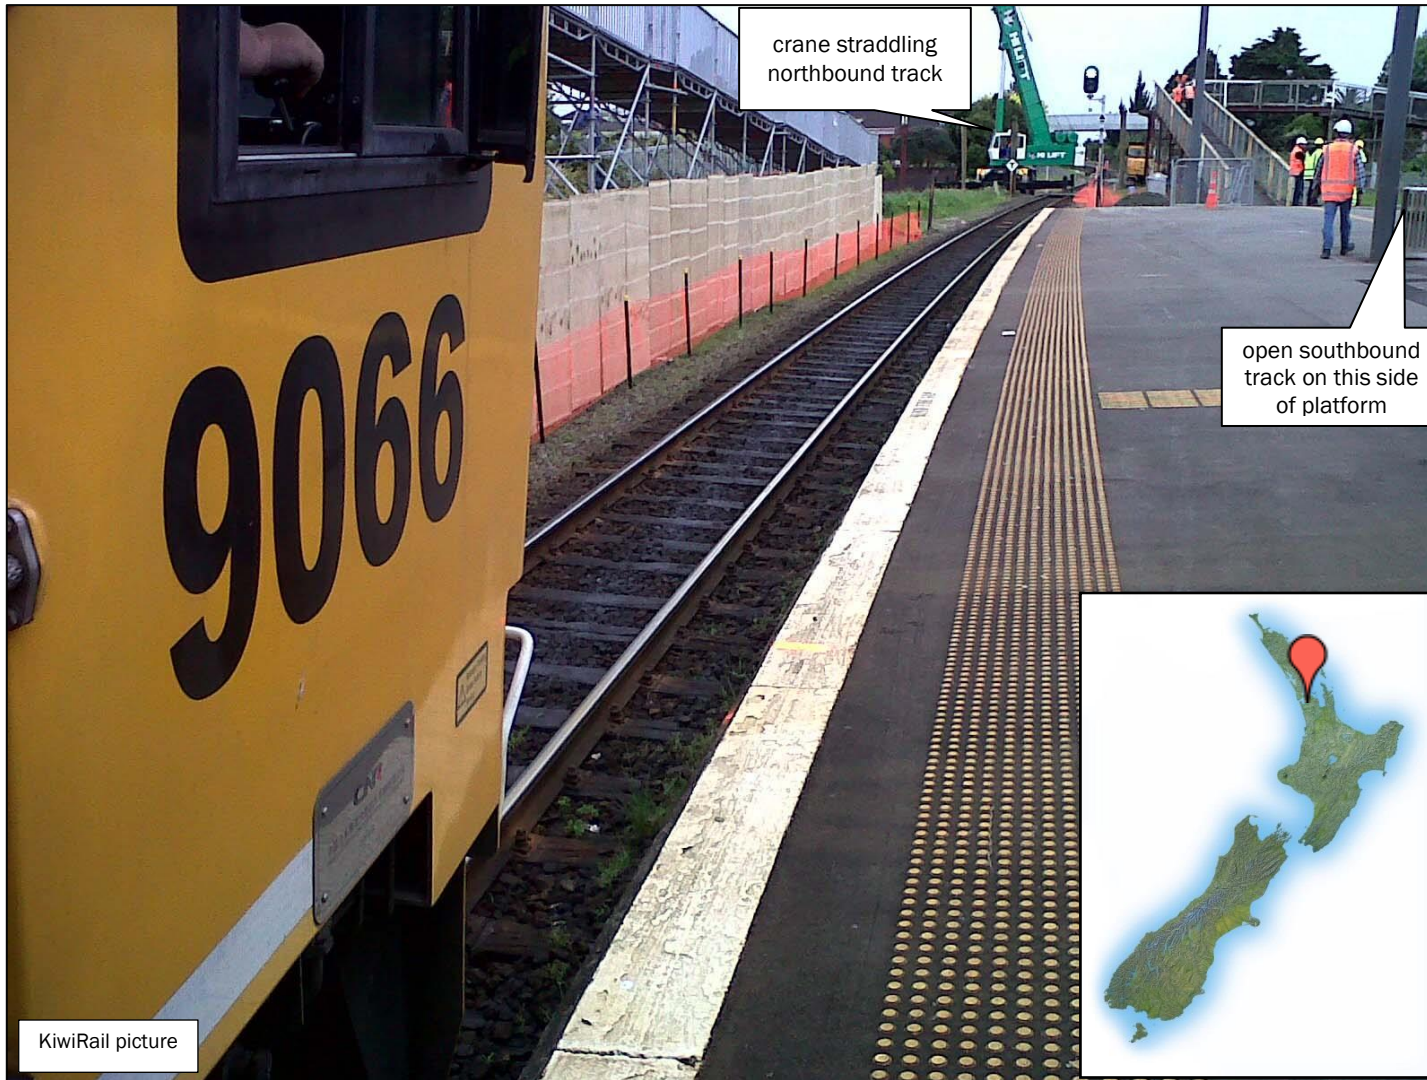
Train 228 stopped on the closed northbound track at Puhinui

- 3.2.17. The freight train had travelled about 750 metres from Block Entry Board No.2 and stopped 97 metres short of the crane. The driver radioed the train controller to inform him of the incident.

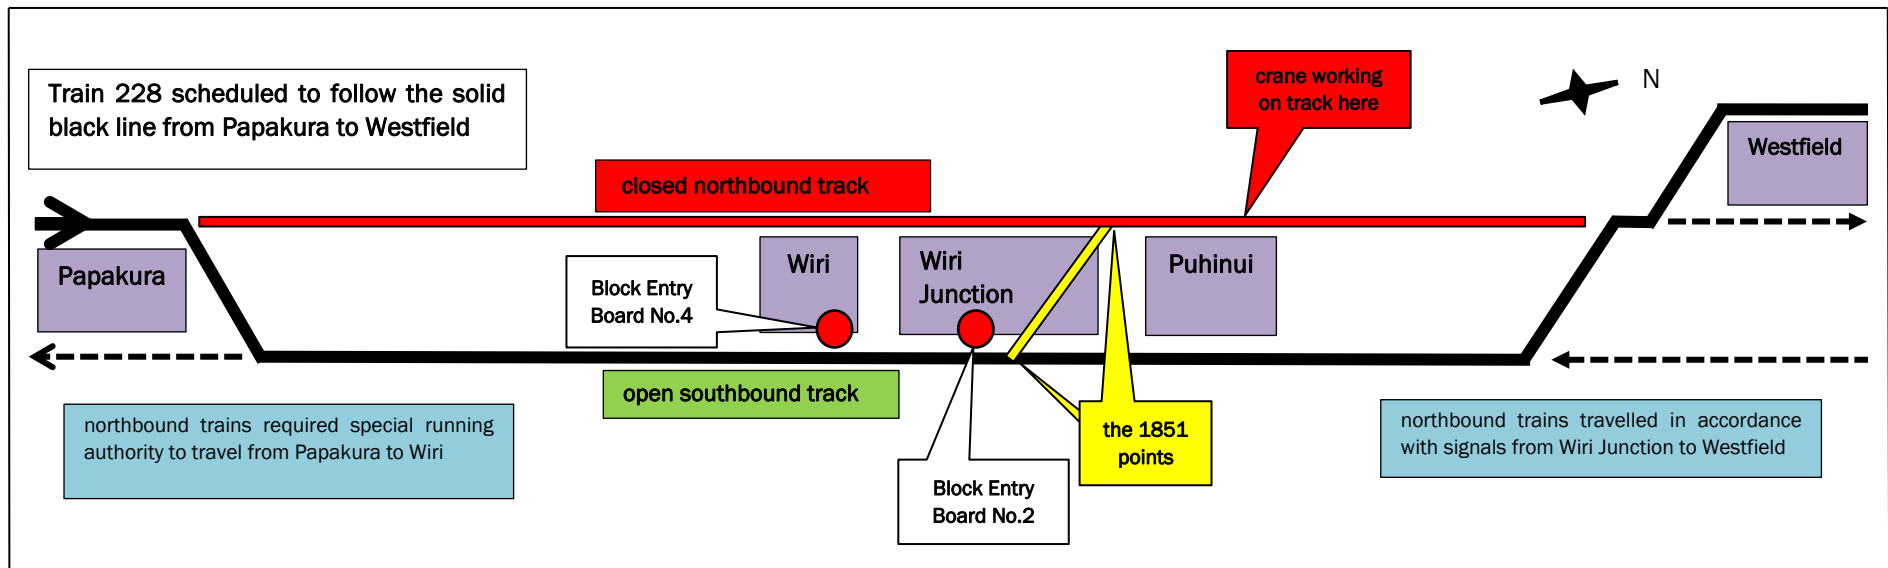
Figure 1
Track layout between Papakura and Westfield (not to scale)

- at the Westfield end
 - at the 1851 crossover points at Wiri Junction.
- 3.2.5. The train controller ought to have arranged for the signals to be control blocked at each of the **entry** points to the work area¹. He did not do this. Instead he arranged control blocking on the signals controlling rail vehicles **leaving** the work area at Papakura and Westfield and did not apply blocking on the 1851 crossover points at Wiri Junction.

- 3.2.8. At 1053 the train controller changed the setting of the 1851 crossover points at Wiri Junction to route the freight train from the open track to the closed northbound track (see Figure 1).

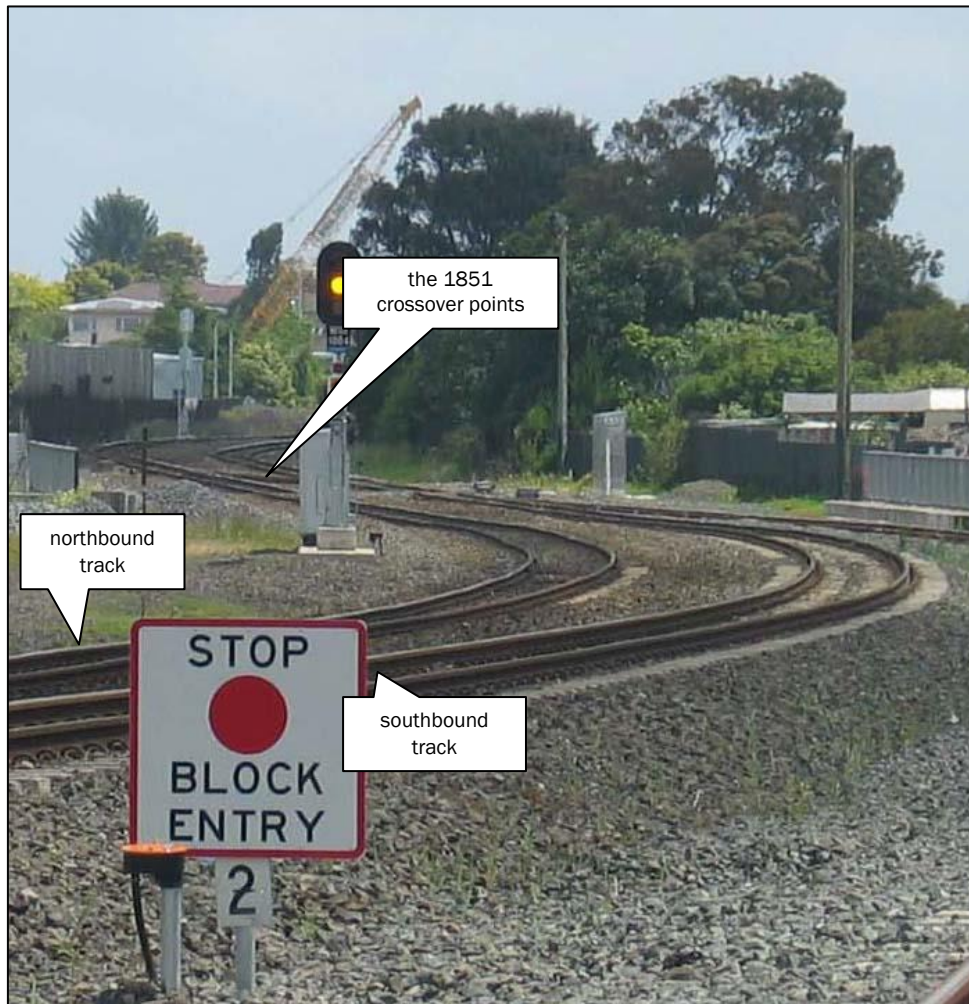
Figure 2
Wiri Junction with a crane working off-track at Puhinui in the background

- 3.2.14. The freight train moved off and soon arrived at Block Entry Board No.2, where the driver stopped his train and requested the train controller’s authority to proceed (see Figure 2). The train controller verbally authorised the freight train driver to pass the board and told him that the route was set for him to travel from the southbound track to the northbound track.

- 3.2.16. The freight train moved past Block Entry Board No.2 at 1213 and reached a speed of 23 kilometres per hour through the 1851 crossover points, and onwards to Puhinui on the closed northbound track. A site protector radioed the driver to stop at the same time that he (the driver) saw the crane straddling the track in front of him at Puhinui. He stopped the train at 1216 hours.
