Inquiry 11-106: Hi-rail vehicle nearly struck by passenger train,
Crown Road level crossing near Paerata,
North Island Main Trunk, 28 November 2011

Final Report

Rail inquiry 11-106
Hi-rail vehicle nearly struck by passenger train, Crown Road level
crossing near Paerata,
North Island Main Trunk, 28 November 2011

Approved for publication: October 2013

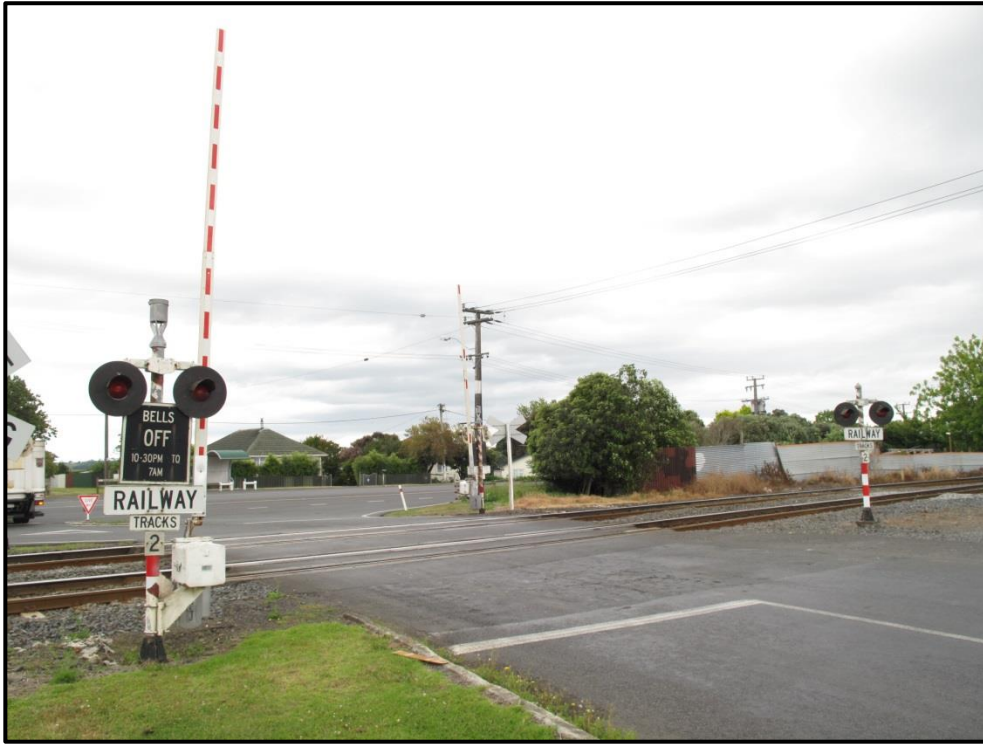
The Crown Road level crossing
(located near Paerata)

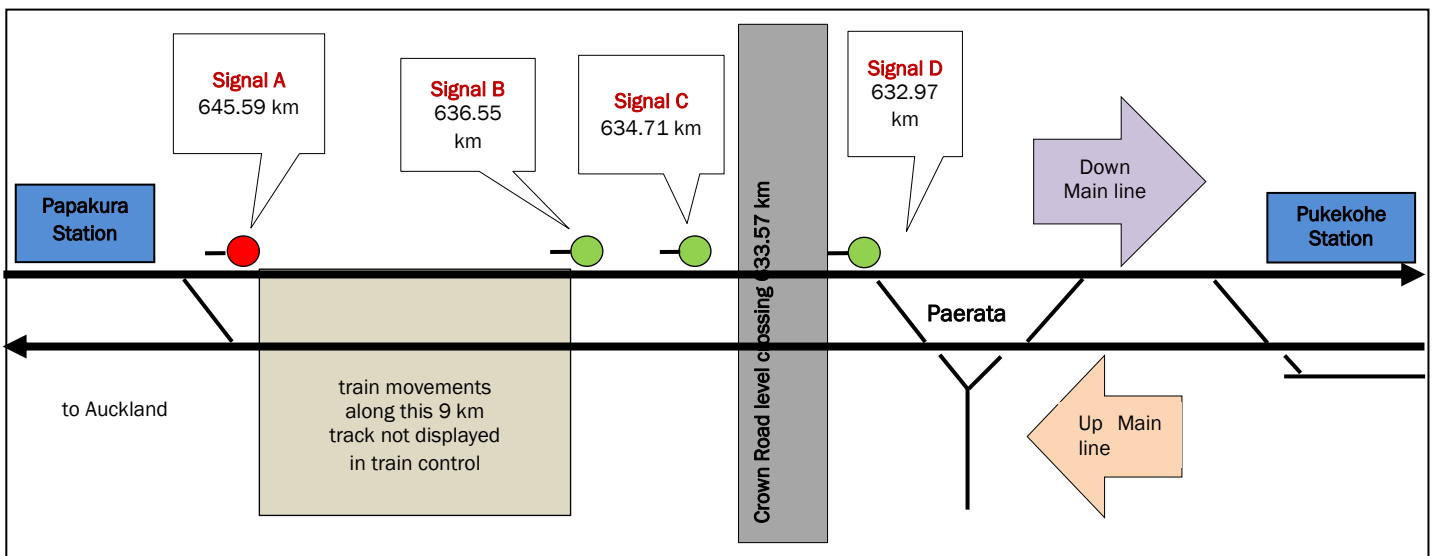
Figure 1
Up Main line and Down Main line from Papakura to Pukekohe

4.3.4. Figure 1 shows the Up Main line and the Down Main line between Papakura and Pukekohe, and the location of the Crown Road level crossing near Paerata. It also shows the 4 signals between Papakura and Paerata:

- the 44 signal (645.59 km) south of Papakura (**Signal A**)
- the 636.55 km intermediate signal (**Signal B**)
- the 634.71 km intermediate signal north of the Crown Road level crossing (**Signal C**)
- the 8L signal (632.97 km) south of the Crown Road level crossing near Paerata (**Signal D**). This signal identified the boundary between Auckland and Waikato train control.

4.3.5. Trains travelling between Signal B and Pukekohe were continuously displayed on the mimic screen, enabling train controllers to see where they were. However, trains travelling between Signal A and Signal B were not, meaning that their movements on this section of track (approximately 9 km long) were not electronically visible to train control (dark territory). In these cases, train controllers had to anticipate train movements by plotting progress on their paper train control diagrams, with the help of other information such as information from the train register.
