Marine Inquiry 11-201, Passenger vessel *Volendam*, lifeboat fatality,
Port of Lyttelton, New Zealand, 8 January 2011

Final Report

Approved for publication: October 2011

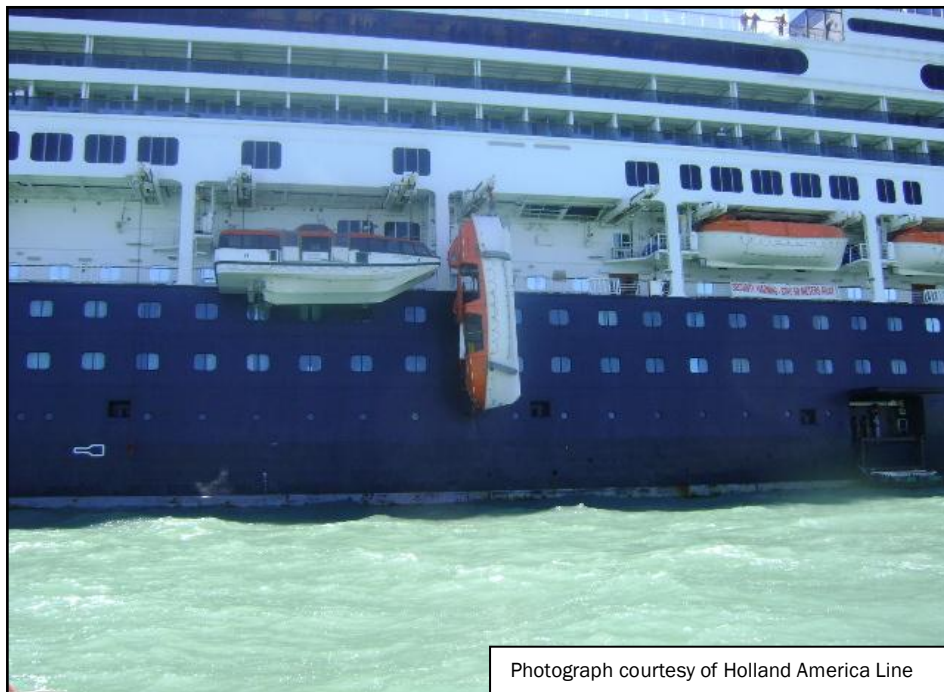
Figure 1
Number 7 lifeboat in vertical position after failure of wire fall

- 3.1.6. As the winch operator was lowering the lifeboat the forward lifeboat wire fall parted and the lifeboat fell bow down, suspended by the aft lifeboat fall (see Figure 1).

- 3.1.7. The aft lifting hook bent backwards under the strain, tearing a path through the fibreglass hull as it did so. As a consequence the safety line rigged between the lifting hooks parted. Because it was this line to which the crew members had attached their safety harnesses, the 2 crew members on the lifeboat fell about 16 m into the water.

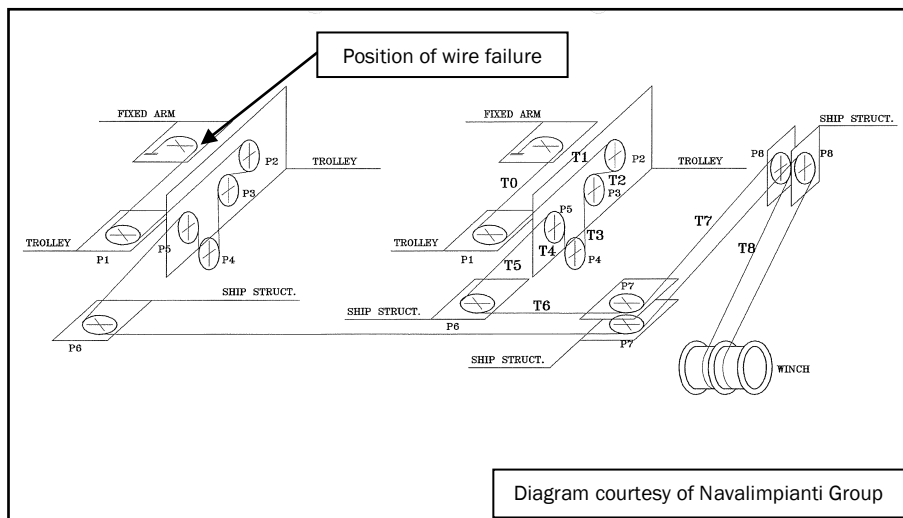
Figure 3
Wire fall reeving diagram

- 3.3.7. The wire falls were wound onto 2 hydraulically-driven winch drums and reeved through a series of sheaves located on the ship, on the telescopic trolley arms and on the fixed arms. Both wire falls terminated after passing around fixed guides located on the outboard end of the fixed arm of the davit (see Figure 3).

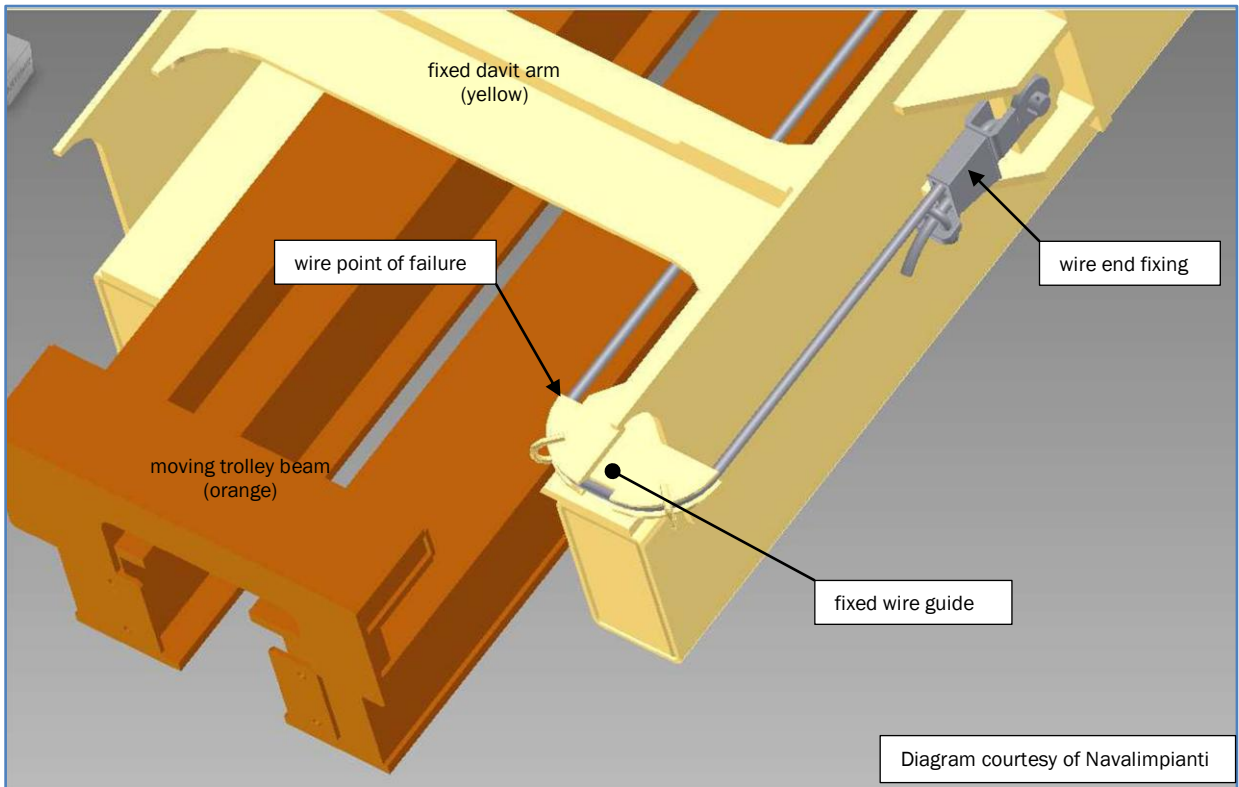
Figure 4
Diagram of davit construction

- 3.4.2. The wire failed at a point just inboard from the end of the fixed guide on the inside of the forward davit arm (see Figures 4, 5 and 6). When being extended, and re-housed the moving trolley arm moved horizontally past this fixed guide. The groove on the fixed guide was of sufficient size to accommodate a 22 mm wire under tension. A vertical bracket on the moveable trolley beam lay adjacent to the fixed guide when the davit was in its stowed position.

- 3.4.3. Figures 4 and 5 show where the vertical bracket had been rubbing against the fixed guide, causing wear marks on the bracket. When number 5 davit was inspected, there was evidence of wire score marks on the bracket (see Figure 7).

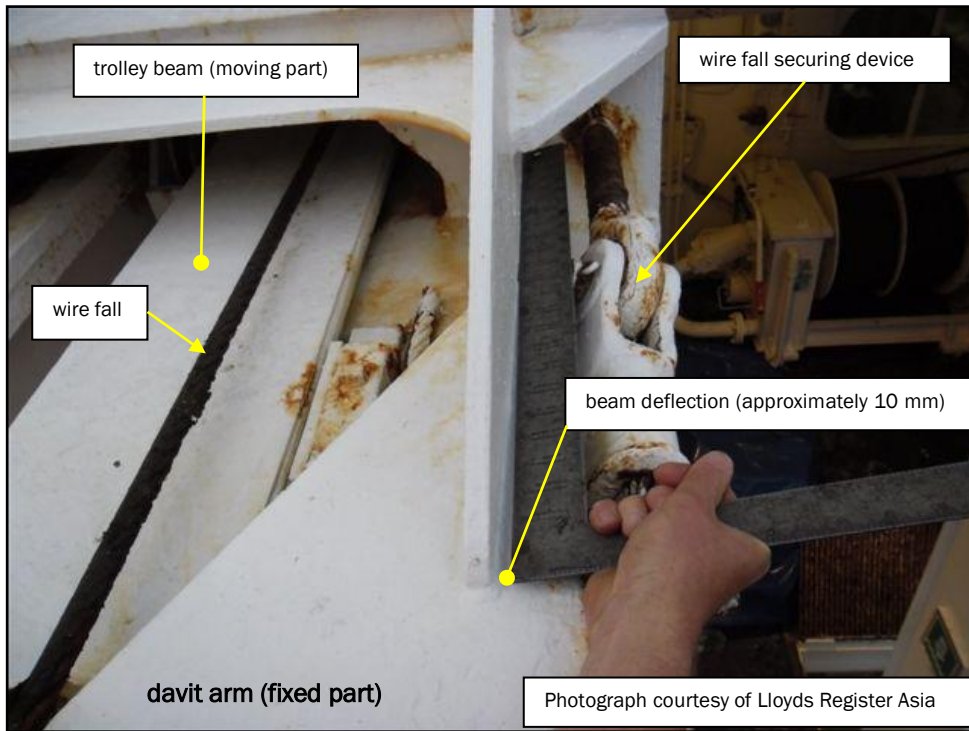
Figure 8
Number 5 davit beam (fixed part) showing deflection

- 3.4.4. When number 5 davit was tested during the inspection, the surveyor noted that when the weight of the lifeboat was taken on the falls there was an elastic deformation³ of the fixed davit arm of up to 15 mm inwards towards the moving trolley beam. On further inspection and measurement the surveyor noted that the fixed davit beam had an inward plastic deformation³ of about 10 mm (see Figure 8).

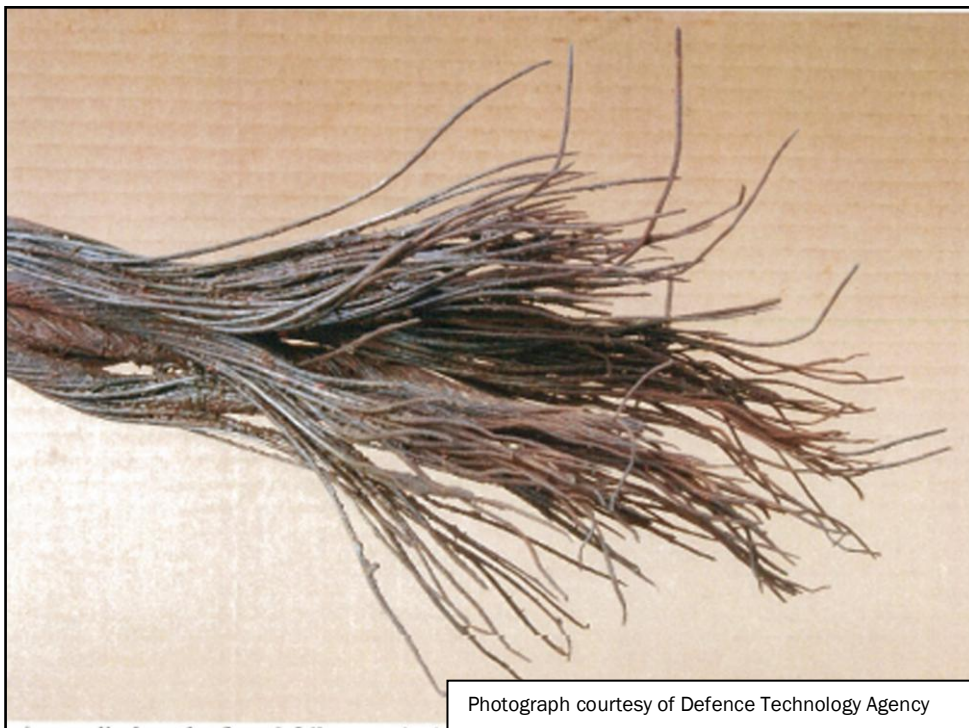
Figure 9
Photograph of the failure point of number 7 lifeboat forward wire fall

32. The failure had occurred in a severely corroded section of the hoist wire. A high proportion of the wires had corroded through and the corrosion had caused a significant reduction in the cross sectional area of other wires which finally failed by tensile fracture. This corrosion was associated with a relative absence of grease in the immediate area of the failure compared to that observed elsewhere.

- 4.2.4. Salt-laden water was then easily able to penetrate the core of the wire from the inside of the guide, and in the absence of lubricant the corrosion process accelerated. The fall wire failed when the corrosion weakened it to a point where it could no longer support the weight of the lifeboat. The wire failed in tension overload.

The wire rope lifeboat fall failed owing to corrosion of the internal wire strands, brought about by a lack of lubrication of the standing part of the wire where it passed around the guide near the terminus of the fall.

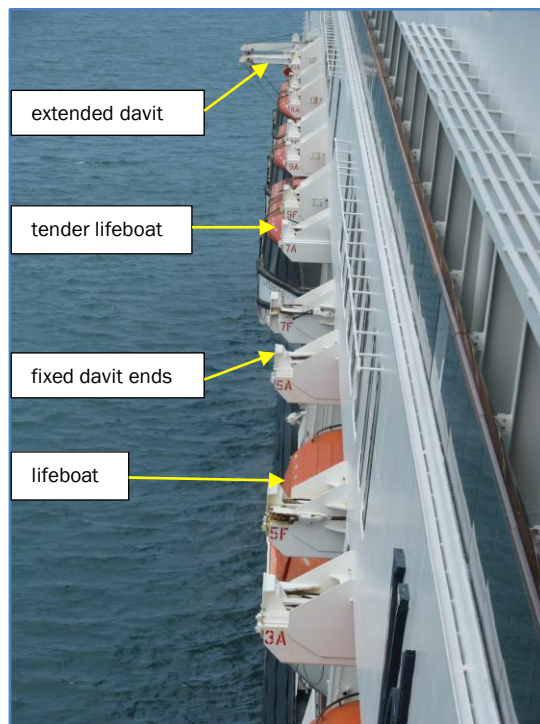
Figure 11
Starboard side of the Volendam looking aft from the navigating bridge showing position of davit ends and stowage positions

- 4.2.1. The ends of the davits where the fall wires passed around the fixed guides were located outside the ship's rail when the lifeboats were in the stowed position, which made access to them for maintenance difficult (see Figure 11). The easiest and preferred means for the crew was to extend the lifeboat out until it was under the ends of the fixed davit arms and use the lifeboat's cabin roof as a work platform.

- 4.2.2. The problem was that with the boat extended out in this fashion the lifeboat fall wires were under tension, so the wire could not be eased out of the guide for inspection or greasing. The maintenance instructions from the manufacturer neither highlighted this problem nor offered a solution.

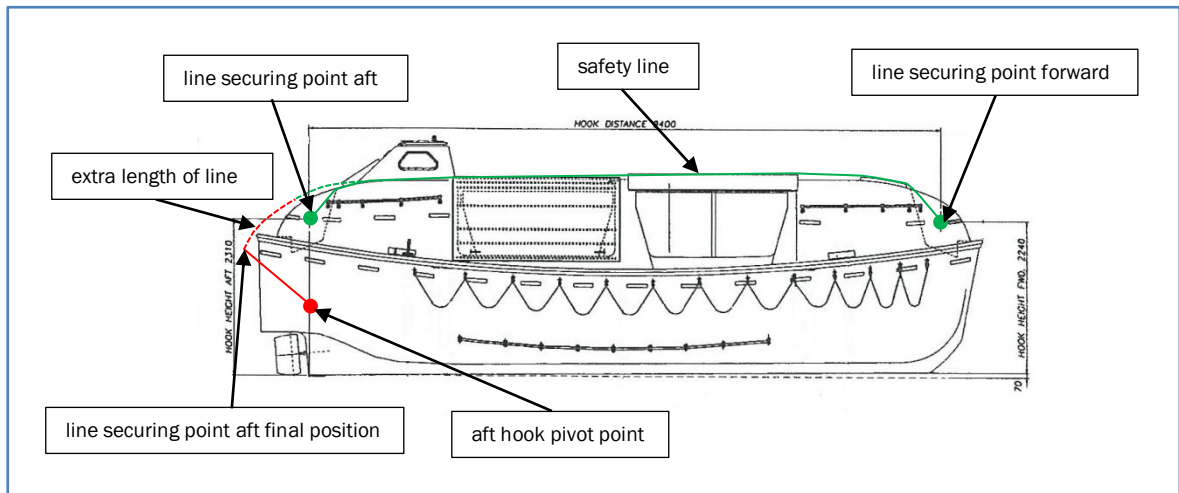
Figure 12
Diagrammatic representation of aft fall hook failure

- 4.3.3. The failure of the lifeboat forward fall wire caused the lifeboat to pivot around the after suspension hook, forcing the hook through the hull of the lifeboat. The resulting spread of the lifting hooks (see Figure 12) causing the safety line to break would not have been easy to foresee.
- 4.3.4. The hazard now, however, has been identified and the company needs to devise an alternative method of connecting safety harnesses. The manufacturer has devised such a system using a wire spanning the davit heads with “fall arrestors” attached, to which safety harnesses are connected.

The safety line rigged between the 2 lifting hooks stretched and broke because the aft lifting hook was damaged when the front of the lifeboat dropped. The crew fell to the sea because their safety harnesses were attached to the safety line that broke.

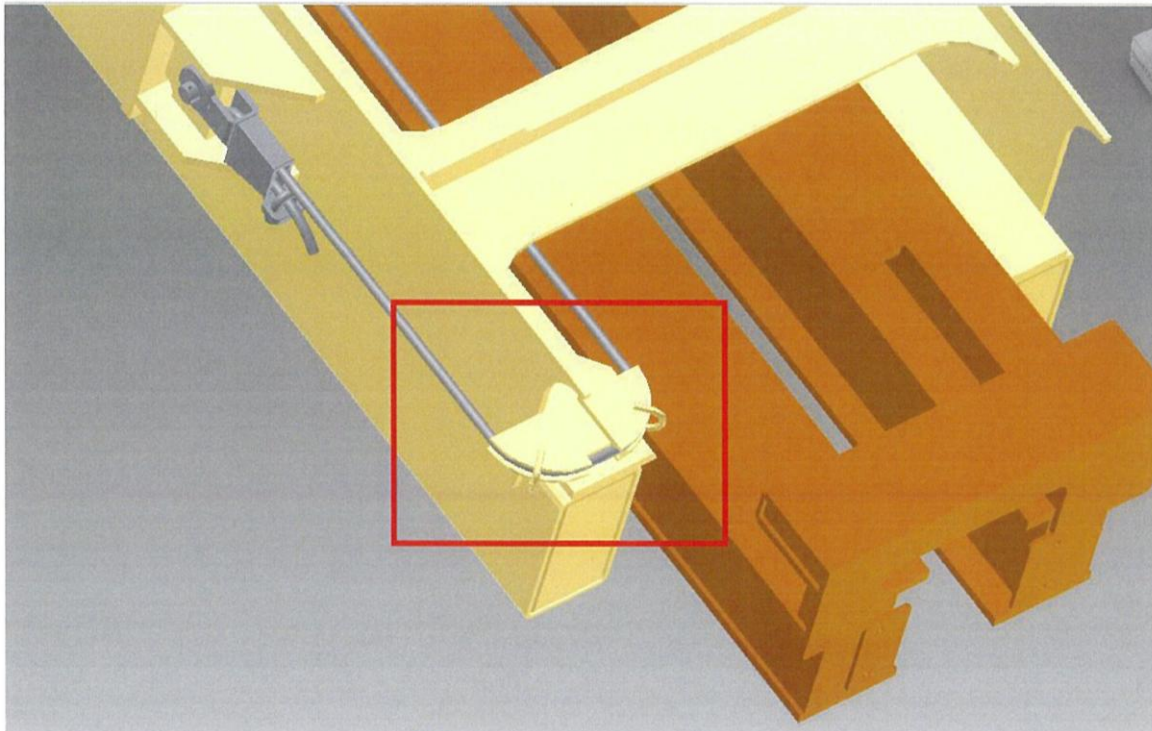
In several types of telescopic davits the fixed end of the wire rope is deviated before to reach the spelter socket of the fixed connection by means of a fixed steel sheave guide. This steel sheave guide is arranged in front of the fixed frame of the davit arm (see the detail in the picture).

It is mandatory to inspect periodically the efficiency of the whole length of the wire rope with special regard to the areas passing through the sheaves including the rope's length along this guide.

It is also mandatory to renew the falls when necessary in way of deterioration or at intervals of not more than 5 years, whichever comes earlier.
