Interim Factual Report 11-201: Passenger vessel Volendam, lifeboat fatality,
port of Lyttelton, New Zealand, 8 January 2011

Interim Factual Report

Marine Inquiry 11-201

Passenger vessel Volendam, lifeboat fatality,
port of Lyttelton, New Zealand, 8 January 2011

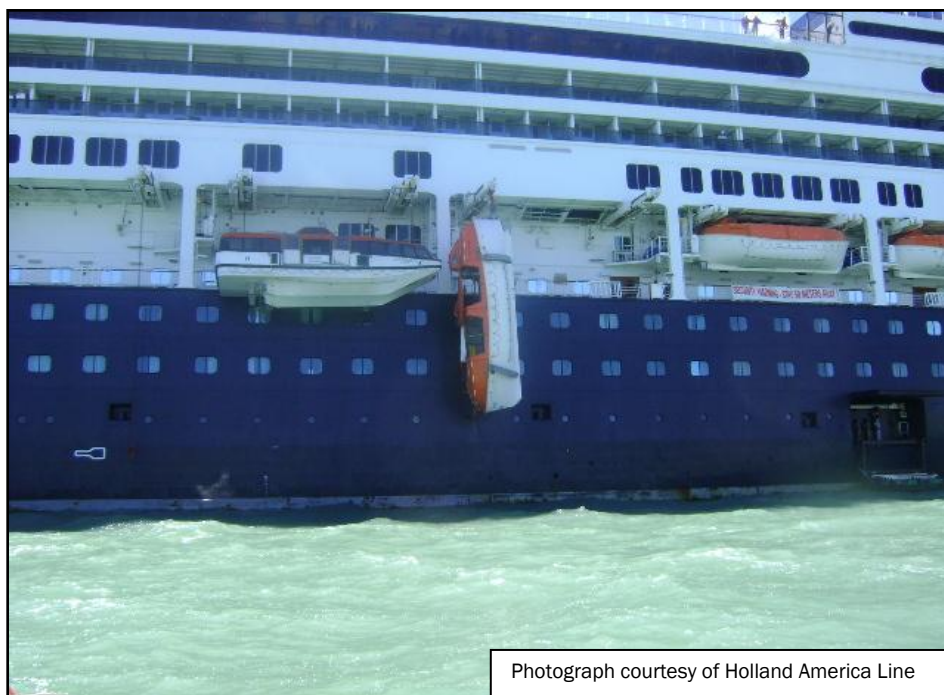
- 2.1.6. As the winch operator was lowering the lifeboat the forward lifeboat wire fall parted and the lifeboat fell bow down, suspended by the aft lifeboat fall (see Figure 1).

Figure 1
Number.7 lifeboat in vertical position after failure of wire fall

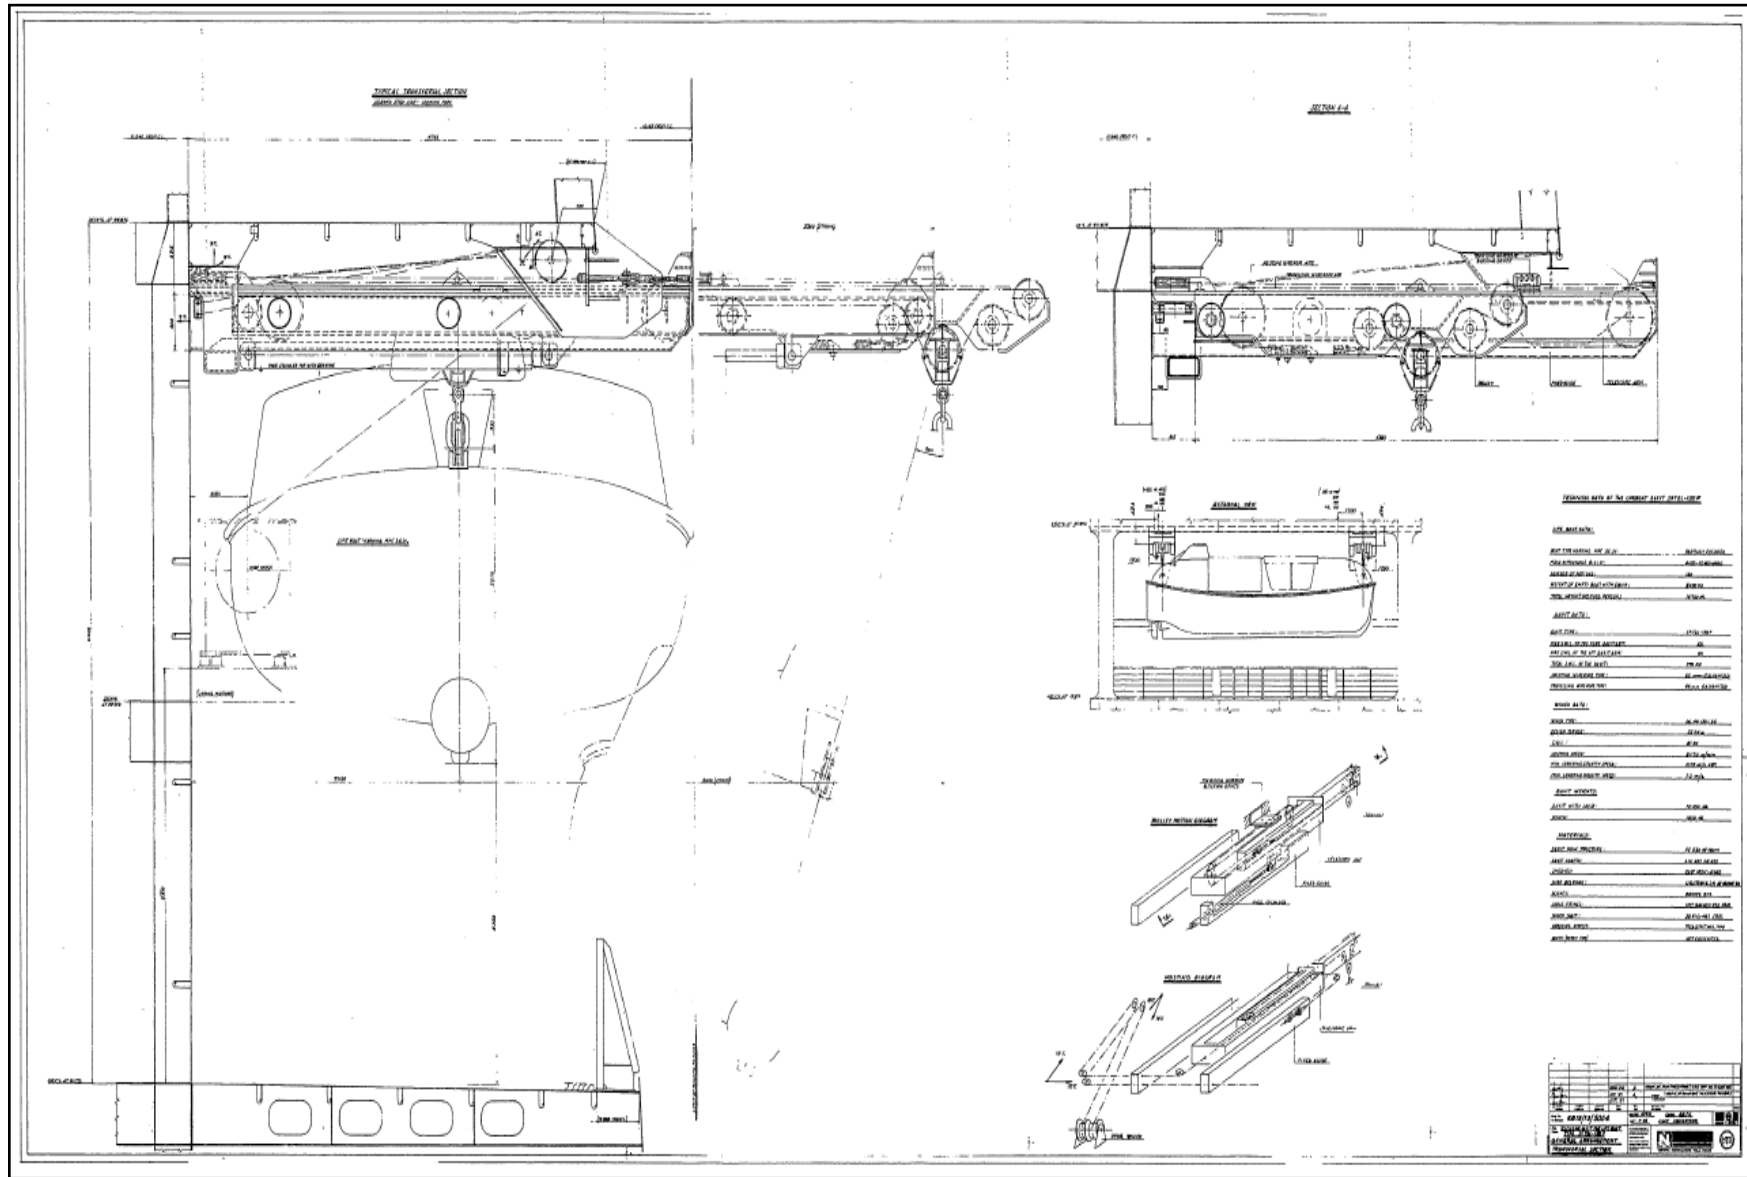
Figure 2
Diagram of the telescopic davit system as fitted to the Volendam

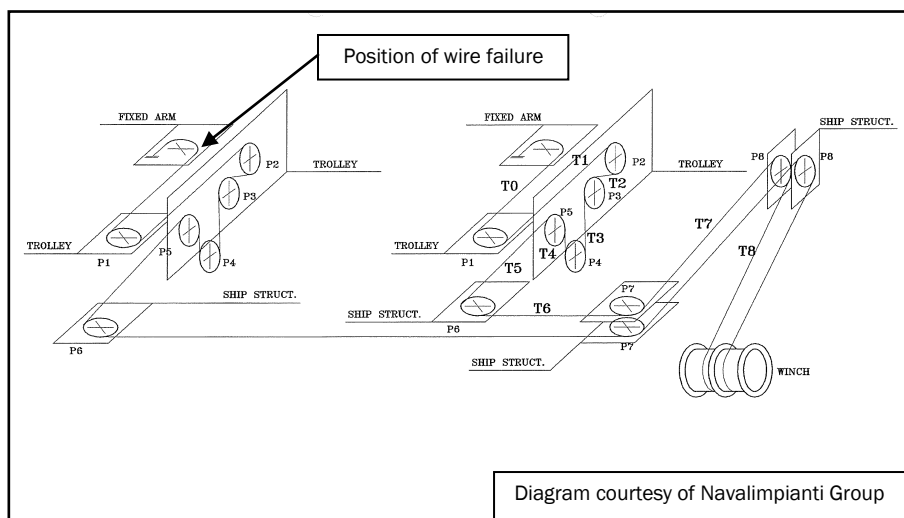
Figure 3
Wire fall reeving diagram

- 2.3.7. The wire falls were wound onto 2 hydraulically driven winch drums and reeved through a series of sheaves located on the ship, on the telescopic trolley arms and on the fixed arms. Both wire falls terminated after passing around fixed guides located on the outboard end of the fixed arm of the davit (see Figure 3).

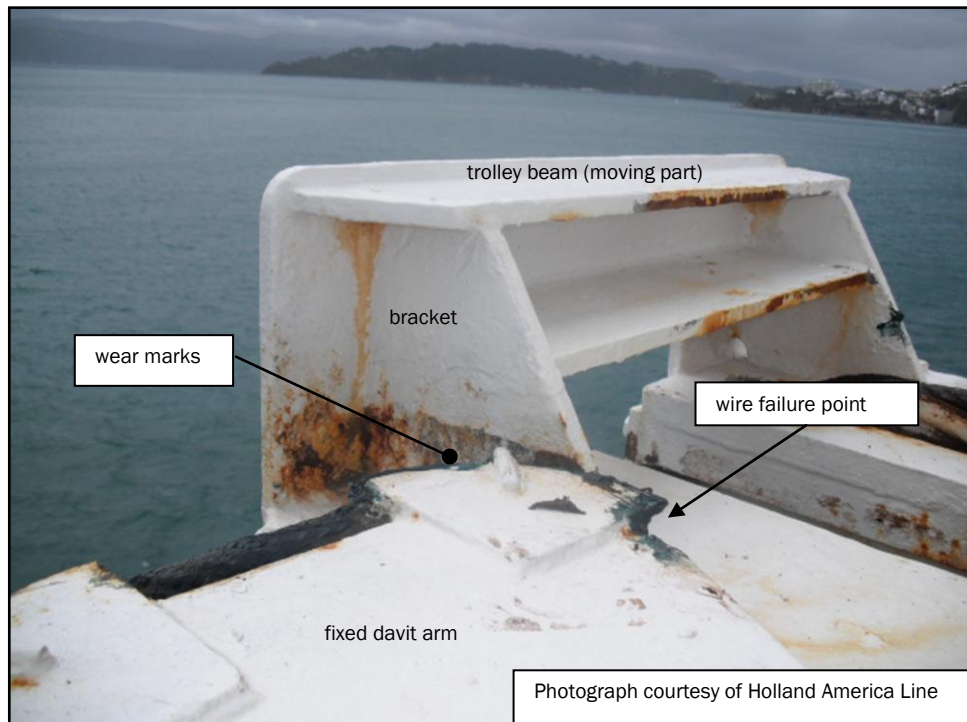
Figure 4
Number 7 forward davit showing moveable trolley beam and wire break point

- 2.4.3. Figures 4 and 5 show where the bracket had been rubbing against the fixed guide, causing wear marks on the bracket. When number 5 davit was inspected, there was evidence of wire score marks on the bracket (see Figure 6).
- 2.4.4. When number 5 davit was tested during the inspection, the surveyor noted that when the weight of the lifeboat was taken on the falls there was an elastic deformation of the fixed davit arm of up to 15 mm inwards towards the moving trolley beam. On further inspection and measurement the surveyor noted that the fixed davit beam had an inward plastic deformation of about 10 mm (see Figure 7).

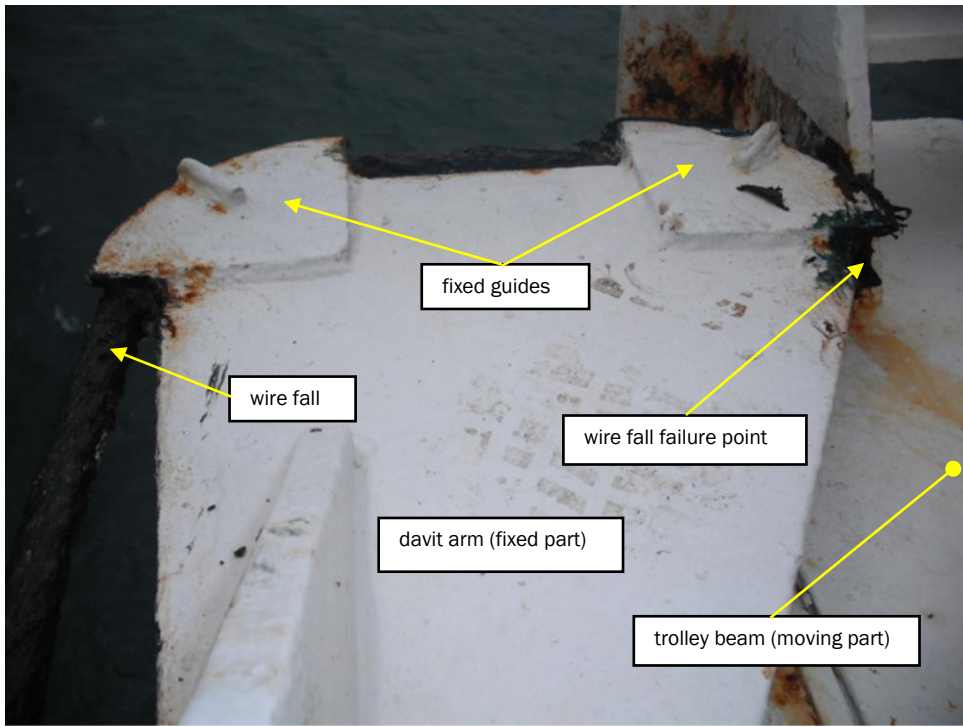
Figure 5
Head of number 7 forward fixed davit arm

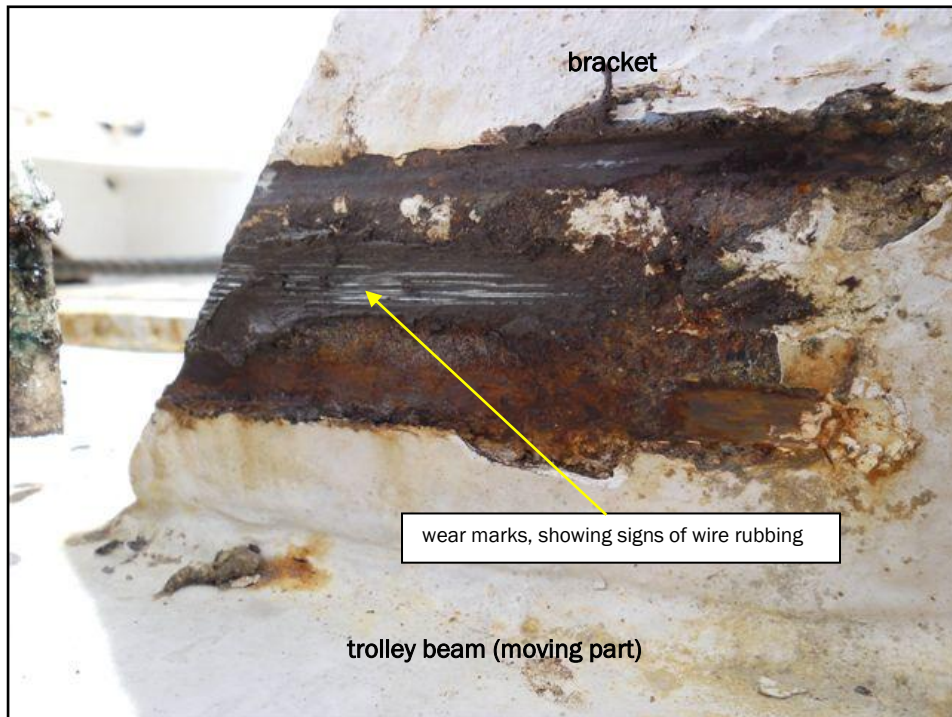
Figure 6
Vertical bracket from number 5 trolley beam

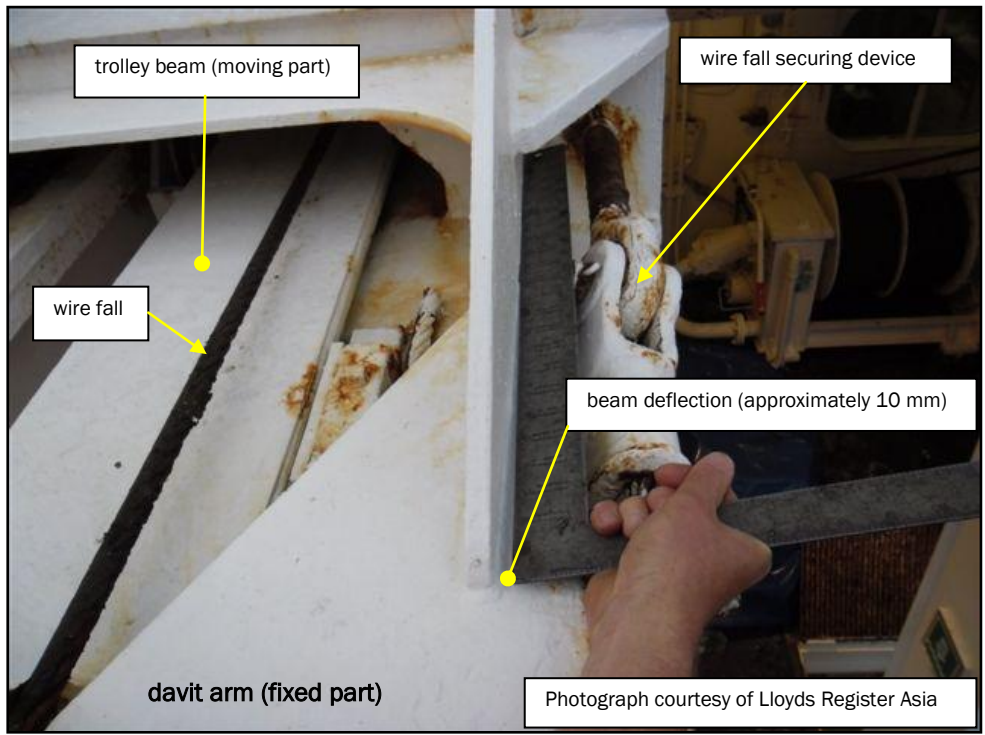
Figure 7
Number 5 davit beam (fixed part) showing deflection

- 4.1.4. The Commission believes it is a further safety issue that the design of the SPTDL-150P davit allows the outer ends of the fixed arm to flex towards the adjacent moving trolley beam when the load is taken by the wire falls. There is evidence that this flexing can cause the trolley beam structure to contact the wire guides, and possibly the wire falls, which could lead to excessive wear and premature failure of the wire rope.

It is recommended that as a matter of urgency, the Navalimpianti Tecnimpianti Group review the design of the SPTDL-150P lifeboat davit system with a view to remedying the tendency in this case for the fixed davit arm to flex inwards under load and contact moving parts of the structure, which could lead to premature failure of components within the system. (011/11)

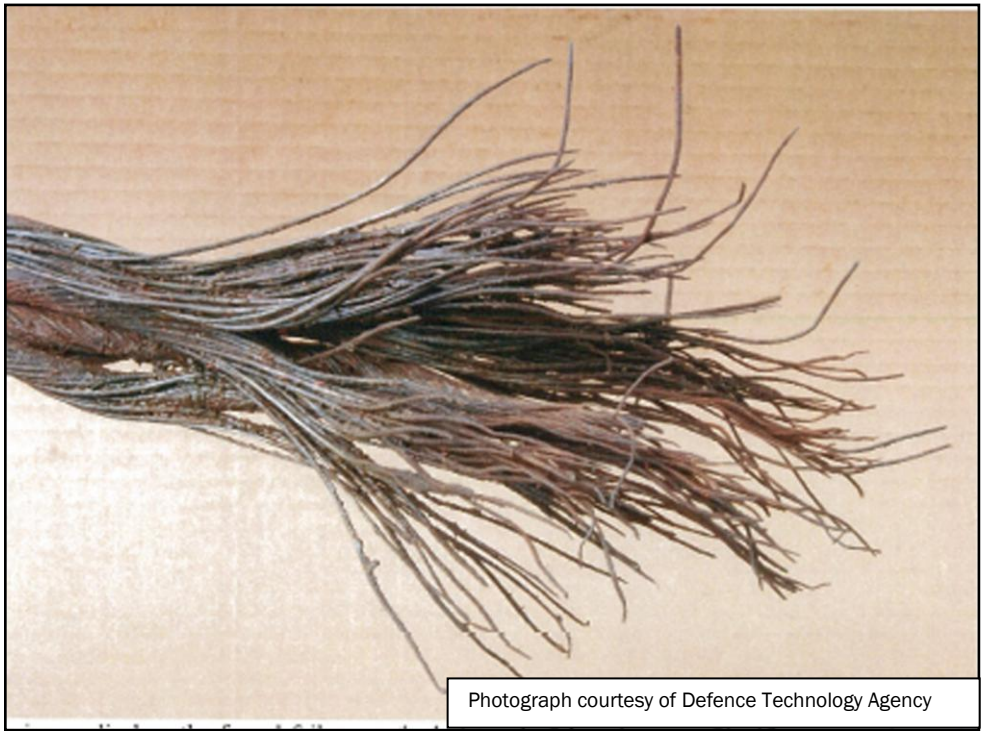
Figure 8
Photograph of the failure point of number 7 lifeboat forward wire fall

32. The failure had occurred in a severely corroded section of the hoist wire. A high proportion of the wires had corroded through and the corrosion had caused a significant reduction in the cross sectional area of other wires which finally failed by tensile fracture. This corrosion was associated with a relative absence of grease in the immediate area of the failure compared to that observed elsewhere.

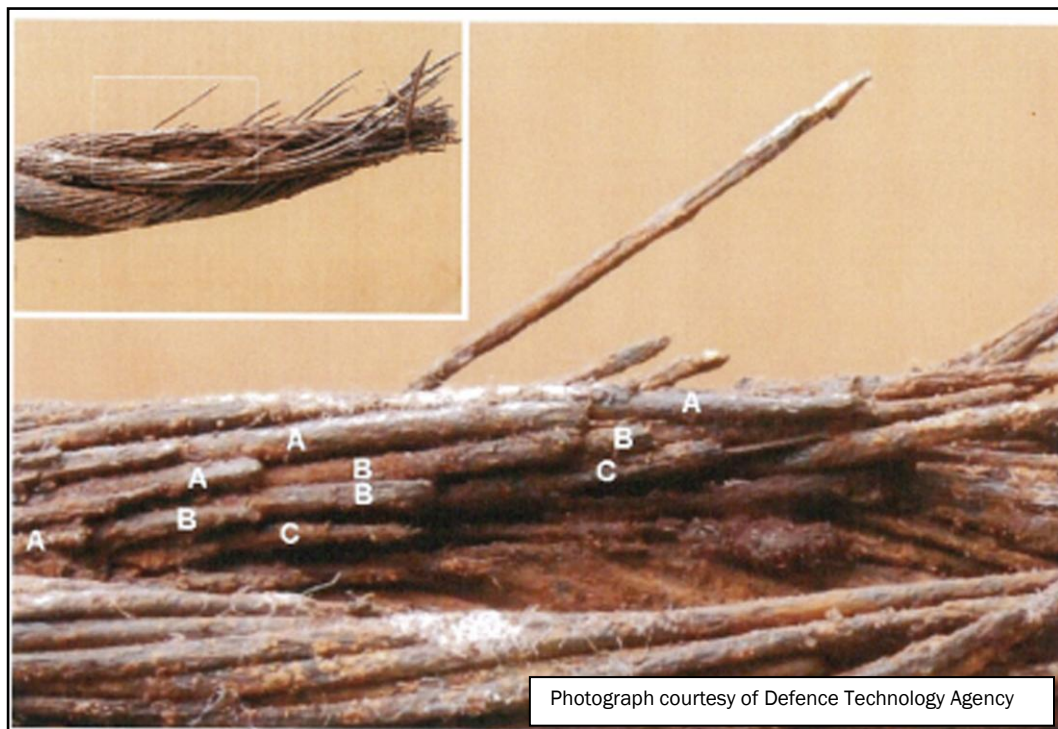
Figure 9
Enlarged photograph of failure point of number 7 lifeboat wire fall
