Inquiry MO-2011-202: roll-on-roll-off passenger ferry *Monte Stello*, contact with rock, Tory Channel,
Marlborough Sounds, 4 May 2011

Final Report

Marine inquiry MO-2011-202
roll-on-roll-off passenger ferry *Monte Stello*
contact with rock
Tory Channel, Marlborough Sounds
4 May 2011

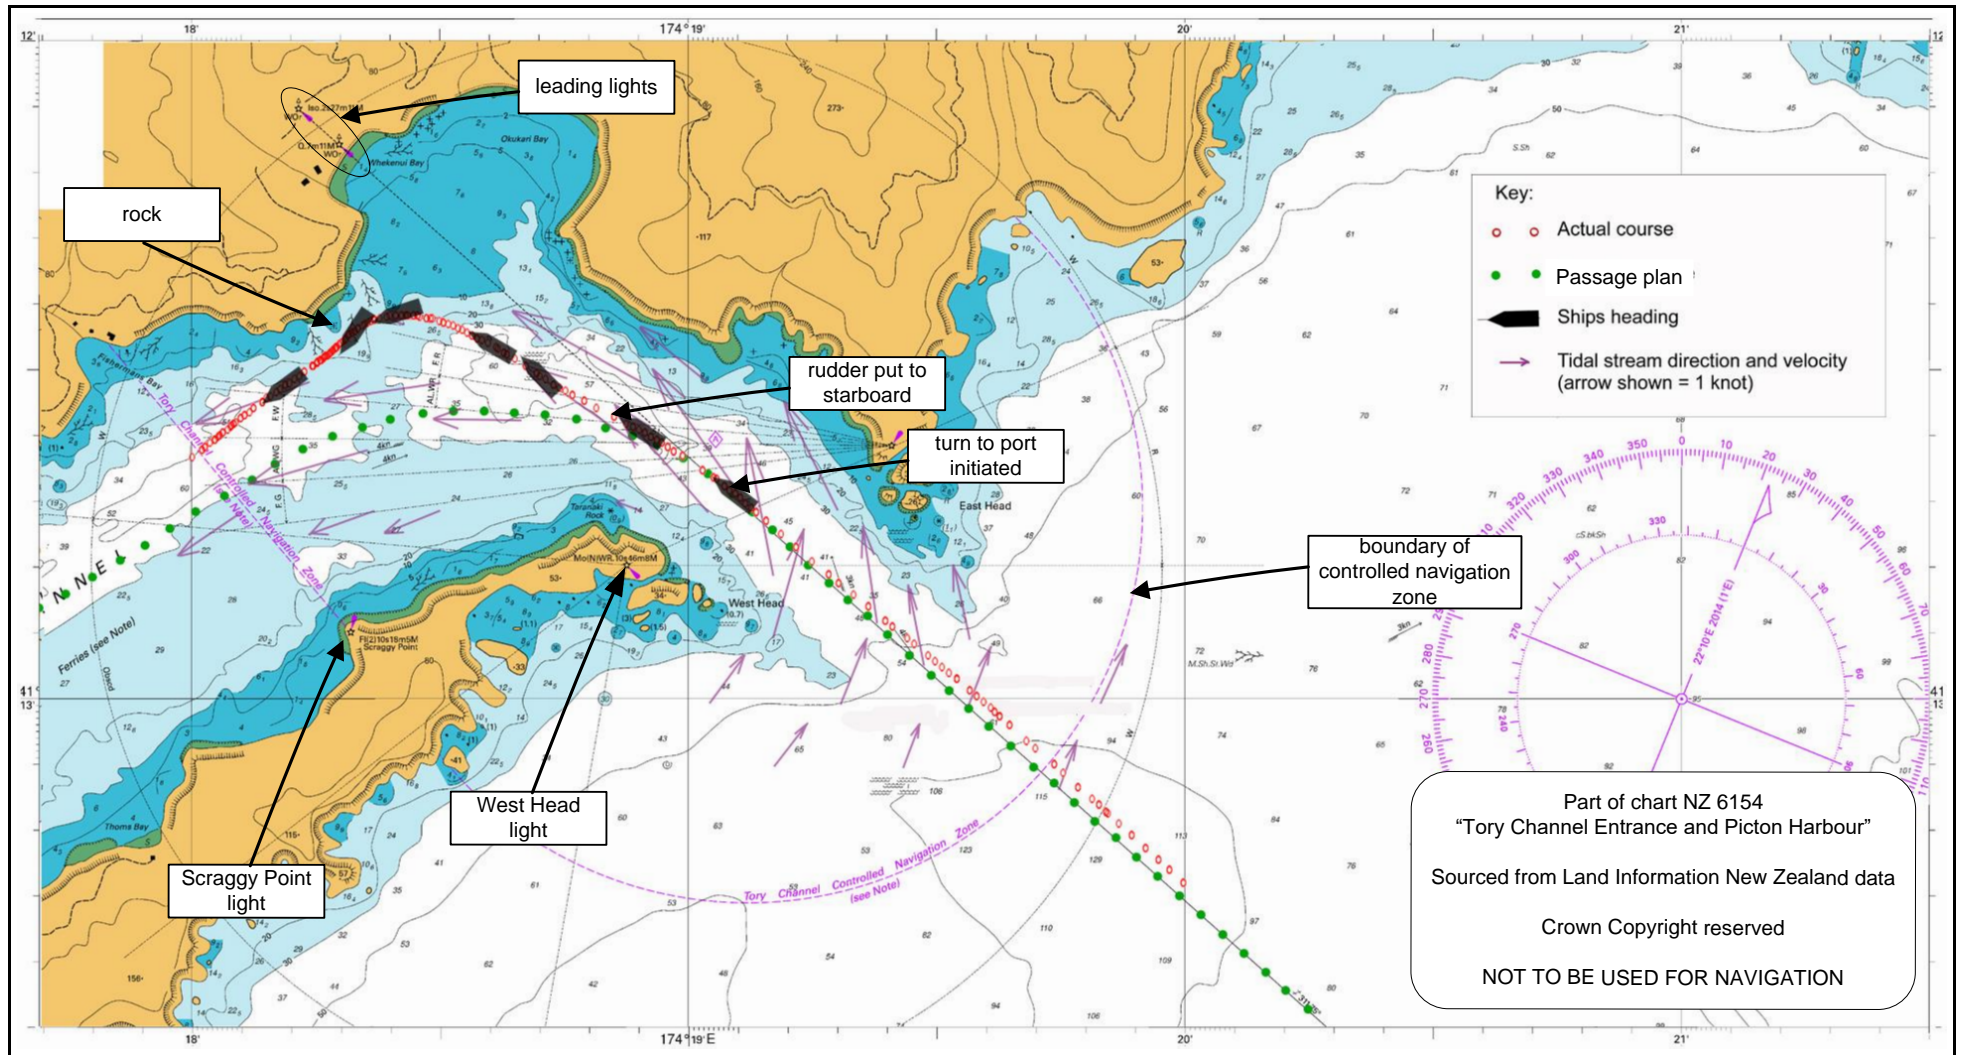
Figure 1
 Part of chart NZ 6154 showing the Monte Stello's planned passage, actual positions and current

- 3.1.9. As the *Monte Stello* came abreast of West Head light at about 0554, the master gave a helm order of "port 10"⁵. The helmsman repeated the order and as he put the helm 10 degrees to port the master acknowledged this correct confirmation. The master then asked the third mate to go to the port bridge wing to look out for the light on Scraggy Point. As the third mate walked across the bridge he looked up at the rudder indicator to confirm it had indeed gone to port 10 degrees.

responding. The helmsman thought the master gave a helm order of “starboard 15”, and placed the helm over to starboard 15 degrees. The lookout said later during his interview that he heard “starboard 15”. The third mate was by then on the bridge wing outside the wheelhouse looking for the Scraggy Point light. He was not therefore monitoring the rudder indicator.

- 3.1.11. The master soon realised that the ship was not responding as he expected and so he checked the ECDIS⁶, which showed the *Monte Stello* was to starboard of the intended track. He gave a helm order of “starboard 20”; he realised he had misspoken and immediately corrected himself by giving the order “midship”, which means to put the rudder to the centre. The lookout also challenged his “starboard 20” order.

- 3.1.12. The master then ordered “hard a-port”. He moved to the engine control and stopped the port engine and reduced the starboard engine to “4”⁷. He then put the port engine to astern and the *Monte Stello* began rapidly turning to port.

- 3.1.13. At about 0555 the starboard quarter⁸ of the *Monte Stello* collided with a rock, which was felt by all personnel on the bridge.
- 3.1.14. The master put the vessel engine controls to slow ahead, and activated the remote controls to close all the watertight doors. He then called the standby mate to inspect below for water ingress. The master also conversed with the engine room crew on the telephone.

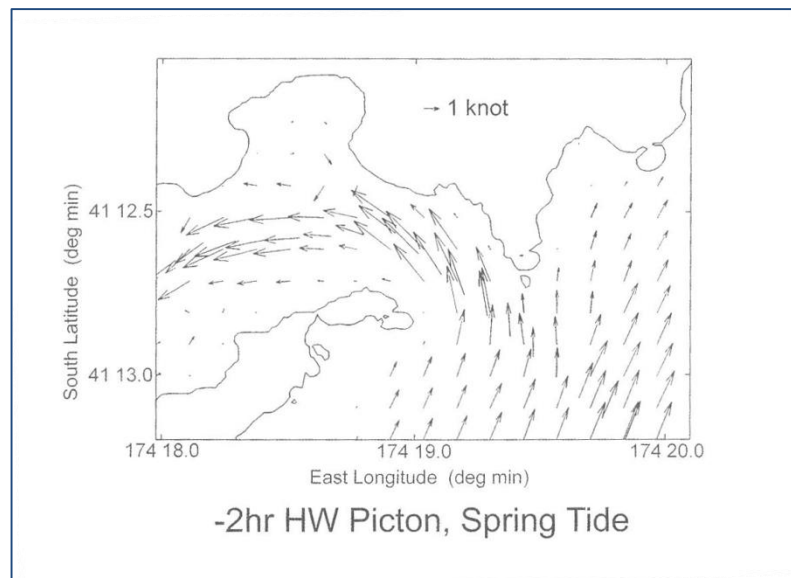
Figure 2
Tidal stream at Tory Channel entrance

- 3.3.1. At the entrance to Tory Channel the wind was 12 knots from the northeast. There was light rain and/or mist. It was pre-dawn and hence it was dark, but there was no cloud. Sea state was slight with negligible swell. The tidal stream was flooding into Tory Channel.
- 3.3.2. New Zealand Nautical Almanac 2011-12 predicted the high water tide at Picton was 0742 on 4 May. The *Monte Stello* entered the Tory Channel Controlled Navigation Zone at about 0552 that morning, which was a little less than two hours before high water at Picton. The New Zealand Nautical Almanac 2011-12 tidal stream diagram for a flood tide at Tory Channel entrance for that time is given in Figure 3. Some of the tidal stream vectors have been superimposed over the chart excerpt in Figure 2.
