Inquiry 11-203: passenger ferry *Jet Raider*,  
catastrophic engine failure, Hauraki Gulf, 27 August 2011

## Final Report

Marine inquiry 11-203  
passenger ferry *Jet Raider*, catastrophic engine failure,  
Hauraki Gulf, 27 August 2011

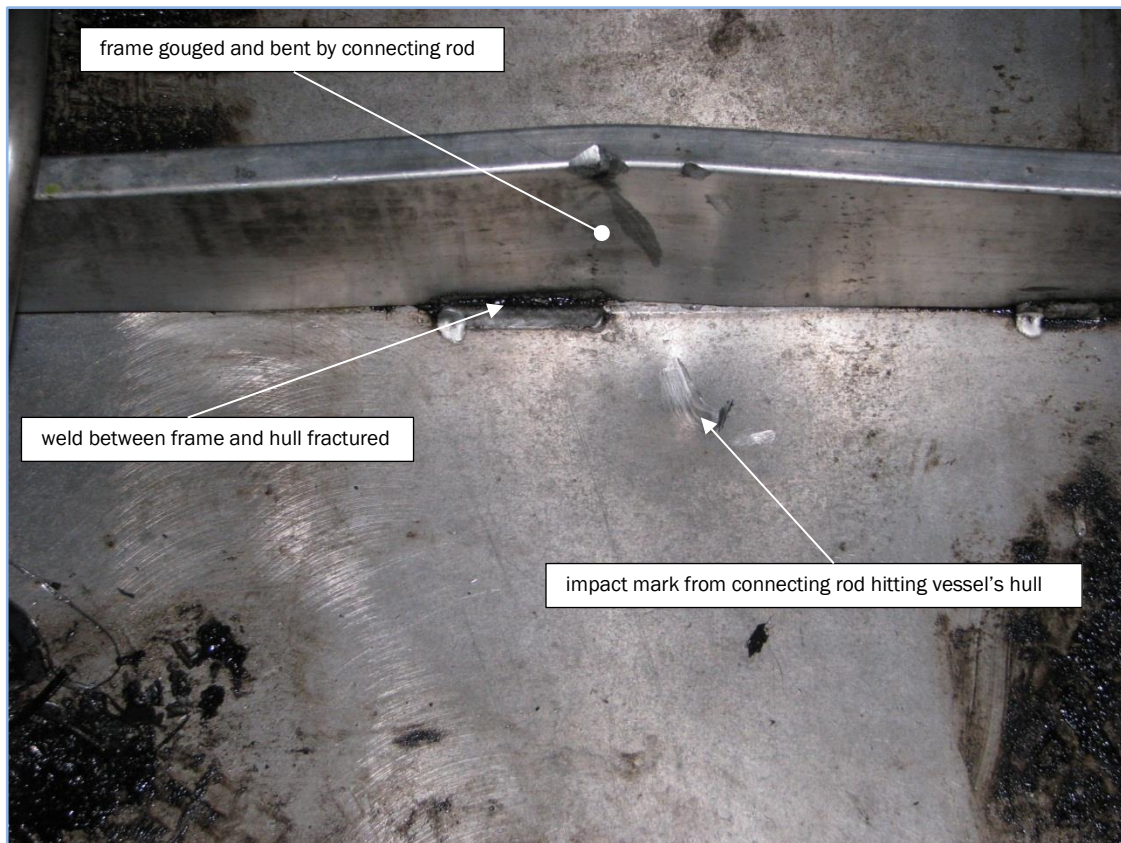
- 3.2.8. The starboard engine was removed from the *Jet Raider* and transported to Fullers' maintenance facility for further investigation and dismantling. When the engine was removed from the vessel it was found that one of the missing connecting rods had exited the crankcase through the bottom of the engine sump. The connecting rod had struck the vessel's hull and one of the hull frames. The hull was gouged and the frame bent. The weld securing the hull to the frame was fractured (see Figure 3).

Figure 3  
Damage caused to hull and frame by connecting rod exiting through engine sump

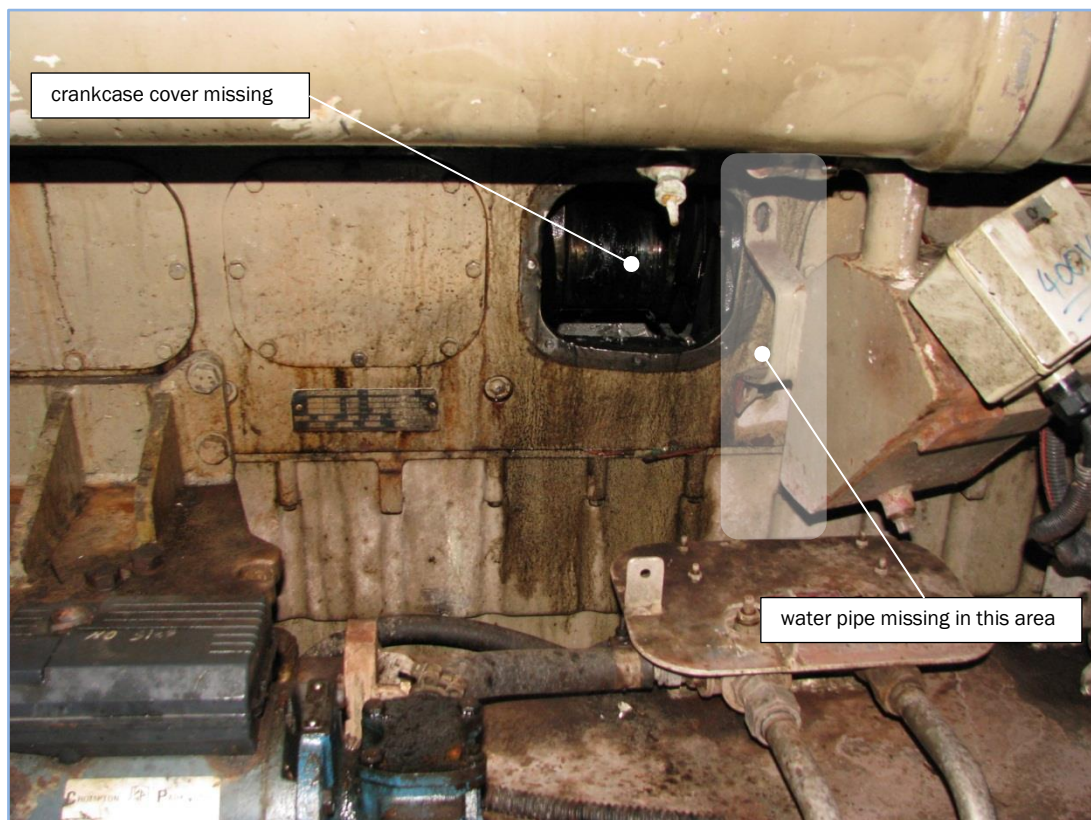
- 3.2.6. The initial inspection of the engine room revealed no evidence of fire. Instead the starboard engine was found to have suffered a catastrophic failure. One of the starboard engine's crankcase covers had blown off and was punctured. A connecting rod<sup>3</sup> was found on the engine room floor plates with other engine debris. The oil filler cap for the starboard engine was missing. A freshwater cooling pipe had been severed and damage was noted on other nearby equipment.

Figure 4  
Starboard engine showing missing crankcase cover

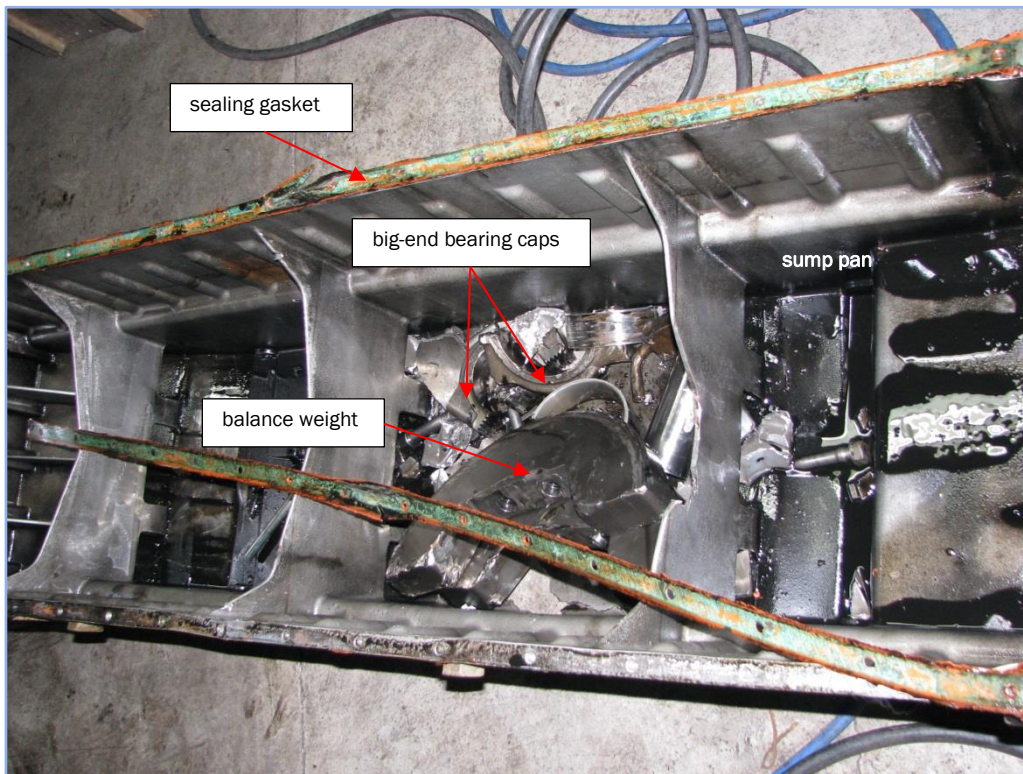
- 2 connecting rods from the number 4 cylinder set
  - parts of the associated connecting rod bolts
  - bearing caps and bearing shells.
- 3.2.10. The Commission engaged the Defence Technology Agency to produce a report into the failure (see Appendix 2 for the full report).

Figure 5  
Engine debris found in sump after lifting main engine block away

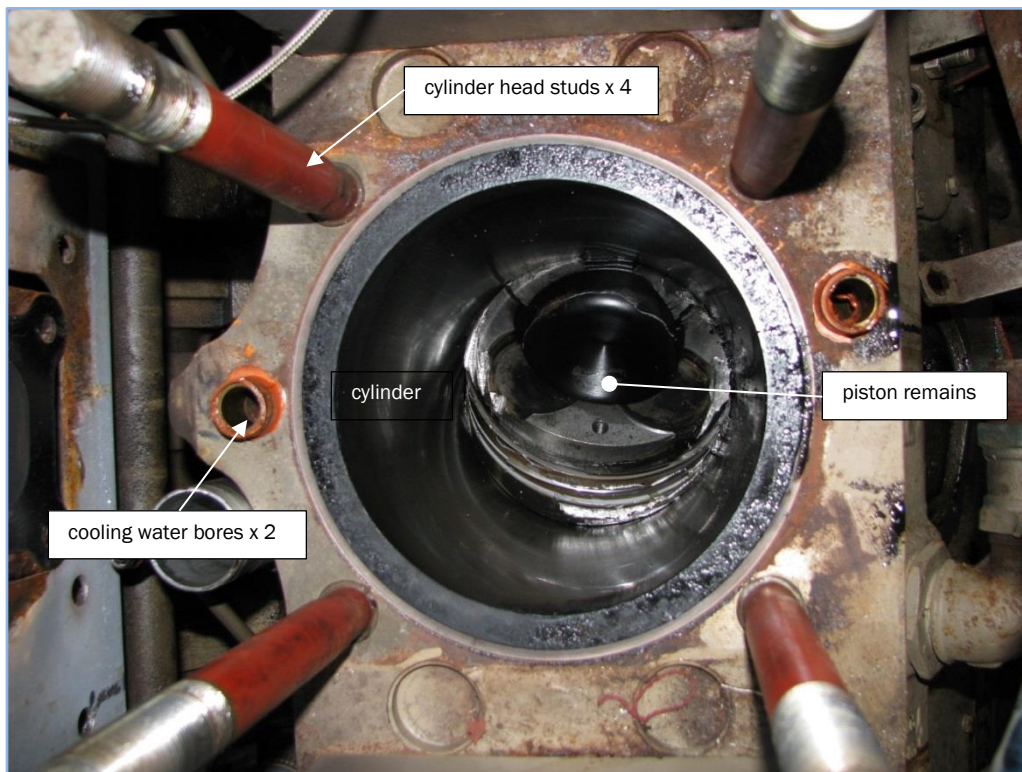
Figure 6  
Remains of piston in number 4 cylinder, bank "A"

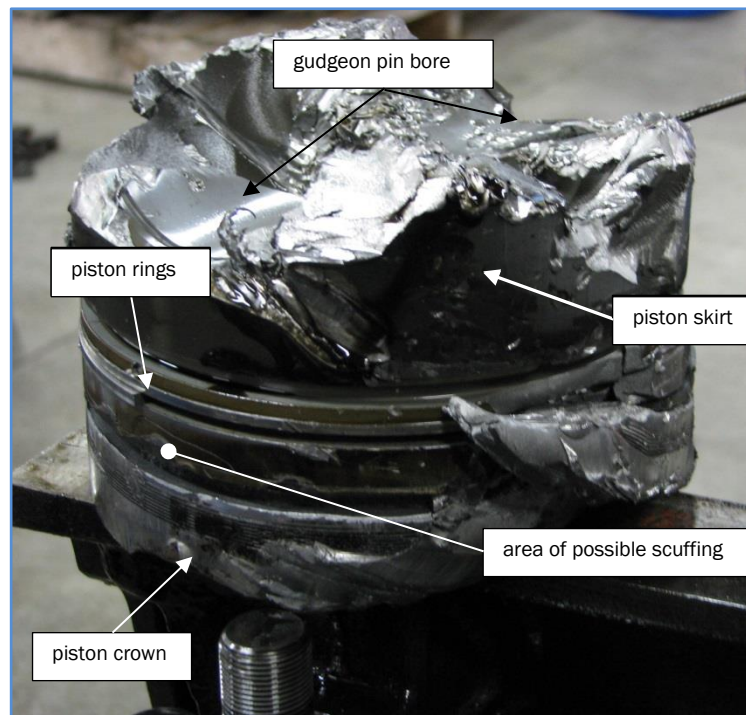
- 4.2.11. Cavitation, corrosive wear or a previous overheating of the number 4 big-end bearings could not be ruled out because any evidence was masked by damage sustained during the failure sequence.
- 4.2.12. The damaged Number 4A piston showed possible piston scuff marks<sup>9</sup> on one side (see Figure 8). Piston scuffing is usually caused by either a lack of lubrication between moving metal parts or a lack of cooling. Localised heating can cause engine parts to weld together momentarily before breaking free. This momentary welding can put excessive strain on the connecting rod bolts, leading to their eventual failure. However, considerable damage to both the cylinder liner and piston made it difficult to determine whether the scuff marks had been present before the engine failure or whether they were incurred when the engine failed.

**Figure 8**  
Number 4A piston after removal from cylinder

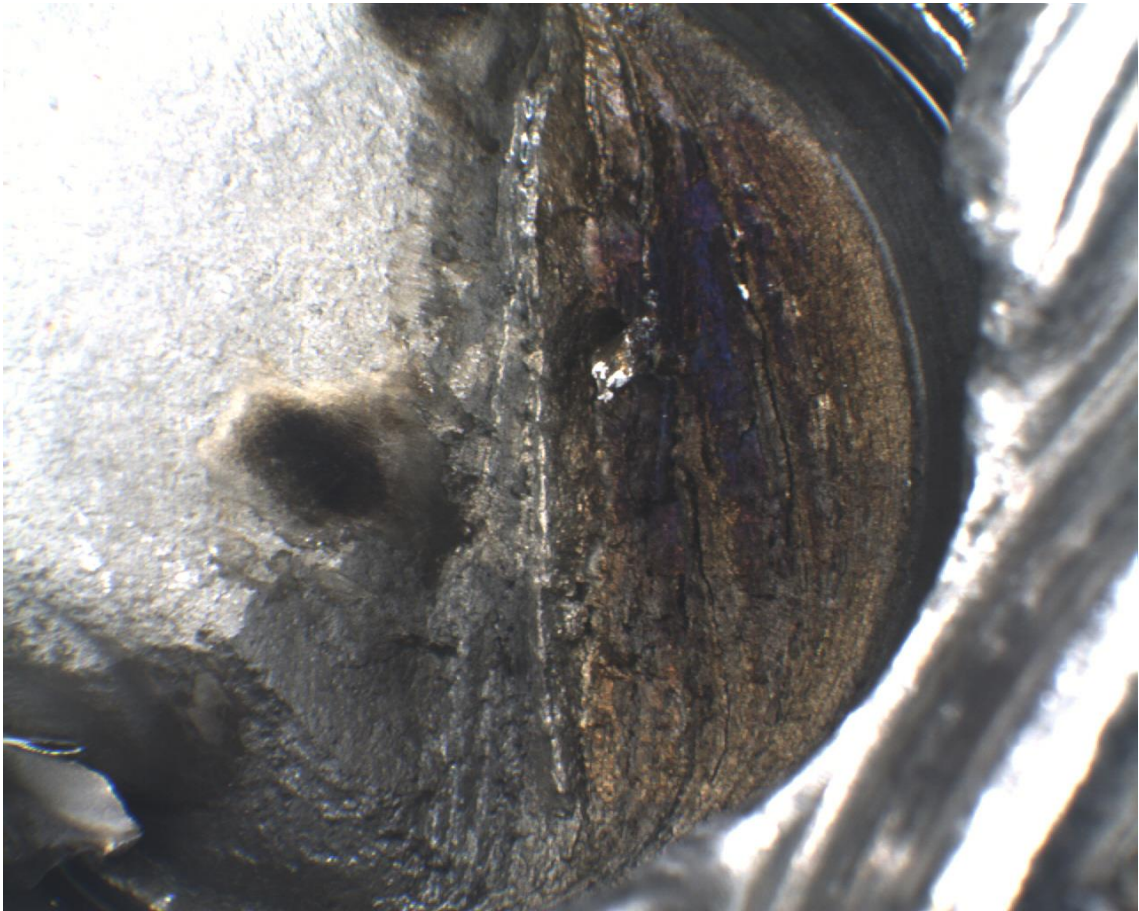
Figure 1. Fracture surface of upper conrod bolt ex conrod S/N 400.

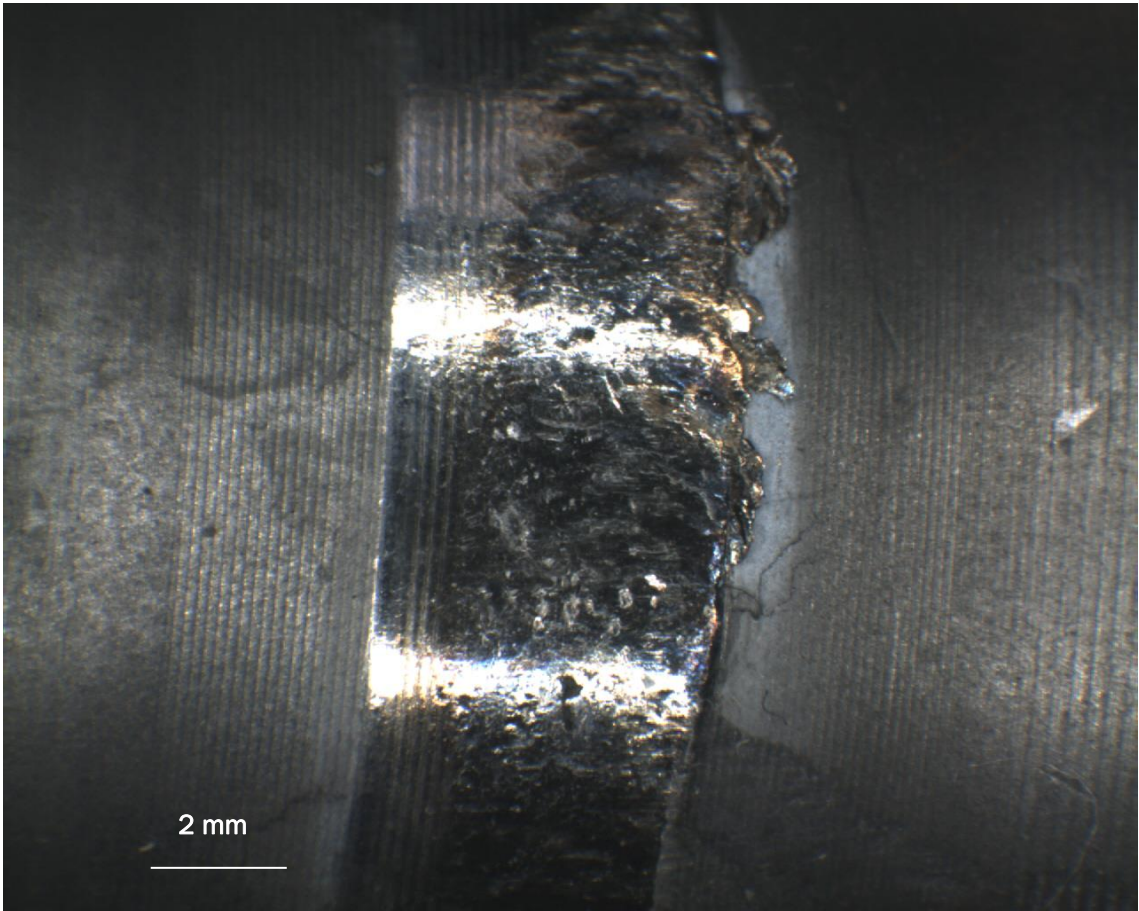
Figure 2. Fretting damage to the upper conrod bolt ex Conrod S/N 400.

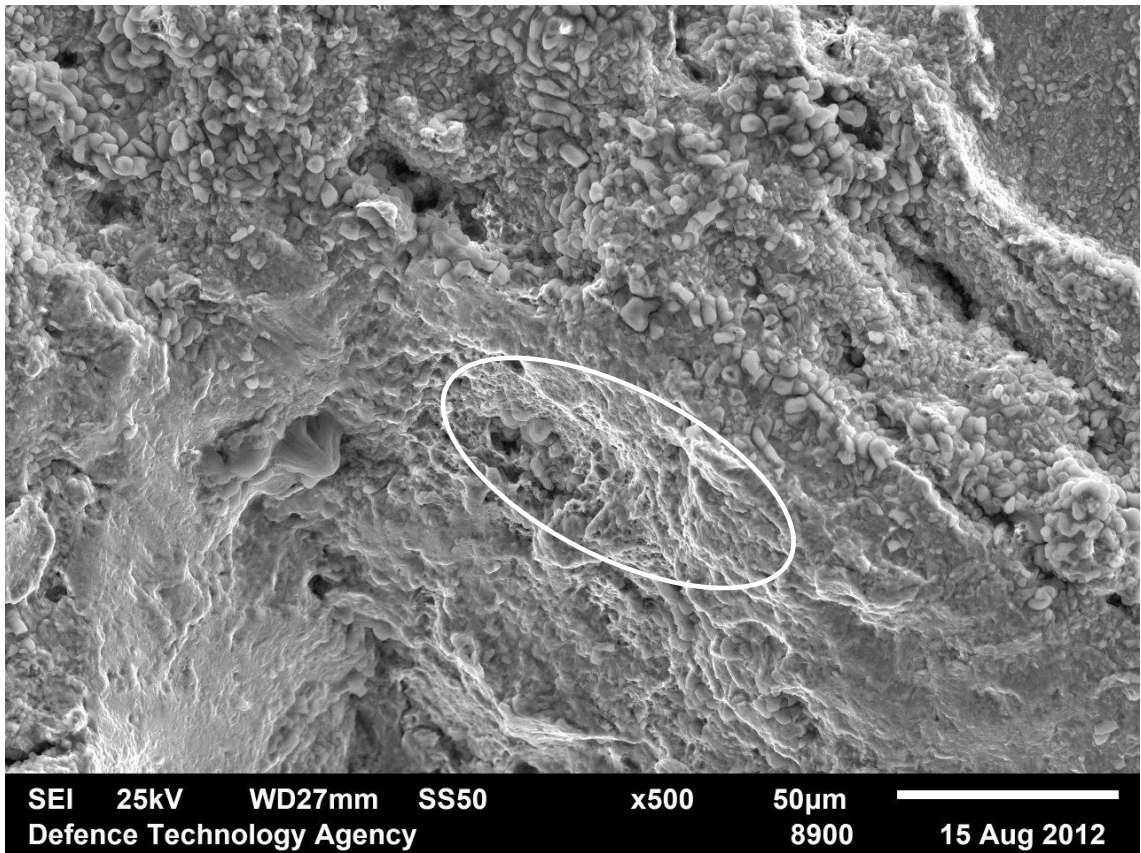
Figure 3. Scanning electron fractograph exhibiting evidence consistent with ductile overload within the ridged portion of the upper conrod bolt ex Conrod S/N 400 shown in figure 1.
