Inquiry 12-101: Load shift on Train 926D struck stationary
Train 845, Main South line, Rolleston, 6 April 2012

Final Report

Rail inquiry 12-101
Load shift on Train 926D struck stationary
Train 845, Main South line, Rolleston
6 April 2012

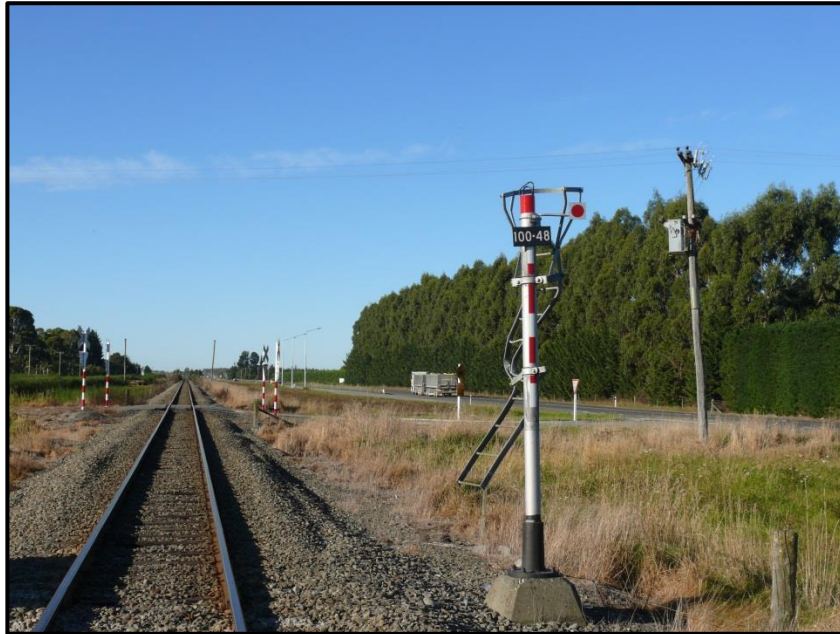
Figure 1
Signal south of Ashburton (photograph from KiwiRail)

- 3.1.7. At 0125 the train passed through Hinds, 57 kilometres north of Timaru, without incident. At some point the load on the wagon shifted again. It struck and damaged a series of track-side signals and level-crossing apparatus. The first was at Ashburton some 74 kilometres north of Timaru. A signal mast head was broken off, and the ladder was bent (see Figure 1). The signal was on the east side of the line 2.75 metres from the centre of the track.

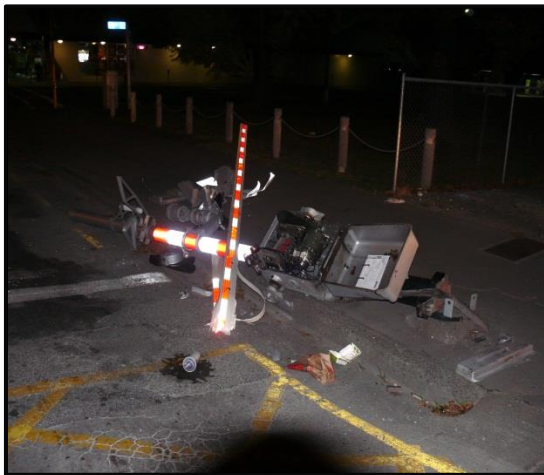
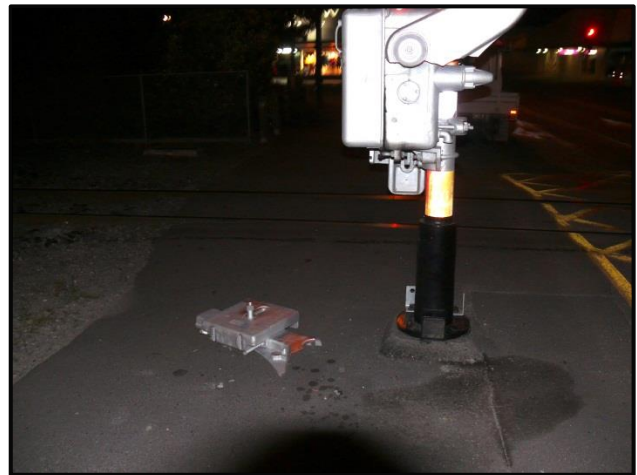
Figure 2
Damage to Moore Street level crossing barrier arms (photographs from KiwiRail)

- 3.1.8. As the train continued towards Christchurch, the displaced load struck and destroyed the south-eastern barrier arm mechanism protecting the Moore Street level crossing at Ashburton (95.45 kilometres Main South line). The complete barrier mast separated at the concrete block (see Figure 2). Damage to the north-western barrier mechanism was less severe. The counterweight became separated and the securing bolt bent.

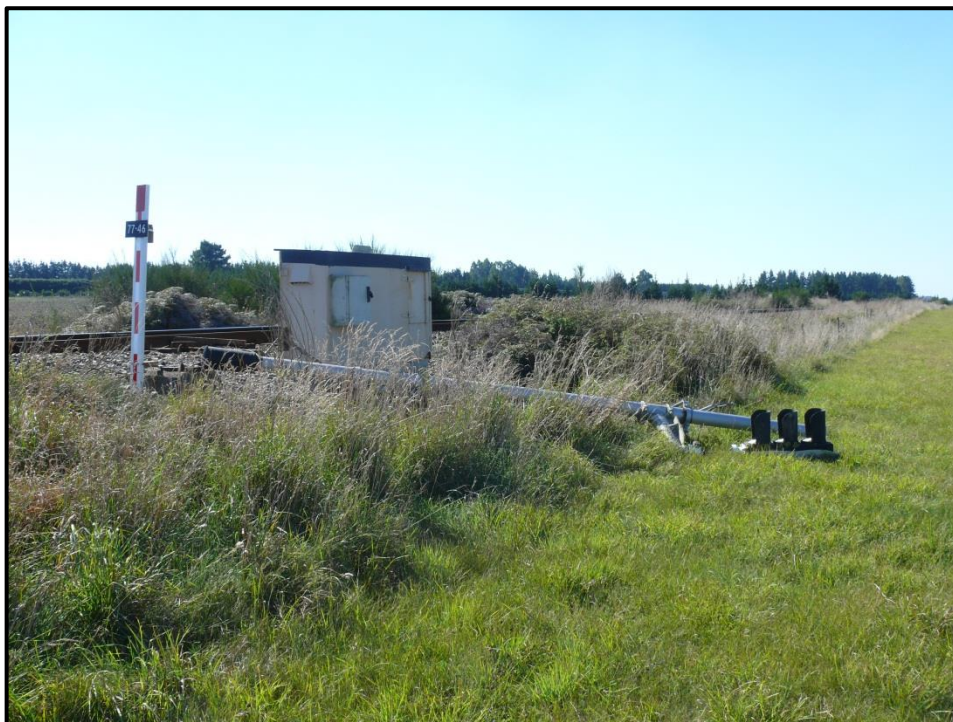
Figure 3
Signal approaching Chertsey (photograph from KiwiRail)

- 3.1.9. The displaced load struck and damaged 5 other signals on the east side of the main line within Ashburton station limits.
- 3.1.10. At about 0153 the displaced load struck 3 signals near Chertsey level crossing, shearing one off at its base (see Figure 3).

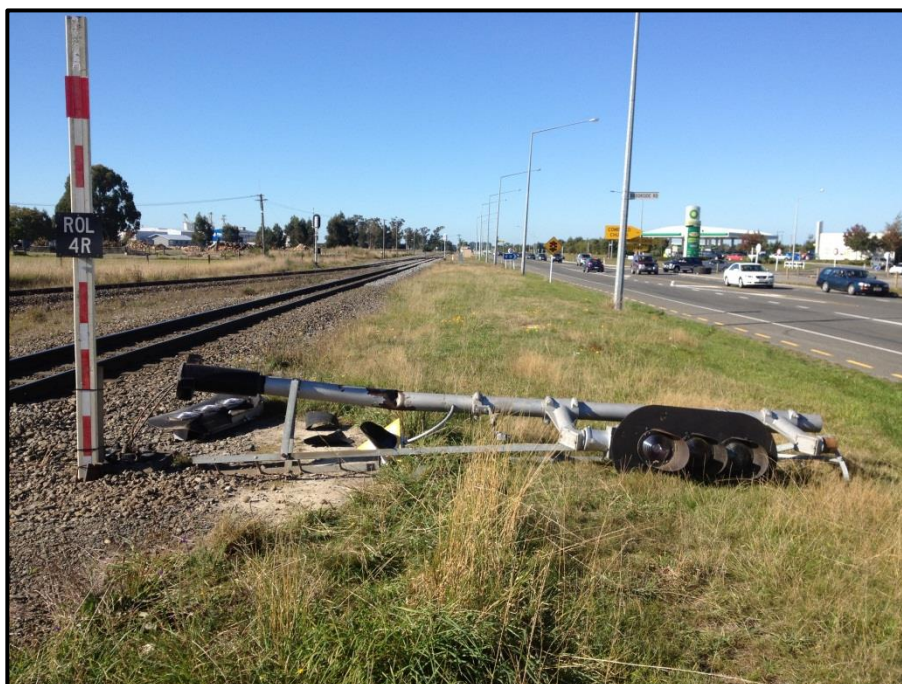
Figure 4
Signal approaching Rolleston

- 3.1.11. Over the next 41 kilometres the train passed 7 signals on the east side of the main line without incident.
- 3.1.12. When the train entered Rolleston Station limits, some 137 kilometres from Timaru, the displaced load struck the signal on the east side of the main line, shearing the signal mast at the base casting (see Figure 4).

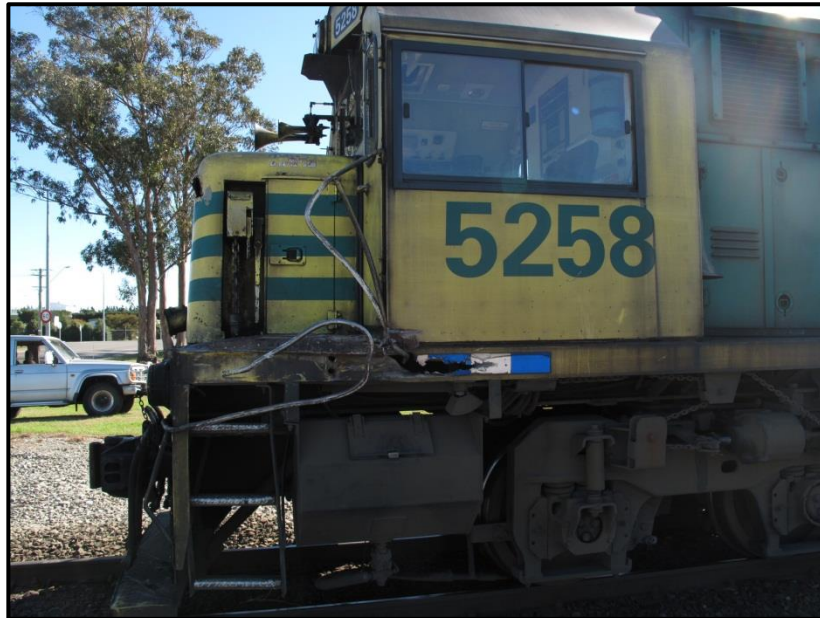
Figure 5
Damage to the locomotive on Train 845

- 3.1.13. At that time, a West Coast-bound train was stationary on the West Main line at Rolleston, waiting to enter the Midland line. KiwiRail procedures required drivers of stationary trains to conduct “roll-by inspections”³ of other trains when they crossed⁴. Once the locomotive of the northbound train had passed, the driver of Train 845 switched his headlight to full in order to carry out the roll-by inspection from his locomotive cab. About the leading third of the train had gone past when out of the darkness he saw the load protruding over his track. The driver was just ducking down behind his driver’s console when the displaced load struck his train. He immediately made a radio broadcast saying, “926, stop, stop, stop you have hit me” (see Figure 5).

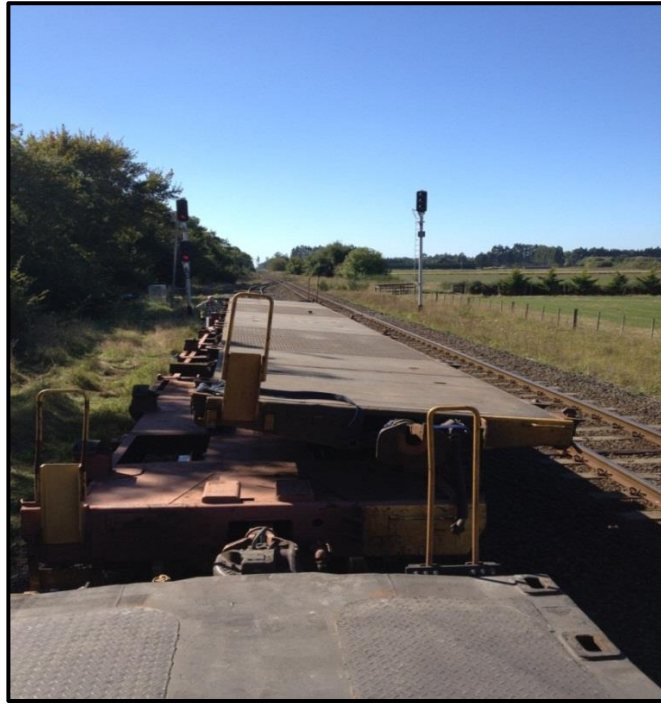
Figure 6
The load overhanging the wagon at Rolleston

- 3.1.14. The driver of the northbound train applied the brakes immediately. The train controller in Wellington’s national train control centre also heard the radio broadcast and responded by changing the indication of the next signal to red (Stop). The driver was able to stop his train before that signal (within 1300 metres).
- 3.1.15. When the driver went back to check his train he found the load overhanging the east side of the wagon (see Figure 6). All 5 webbing straps used to secure the load had failed.

- 4.2.9. In those final kilometres before striking the stationary train at Rolleston, the load appeared to have been almost, if not totally, unrestrained. First it struck several structures on the east side of the train. Then it struck the stationary train standing on the west side of the train, and after striking the stationary train it was found overhanging on the east side again, with no lashings left securing it.
