Inquiry RO-2012-103: Derailment of freight Train 229,
Rangitawa-Maewa, North Island Main Trunk, 3 May 2012

Final Report

Rail inquiry RO-2012-103
derailment of freight Train 229,
Rangitawa-Maewa
North Island Main Trunk
3 May 2012

Approved for publication: May 2016

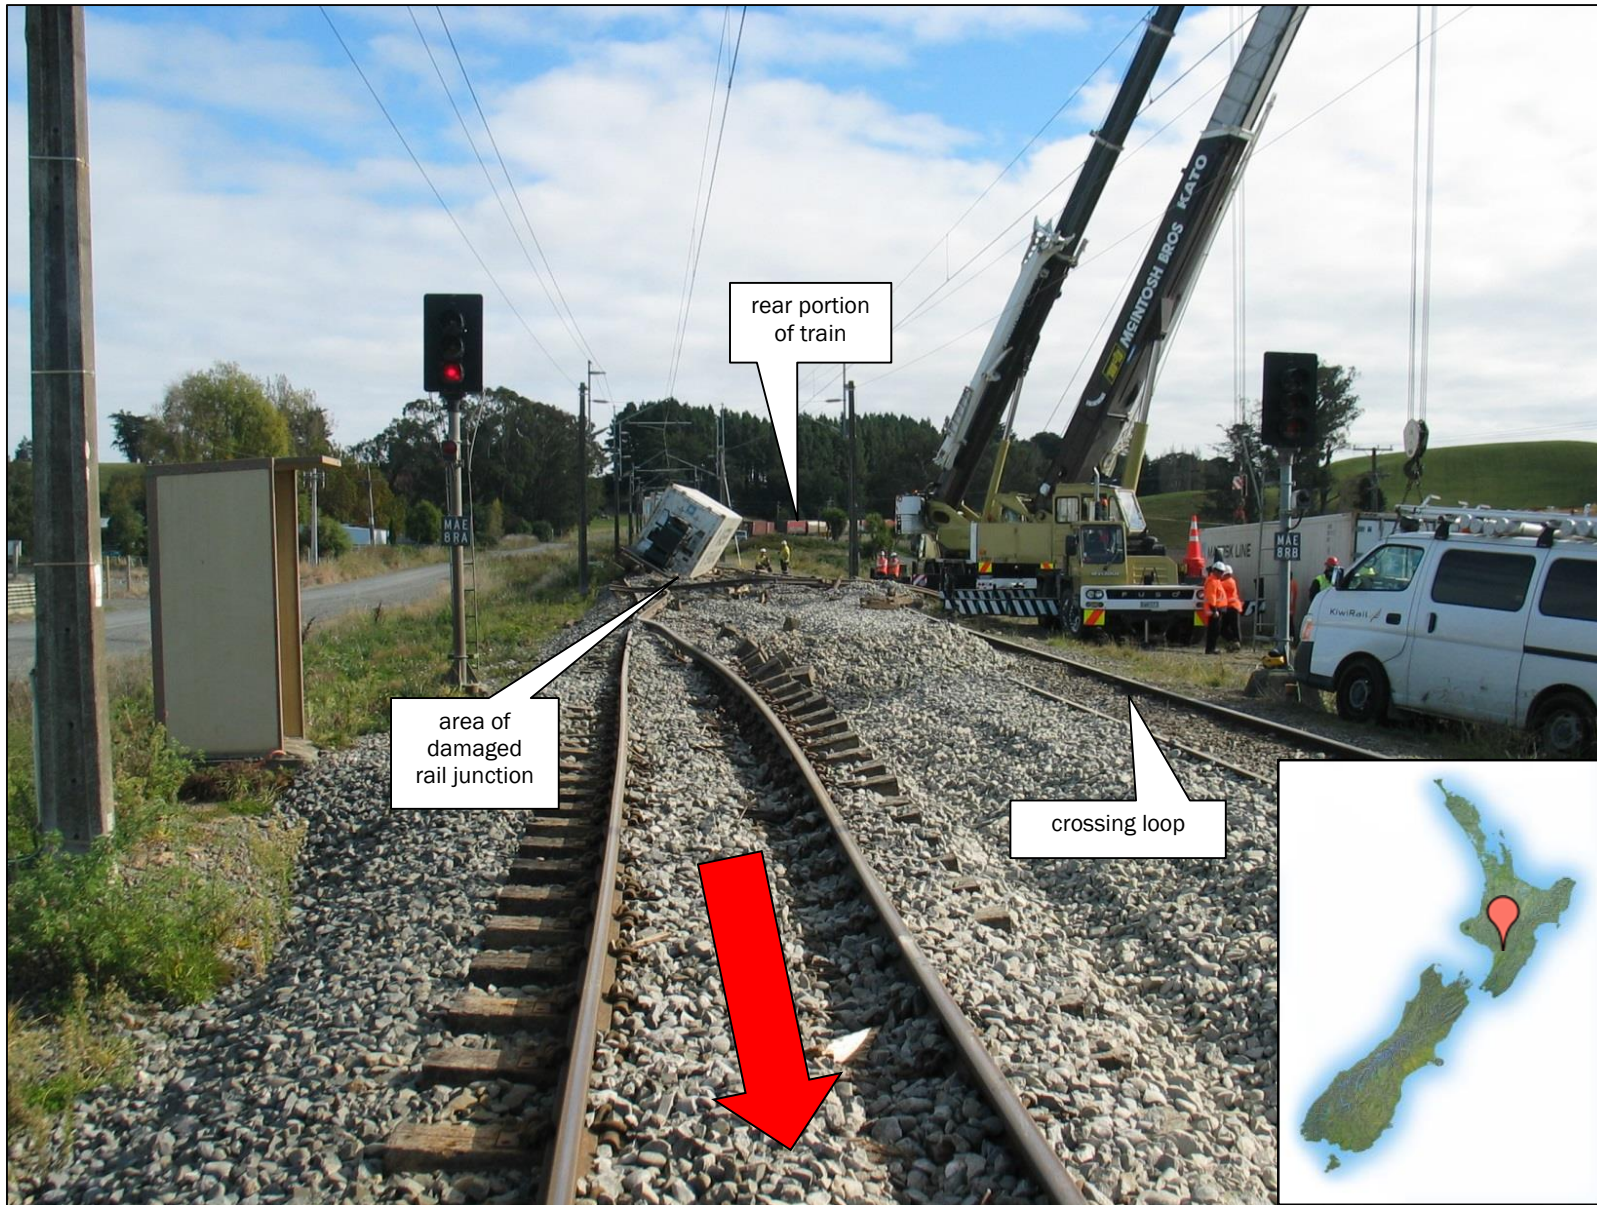
The derailment scene at Maewa, viewed opposite to the train's direction of travel (red arrow)

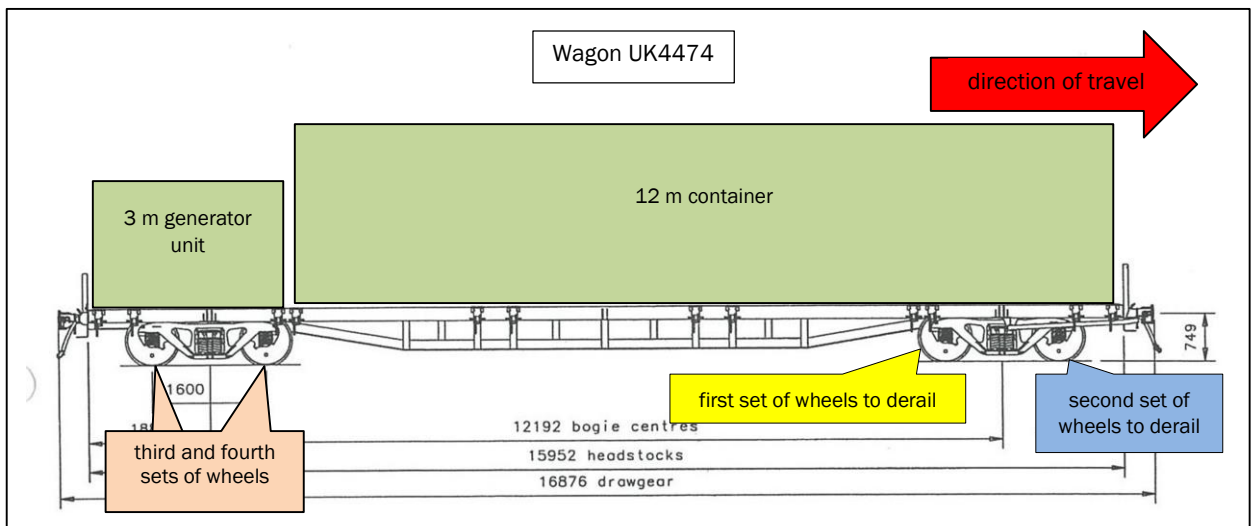
Figure 2
Elevation and load configuration of the first wagon that derailed (not to scale)

- 3.1.3. At 0030 on 3 May 2012, the train driver reduced power and applied braking to slow the train down from 76 kilometres (km) per hour for a 40 km per hour (km/h) temporary speed-restricted area. The speed restriction extended over 620 m of track between Rangitawa and Maewa.
- 3.1.4. The train was travelling at 35 km/h¹ through the speed-restricted area when the second set of wheels on the fifth wagon behind the locomotives derailed to the left-hand side of the track, followed shortly afterwards by the first set of wheels. The third and fourth sets of wheels remained on the track (see Figure 2).

- 4.2.3. In this case the wagon that first derailed was found to comply with the KiwiRail maintenance limits. The friction wedge heights were 29 mm compared with the maximum allowable 39 mm. The way the wagon was loaded was compliant with KiwiRail's freight handling code.

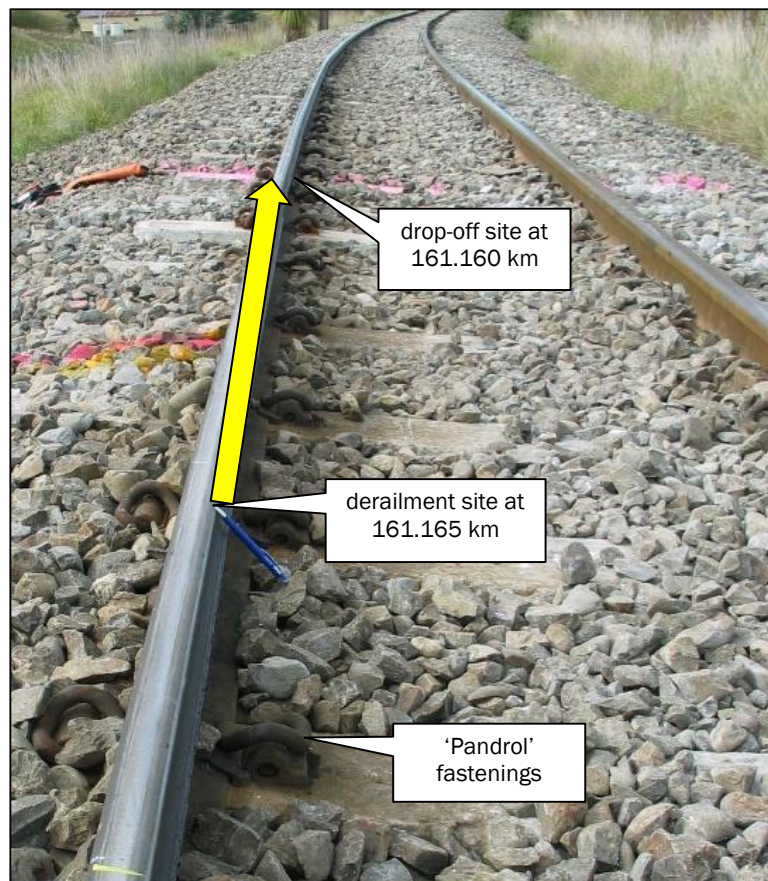
Figure 3
Derailment site (looking in the direction of travel)

3.3.1. The first set of wheels derailed to the left-hand side of the track in the direction of travel (see Figure 3). Gouge marks showed where the wheel rim travelled along the top of the rail until it dropped off the outside 5 m farther on.

- 3.3.2. The derailment site was located within a 264 m right-hand curve in the direction of travel. The curve had a radius of 420 m and was located on a 1 in 75 descending gradient on an embankment comprising a well-drained, medium-strength ground formation.
- 3.3.3. The track infrastructure comprised 50-kilograms-per-m, continuously welded rail fastened with 'Pandrol' (manufacturer's name) fastenings to concrete sleepers (see Figure 3). The sleepers, rail and fastenings had been installed in 1983 and were considered to be in a fair condition. The ballast was clean and well spread to form shoulders at the ends of the sleepers and filled the area between the sleepers and rails.

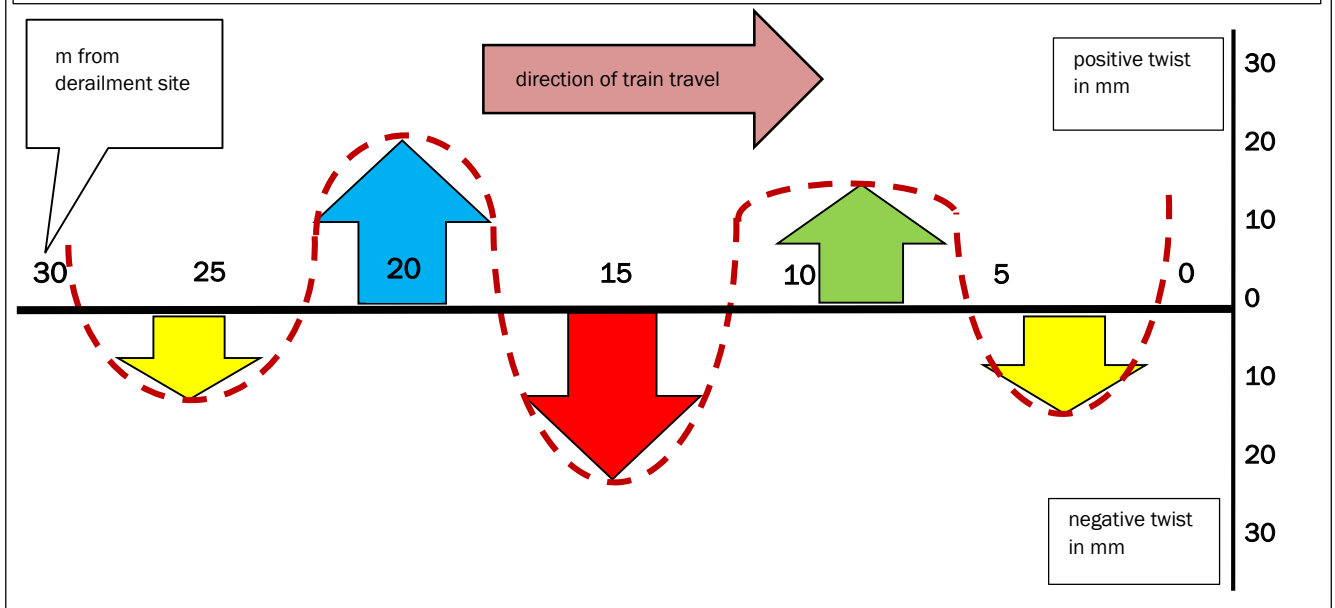
Figure 4
A plan of the track twist defects approaching the May 2012 derailment site (not to scale)

- 3.4.1. Straight sections of track are constructed with the rails level. When the track takes on a curve the outer rail is raised above the inside rail and this feature is known as cant³. The standard amount of cant depends on the radius of the curve. The standard cant was 70 millimetres (mm) for the curve where the derailment occurred.
- 3.4.2. Any variation from this standard cant over a 4 m length of track is known as a 'track twist'. A track twist is a defect that can cause wagons on a train to rock or oscillate as they travel over the twist.
- 3.4.3. The post-accident measurement of the track geometry revealed five track twist defects that ranged from 11 mm to 22 mm from the standard cant. All of the twist defects were within a 30 m length of track leading up to the derailment site and were sequentially in opposite directions (see Figure 4).

The cant standard for the curve where the derailments occurred was a 70 mm height difference across the two rails. The arrows represent variations to the cant measured in mm over 4 m lengths after the May derailment. Red required repairs within seven days, blue within four weeks, green within 26 weeks and yellow within 52 weeks.

- 3.5.1. KiwiRail had found a pattern of twist defects following the derailment six and a half weeks before this accident. They were similar values to those found after this derailment (see Figure 4). However, the track twist represented by the green arrow was more severe at 26 mm and required rectification within two days.
- 3.5.2. KiwiRail had concluded that the twist defects were the primary cause of the March derailment. Consequently, there was one track twist that KiwiRail standards required to be fixed within two days and one that was required to be repaired within one week. KiwiRail was unable to provide records of any repairs made to remedy the twist defects before this accident, six and a half weeks later.

- 4.3.1. Records showed that on 10 occasions between July 2009 and November 2011, KiwiRail's track-evaluation car had identified and reported the same pattern of track twist defects that contributed to this and the derailment six and a half weeks prior. On each occasion maintenance staff had carried out repairs. However, either the repairs had not remedied the track faults or the root cause of the defects had not been addressed, because they had reappeared with the next pass of the track-evaluation car. KiwiRail had not required track maintenance staff to record the nature of the repair work undertaken, the materials used or the methods applied. No records had been kept of the condition of the track after each repair.

- 4.3.6. A review of KiwiRail's track database for the area between Rangitawa and Maewa showed no evidence of the defects reappearing following three journeys of the track-evaluation car during 2015.

- 4.3.7. KiwiRail now requires a senior track engineer to review the track defect printout after each track-evaluation car journey to identify and analyse the most serious defects. Dependent upon the type, number and severity of the defects identified, the following actions are undertaken:

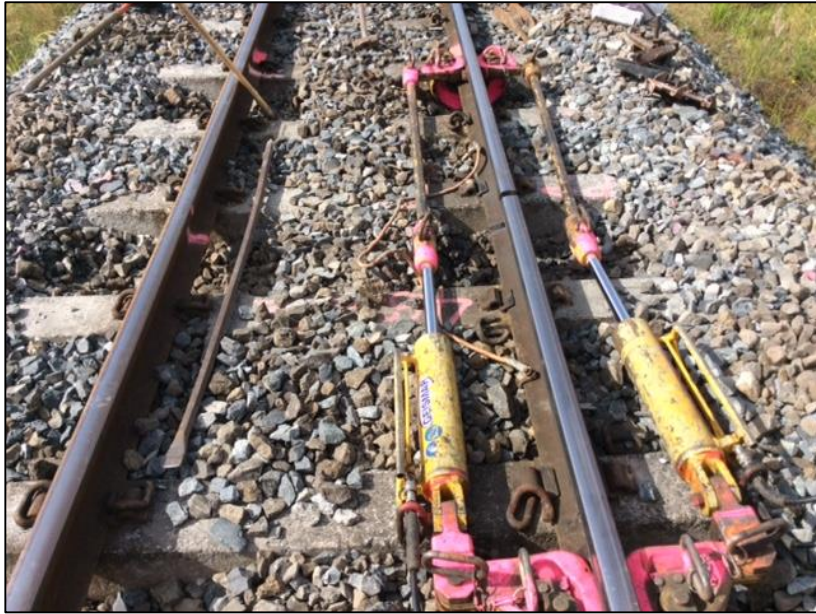
Figure 5
An example of rails being pulled together during a de-stressing operation

- 3.6.1. The following paragraphs describe maintenance work and two subsequent track failures that were unrelated to the cause of the two derailments but occurred within the same area.
- 3.6.2. De-stressing rail is a track maintenance work process of adjusting a length of rail in a section to prevent the rail buckling as the rail expands and contracts under extremes in temperature. On 21 November 2011 (four months before the March derailment), 500 m of rail was de-stressed through the area where both derailments later occurred. Measured lengths of rail were cut out and removed, then the remaining rails were hydraulically pulled together and re-joined, and, welded as part of the de-stressing process (see Figure 5).

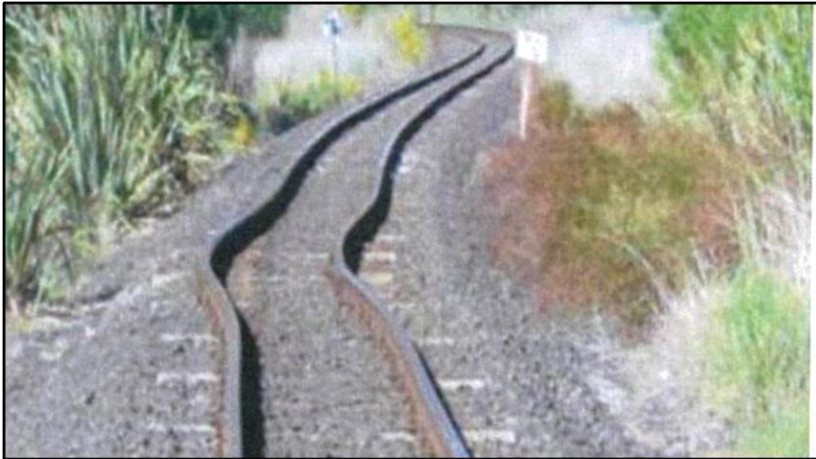
Figure 6
An example of a track buckle

- 3.6.3. On 6 December 2011, 15 days after the de-stress work, one of the new welds failed. The rail that contained the weld failure was replaced on the same day.
- 3.6.4. One week later, on 13 December 2011, a track buckle failure was found 8 m from the site of the weld failure. A track buckle occurs when hot weather causes rail to expand, causing compression forces. When these forces exceed the resistance provided by the sleepers and ballast, the track can buckle sideways (see Figure 6).

- 4.3.8. Following the heat buckle and weld failure, KiwiRail conducted an internal investigation into the track buckle, which identified the following concerns regarding the quality of the track de-stress project completed three weeks previously and also the later repairs completed at the weld failure site:

- the rail used to replace the weld failure was unsuitable
 - the ballast each side of the track was in a weak condition
 - the longstanding track defects [the track twists] remained.

- 3.6.5. The track buckle site was stabilised and a short length of replacement rail inserted on the same day. On 14 and 15 December 2011 maintenance staff returned to the site to complete the repair work, which included extracting, shifting and inserting a 20 m length of rail through the area and welding track joints.
- 3.6.6. Records show that on 19 December 2011, in addition to the de-stressing work required, there was insufficient ballast on each side of the track in the vicinity of the track buckle site.

- 6.9. KiwiRail has expanded on its track buckle investigative procedures so that track engineering personnel can analyse and identify the cause of each event.
