Inquiry 12-202: Fishing vessel *Torea*,  
collision with uncharted rock, Foveaux Strait, 24 August 2012

Marine inquiry 12-202  
Fishing vessel *Torea*, collision with uncharted rock, Foveaux  
Strait, 24 August 2012

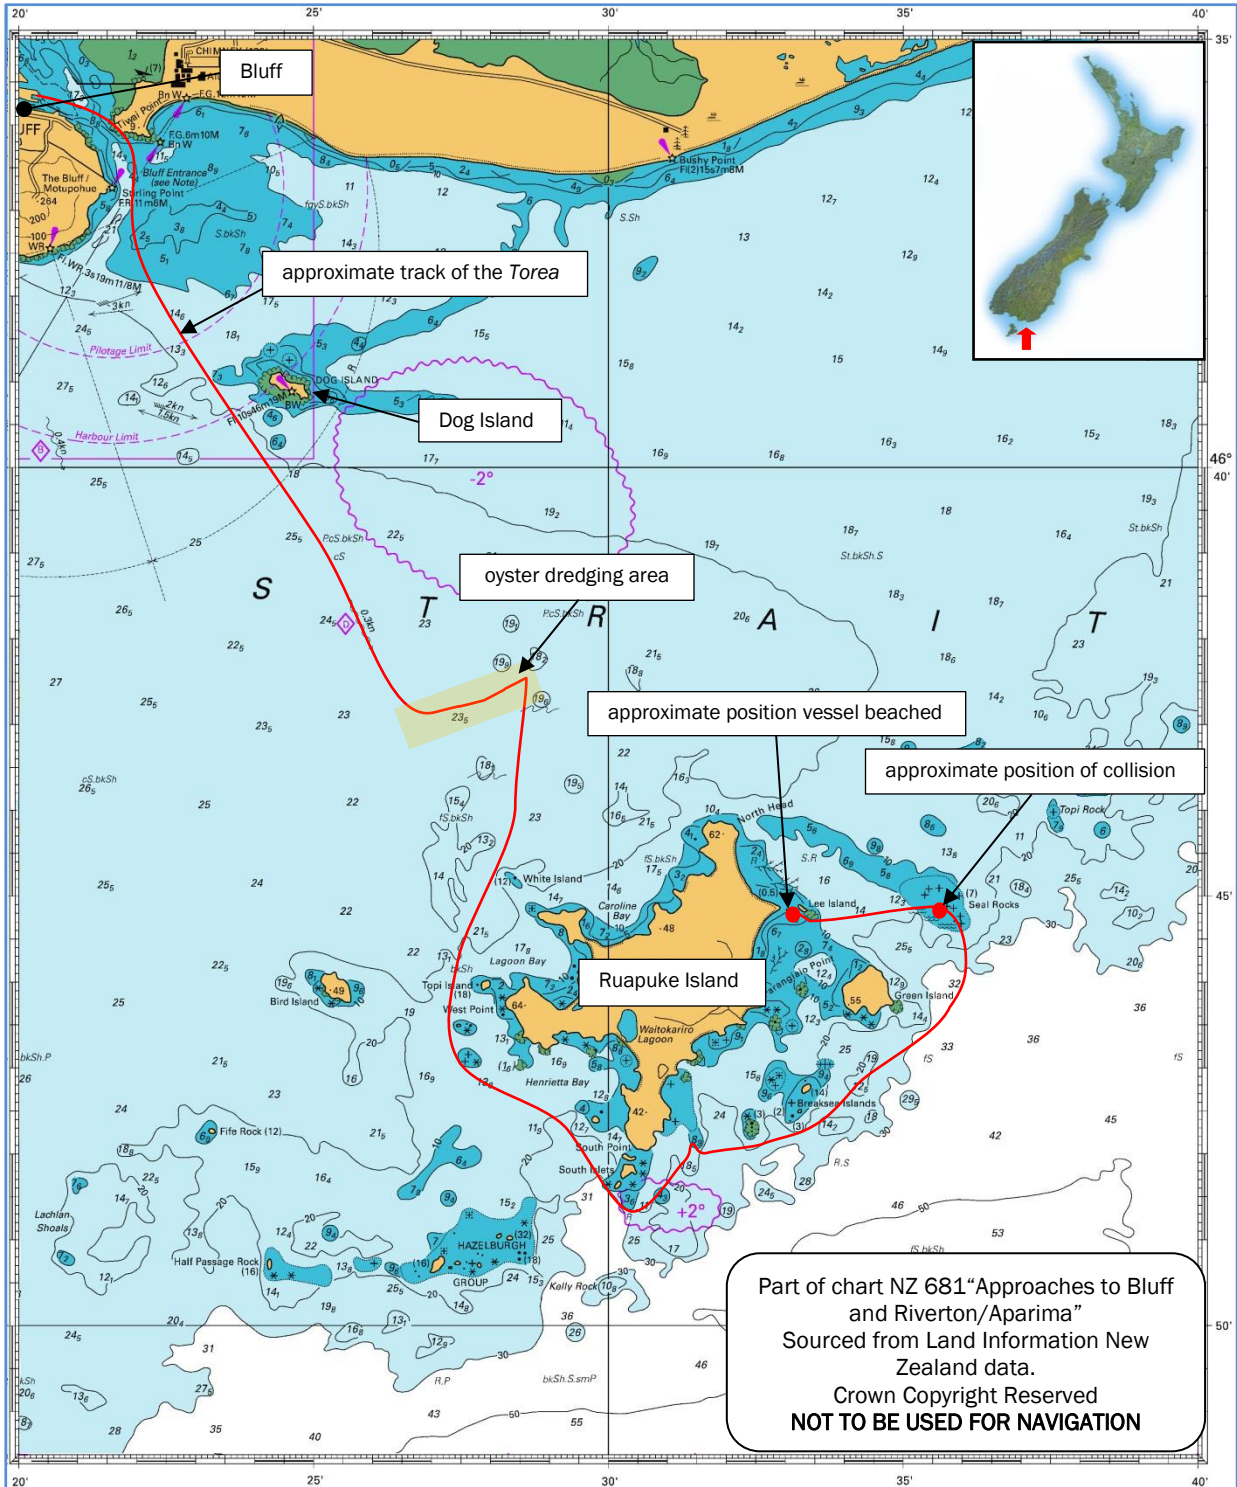
Figure 1  
 Chart of the general area showing the approximate track of the Torea

- 3.1.5. The *Torea* proceeded to between Ruapuke Island and Dog Island to dredge for oysters (see Figure 1). The *Torea* completed about 4 or 5 tows until all the charter passengers and crew had caught their quota.

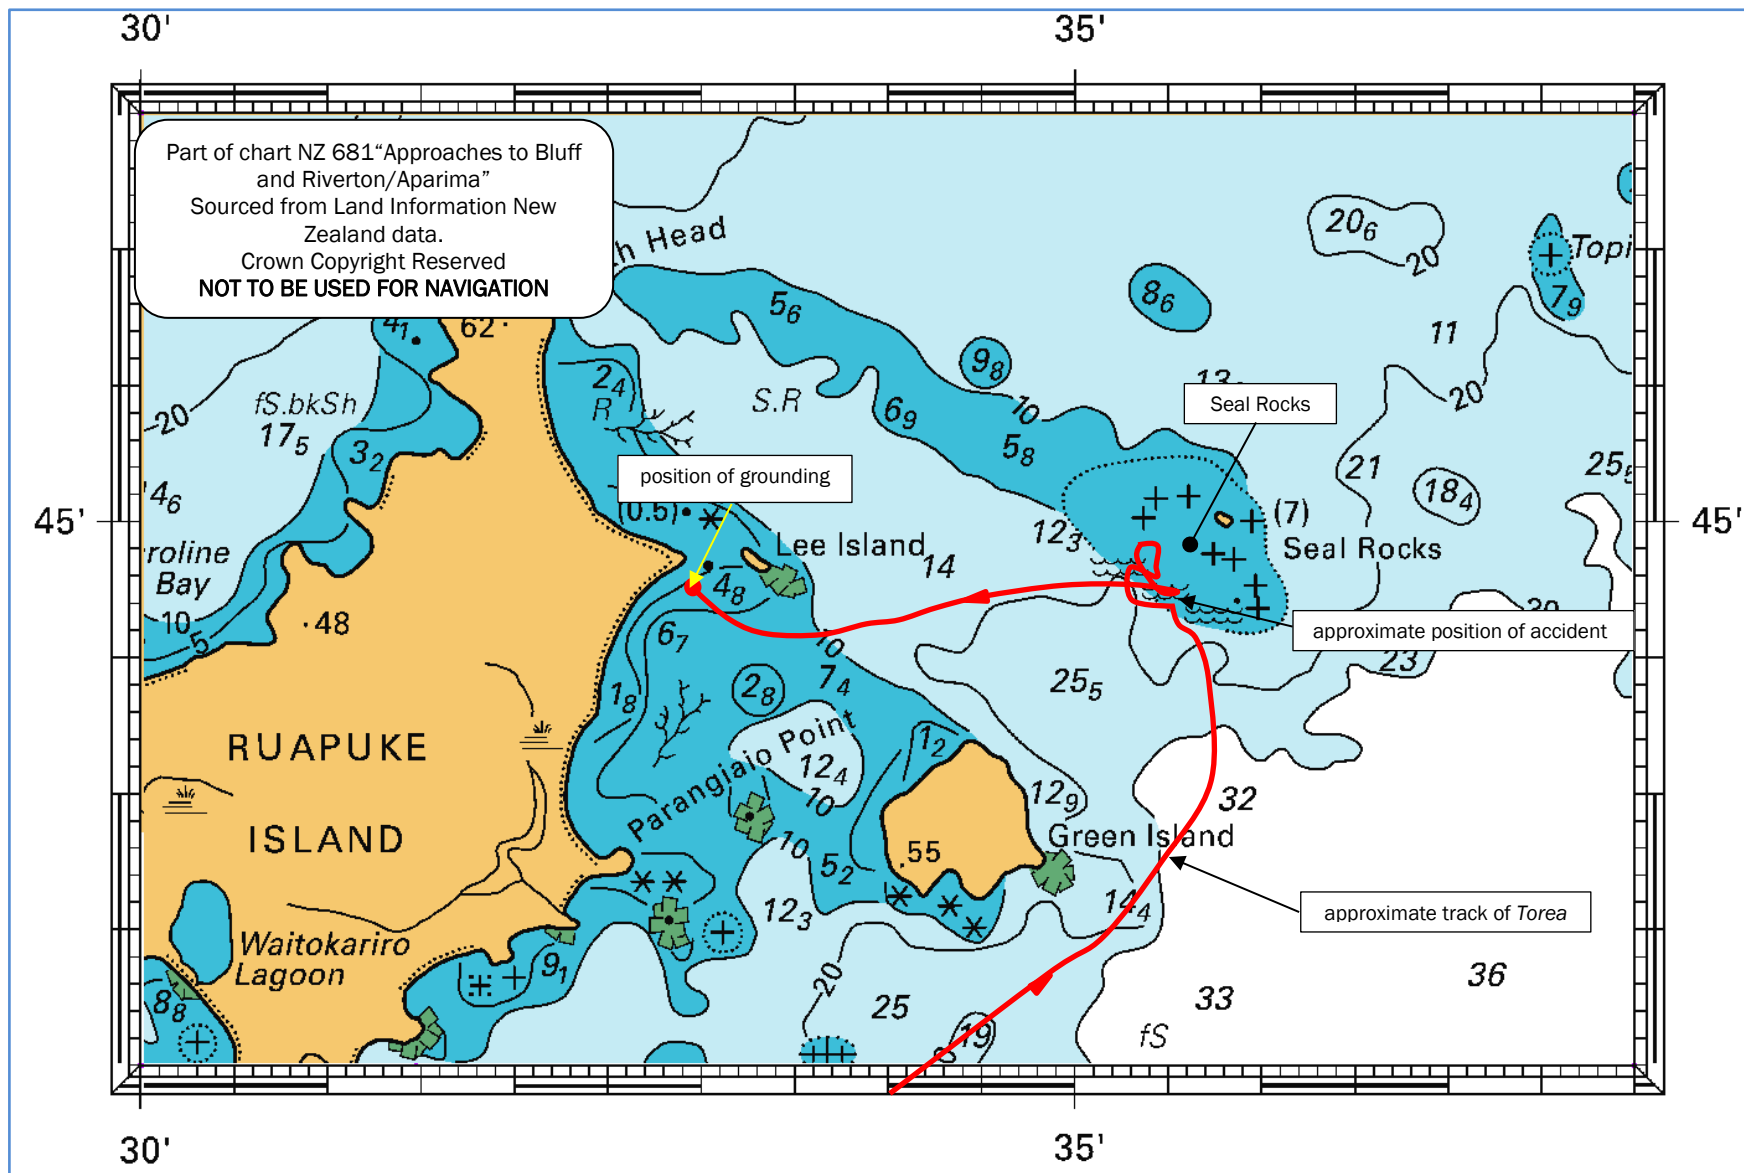
Figure 2  
 Chart showing the Torea's track to the east of Ruapuke Island

- 4.2.4. He determined from his previous tracks where he knew uncharted rocks existed. At the end of his second drift, where he was positioned between 2 previous successful tracks, the master put the throttle forward and turned to the east into what he believed to be clear water. One of the crew members had just started telling the master that the water depth was reducing when the *Torea* collided with the rock. In this case the collision could possibly have been avoided, or the damage minimised, had the skipper kept the *Torea*'s speed to a minimum until he was sure he was clear of the rocky area.

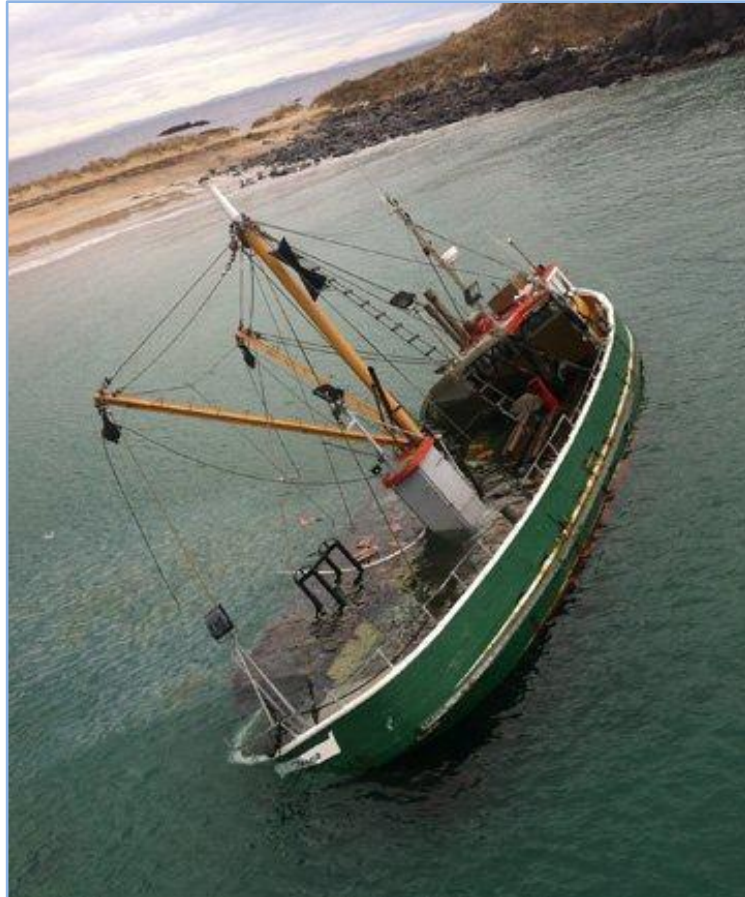
- 3.1.13. The *Torea* grounded as it approached the beach. By that time seawater had almost filled the forecabin, and had begun flooding the engine room through holes near the top of the bulkhead that separated the 2 compartments.

Figure 3  
The *Torea* aground and partially submerged off Ruapuke Island

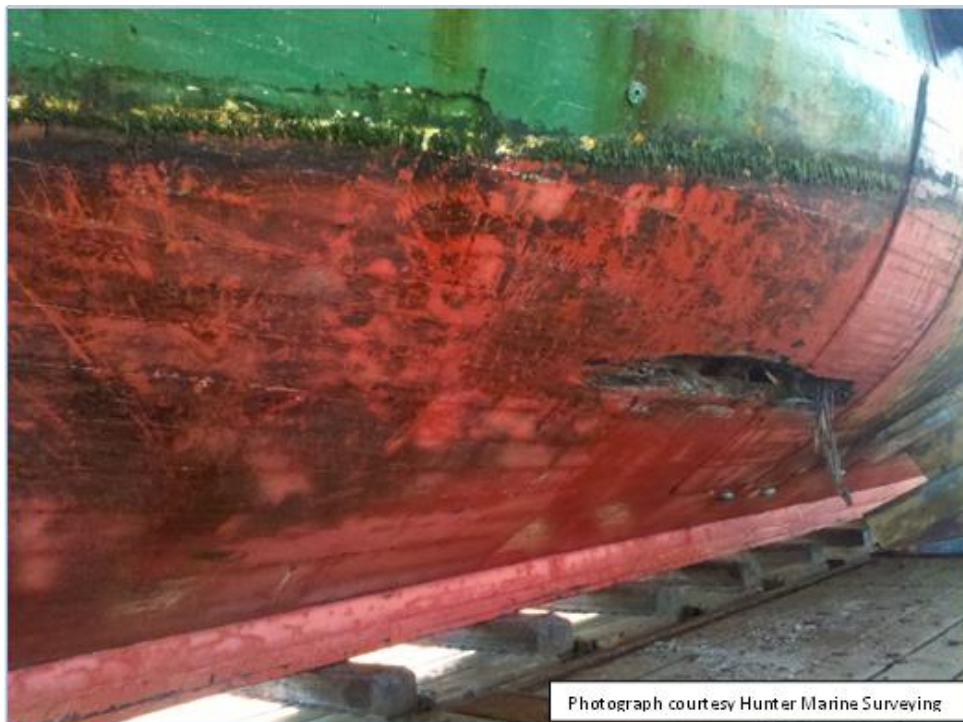
| <b>Damage</b> | forefoot and stem of vessel crushed. Hull planking in way of the forecastle accommodation split. Extensive damage to vessel's interior and equipment due to water immersion |

Figure 4  
Damage sustained to the port side of the underwater hull of the *Torea*

- 5.1. The *Torea*'s hull was breached when it struck an uncharted rock while the vessel was routinely manoeuvring close to rocks in search of its targeted fish species.
- 5.2. There was no technical or mechanical failure that contributed to the accident.
- 5.3. The *Torea* was appropriately crewed, surveyed and fit for its intended purpose.
- 5.4. The *Torea* was carrying 4 more passengers than was permitted by its safe ship management maritime document. The company procedures were not robust enough to ensure that the maximum permitted number of passengers was not exceeded.
- 5.5. The skipper's and crew's initial response after the *Torea* struck the rock was rapid and well coordinated, as was the first response by those involved in the search and rescue plan.
