Final report MO-2012-203: Fire on board *Amalal Columbia*  
12 September 2012

Marine inquiry MO-2012-203  
Fire on board *Amaltal Columbia*  
12 September 2012

Approved for publication: February 2017

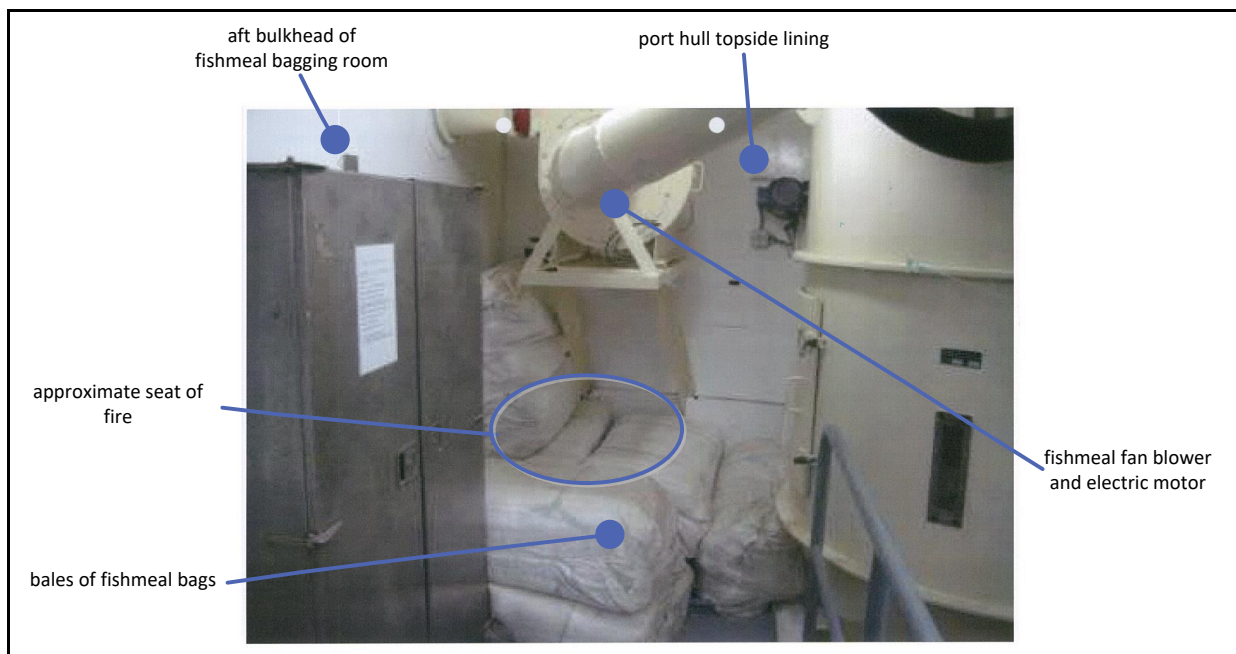
**Figure 2**  
Fishmeal bagging room of the *Amaltal Columbia*'s sister vessel

- 4.2.1. The seat of the fire was in the fishmeal bagging room located at the forward port side of the fish processing factory (shown in Figure 1). The fishmeal bagging room of the *Amaltal Columbia*'s sister vessel is nearly identical in layout and content. A photograph of it is reproduced in Figure 2.

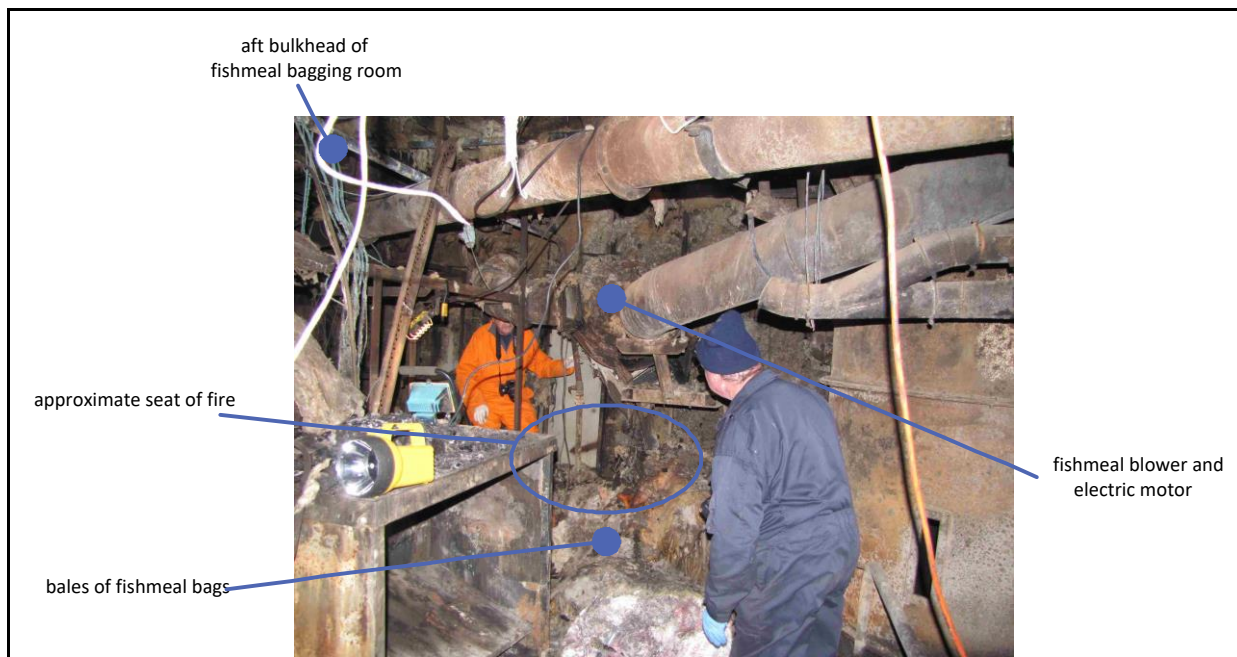
**Figure 3**

- 4.2.2. The seat of the fire was identified by accounts from the crew who first saw the fire, and the pattern of the burn damage assessed during the scene examination.

The fishmeal bagging room of the *Amalal Columbia*, from approximately the same position as Figure 2

1. The seat of the fire was located within bales of empty polypropylene bags stored in the fishmeal bagging room on the fish processing deck.
2. The Commission was not able to establish conclusively the source of ignition for the fire. However, it was about as likely as not to have been either the failure of a fluorescent light fitting or a failure within a fan unit, both of which were located above the seat of the fire.

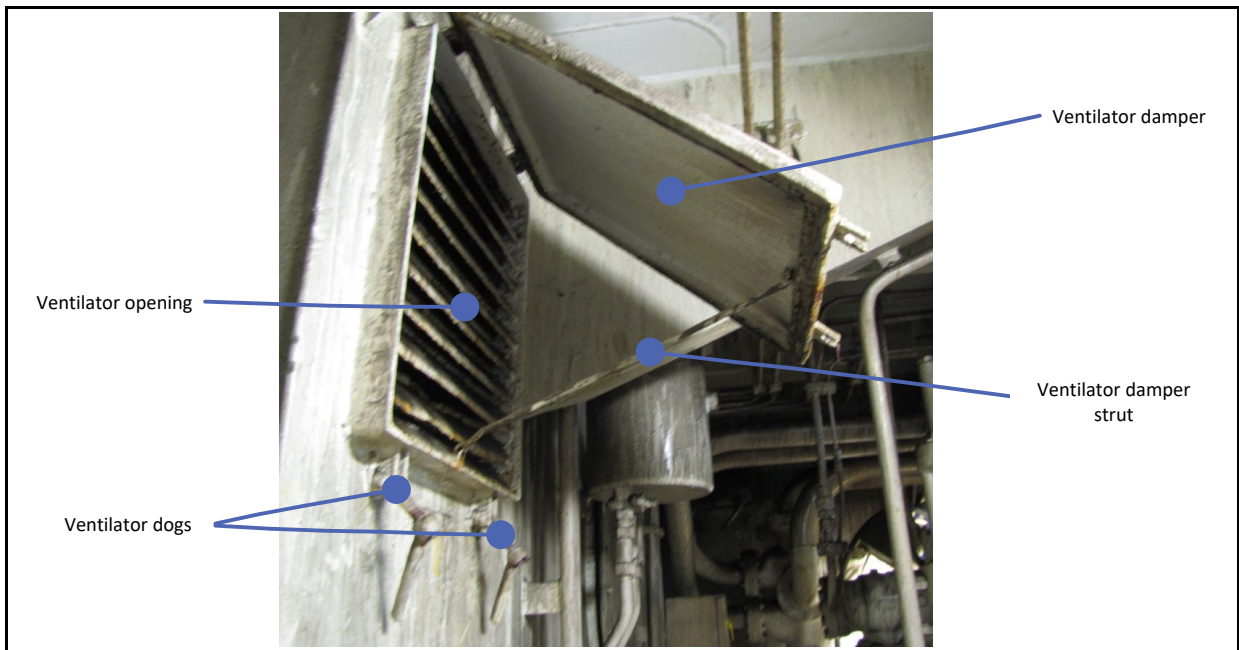
Figure 4  
Ventilator opening with ventilator flap in open position

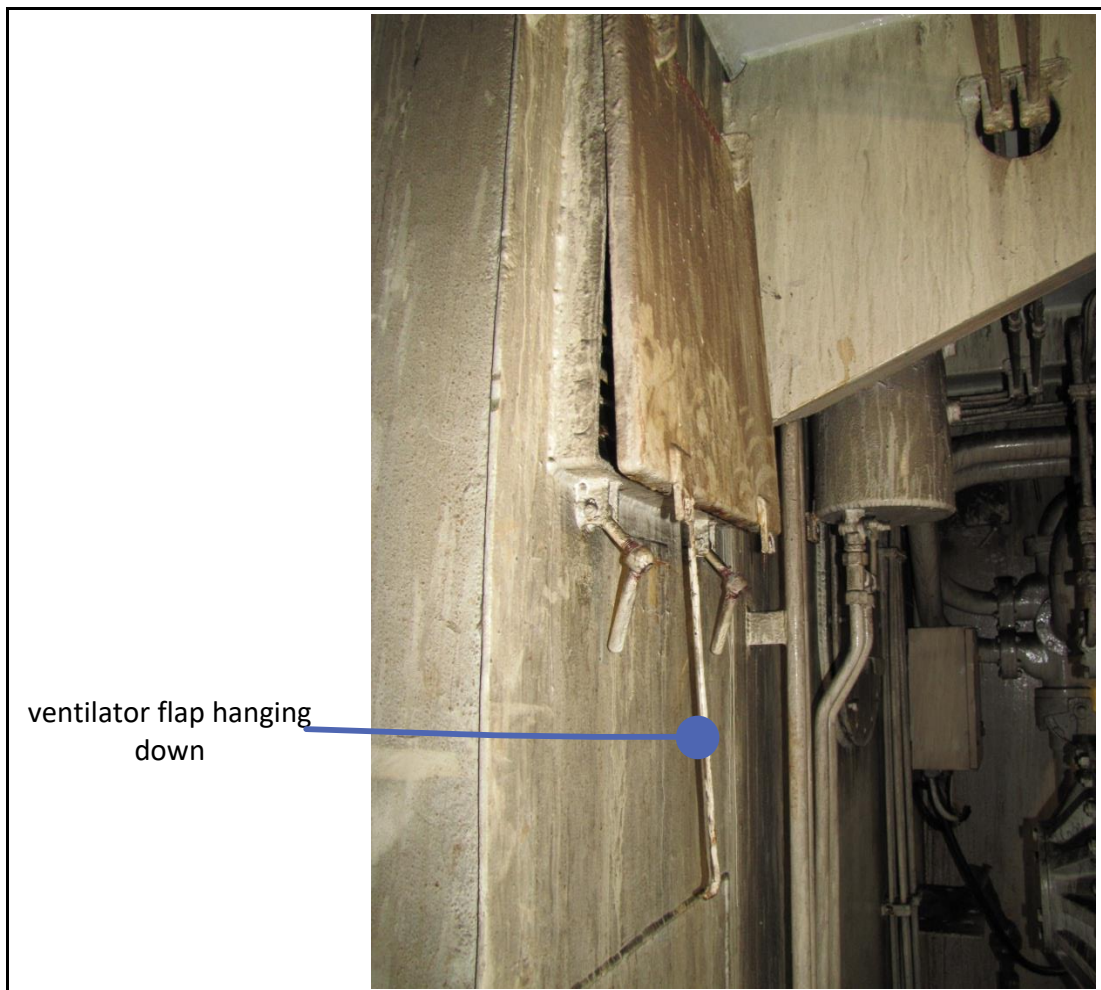
- 4.5.4. During the post-fire examination the flaps were able to be closed and secured as designed, and the master said they had been closed during the firefighting effort. However, during the fire the crew found it difficult to close the flaps when unable to see the mechanism through the dense smoke, and were hindered further by the intense heat and their manoeuvrability being hampered by the firefighting suits and breathing apparatus.

- 4.5.5. Fighting fires on board a ship is a time of high stress for the crew, who are working under difficult conditions, as this case demonstrates. For this reason mechanisms for shutting down ventilators in the event of fire should be quick, easy and intuitive to operate. The design of the ones on board the *Amaltal Columbia* did not meet these criteria.

Figure 5  
Ventilator opening with strut hanging down, obstructing the flap from closing fully

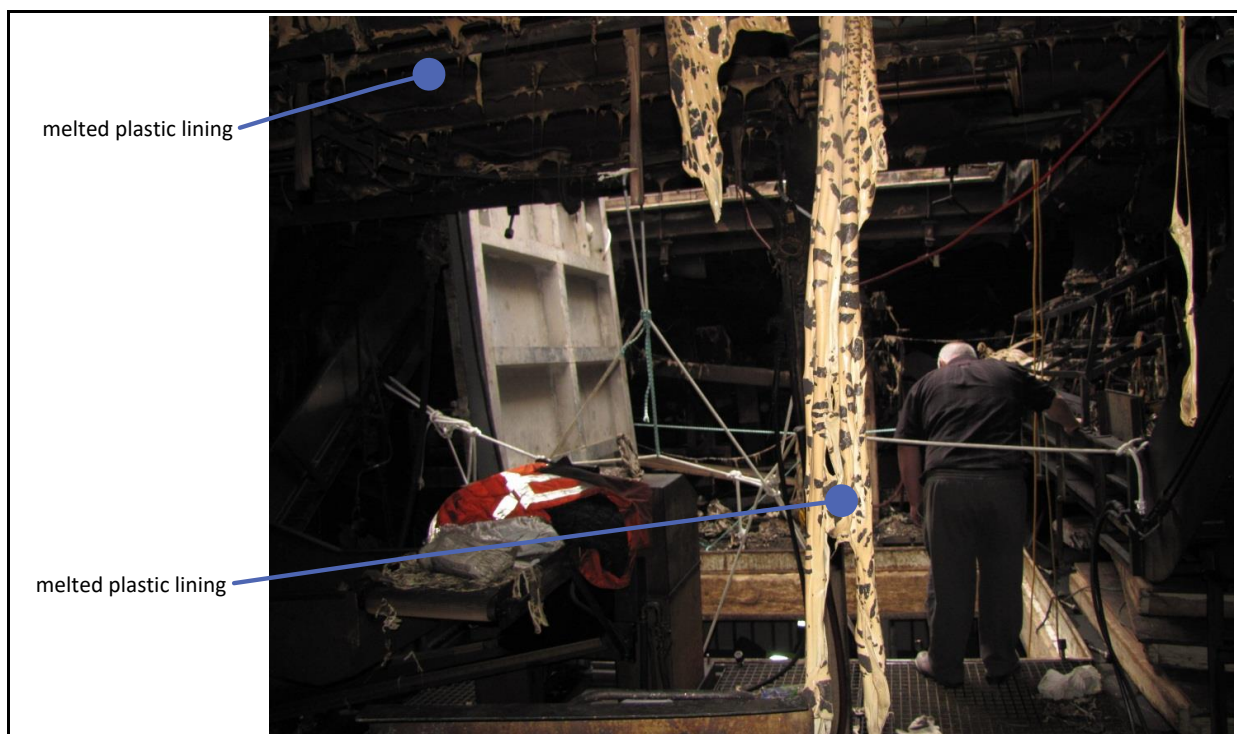
Figure 6  
Photo taken in fish processing factory

- 4.6.2. The plastic lining melted and appeared to have burnt during the fire, producing thick, acrid smoke that hindered initial firefighting efforts. An example of the burnt and melted plastic lining can be seen in Figure 6. Most plastics are highly flammable and will accelerate the spread of a fire.

- 4.6.3. Nobody knew the fire rating of the plastic lining. Current maritime rules require that such materials are fire retardant so as to slow or help prevent the spread of fire. As with the other aspects of ship design referred to above, the vessel had been built before Part 40D came into force, and requirements around fire-retardant linings had not applied.

- 5.6. It could not be established whether the material used to line the fish processing deck had fire-retardant properties, but it appeared to have burned and likely accelerated the spread of fire.

- 4.6.4. From a risk perspective, operators should consider the fire-retardant qualities of materials used in all areas of a ship prone to fire, especially when changing or refitting any space.
