Inquiry AO-2013-002: Robinson R44, ZK-HAD, engine power loss and ditching,
Lake Rotorua, 24 February 2013

Aviation inquiry AO-2013-002
Robinson R44, ZK-HAD
engine power loss and ditching
Lake Rotorua
24 February 2013

Approved for publication: December 2014

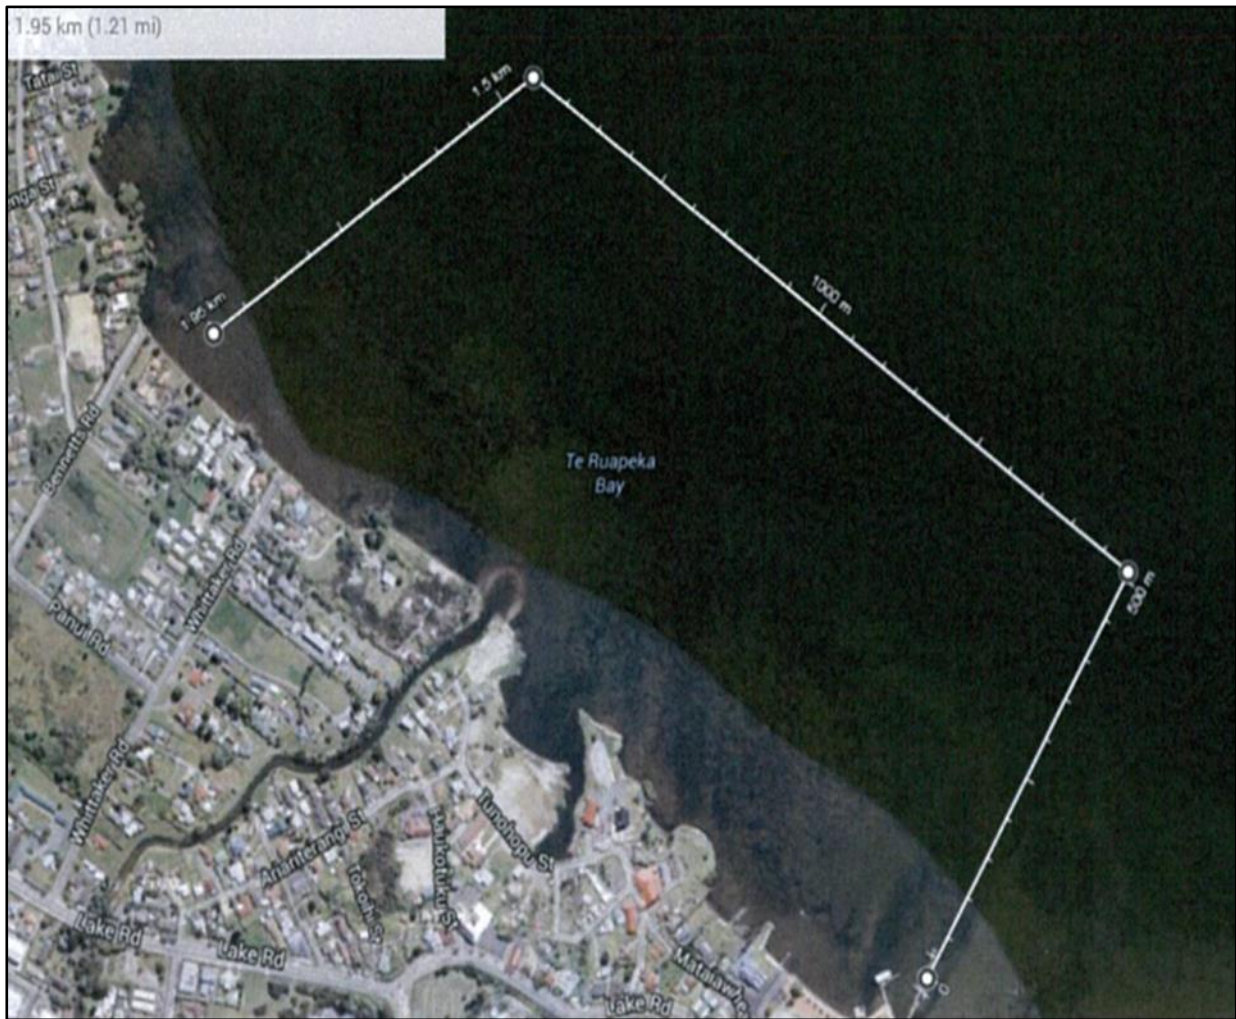
Figure 1
Approximate flight path

- 3.1.1. On 24 February 2013 at 0800, the pilot arrived at Rotorua airport and carried out a pre-flight inspection of the helicopter, registration ZK-HAD (the helicopter), checked the fuel load on board and performed a fuel drain check. The fuel on board was approximately 70 litres and nothing abnormal was found during the fuel drain and pre-flight checks. At 0845 the pilot flew the helicopter from the airport to the lakefront helipad, a flight time of about five minutes.

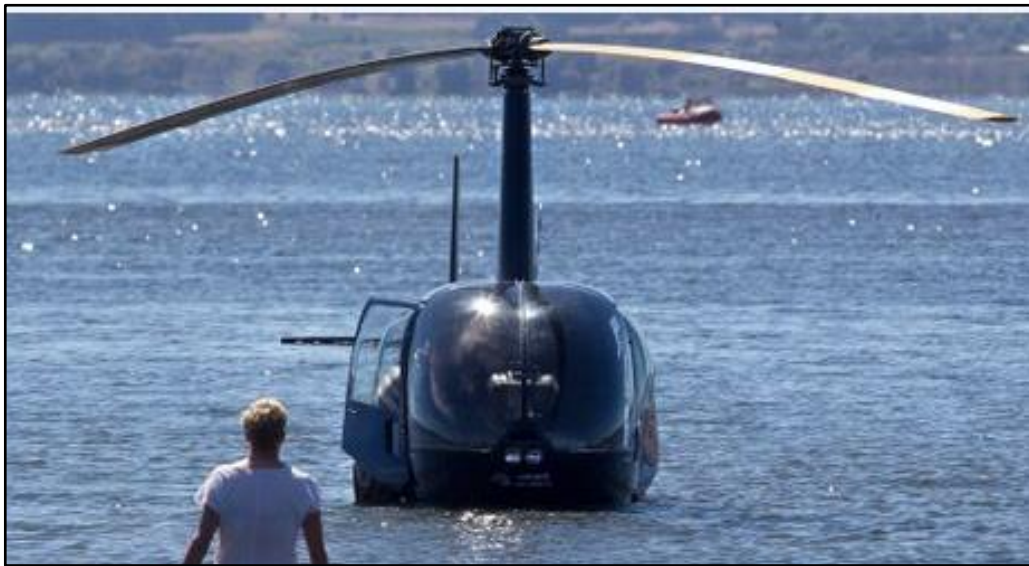
Figure 2
ZK-HAD in the lake

3.4.1. The helicopter was moved from the lake to Rotorua airport and examined by the two Commission investigators, assisted by two experienced helicopter engineers. The inspection initially focused on the engine and fuel system. The helicopter itself had suffered little damage. The underside of the cabin had suffered water compression dents when the helicopter struck the lake. A tail rotor blade was bent, and the tail rotor driveshaft was broken, when the tail rotor struck the surface of the lake.

3.4.2. There was no obvious external damage to the engine. Approximately 45 litres of fuel was in the fuel tanks, which would have been enough for about 45 minutes' flying time. The fuel had the appearance and smell of clean aviation gasoline. The fuel supply and metering system integrity was confirmed, with no leaks under boost pump pressure. The fuel injection system nozzles were free of obstructions and delivered the minimum flow rate as per the engine maintenance manual requirements. The engine control rigging was checked and found to be correct. The oil and fuel filters were free of contaminants.

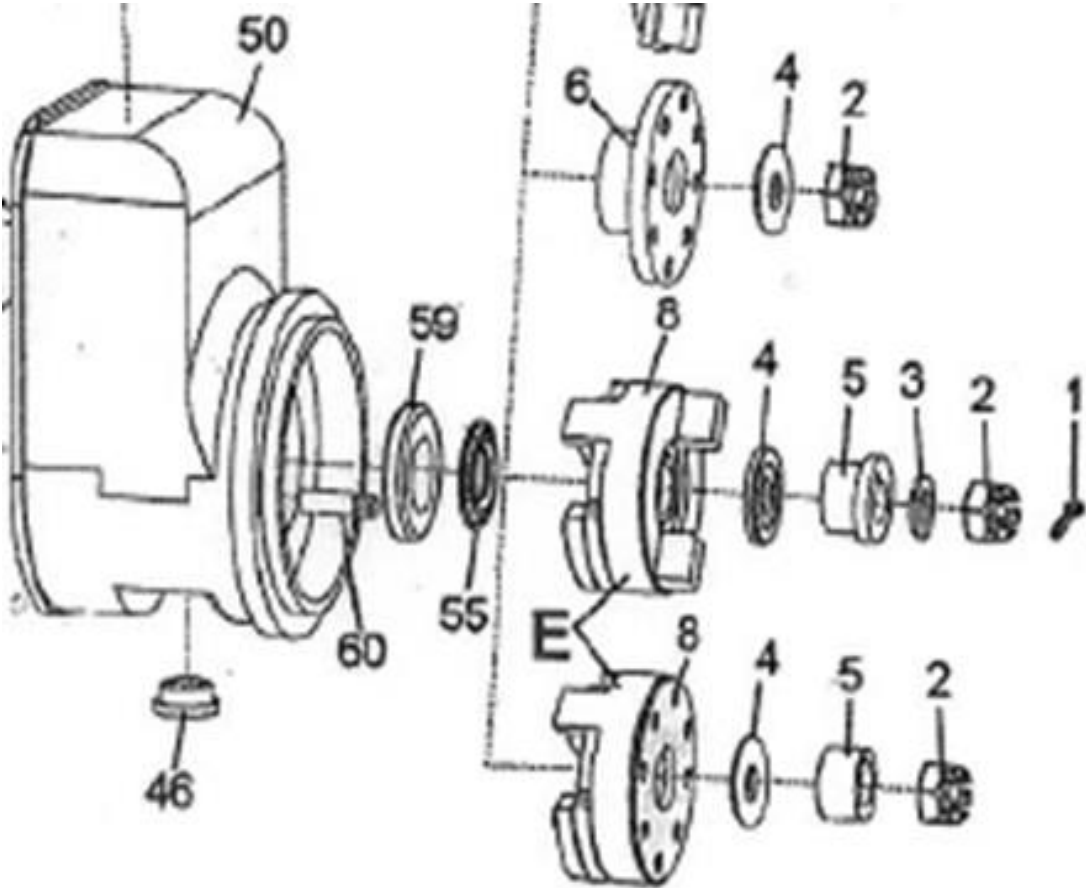
Oil slinger item # 55

3.4.5. The magnetos were disassembled and visually inspected for defects. Both magnetos were found to have cracked distributor blocks, and the oil slinger was missing from the right magneto. The oil slinger was designed to prevent engine oil entering the contact breaker compartment. A new oil slinger was fitted to the right magneto, and both magneto distributor blocks were replaced.

- Magnetos**
- 4.2.3. The magnetos are a self-contained engine component, consisting of a rotating permanent magnet, field coils and breaker points, which generates the spark at a set time across the engine spark plugs that initiates the combustion of the fuel/air mixture. Both the left and right magnetos supply a spark to every cylinder, for redundancy and efficiency. This means that if one magneto is defective, the engine should still run with a reduced power output. When the magnetos were inspected after the incident, both the left and right magneto distributor blocks were found to be cracked. Also, a substantial amount of engine lubricating oil was found inside the breaker compartment of the right magneto.

- 4.2.5. The oil found in the breaker compartment on the right magneto was more significant. During the conformity inspection Aeromotive had inspected both magnetos in accordance with the manufacturer's 500-hour inspection schedule. That involved disassembly of the magnetos.

- 4.2.9. When considering the amount of oil found in the right magneto after the incident and the effect this would have had on the magneto's performance, it is highly likely that the omission of the oil slinger when reassembling the right magneto contributed to the engine loss of power. However, other possibilities were considered and are discussed below.
