Final Report AO-2013-003: Robinson R66, ZK-IHU,
Mast bump and in-flight break-up, Kaweka Range, 9 March 2013

Aviation inquiry AO-2013-003
Robinson R66, ZK-IHU
Mast bump and in-flight break-up
Kaweka Range, 9 March 2013

Approved for publication: April 2016

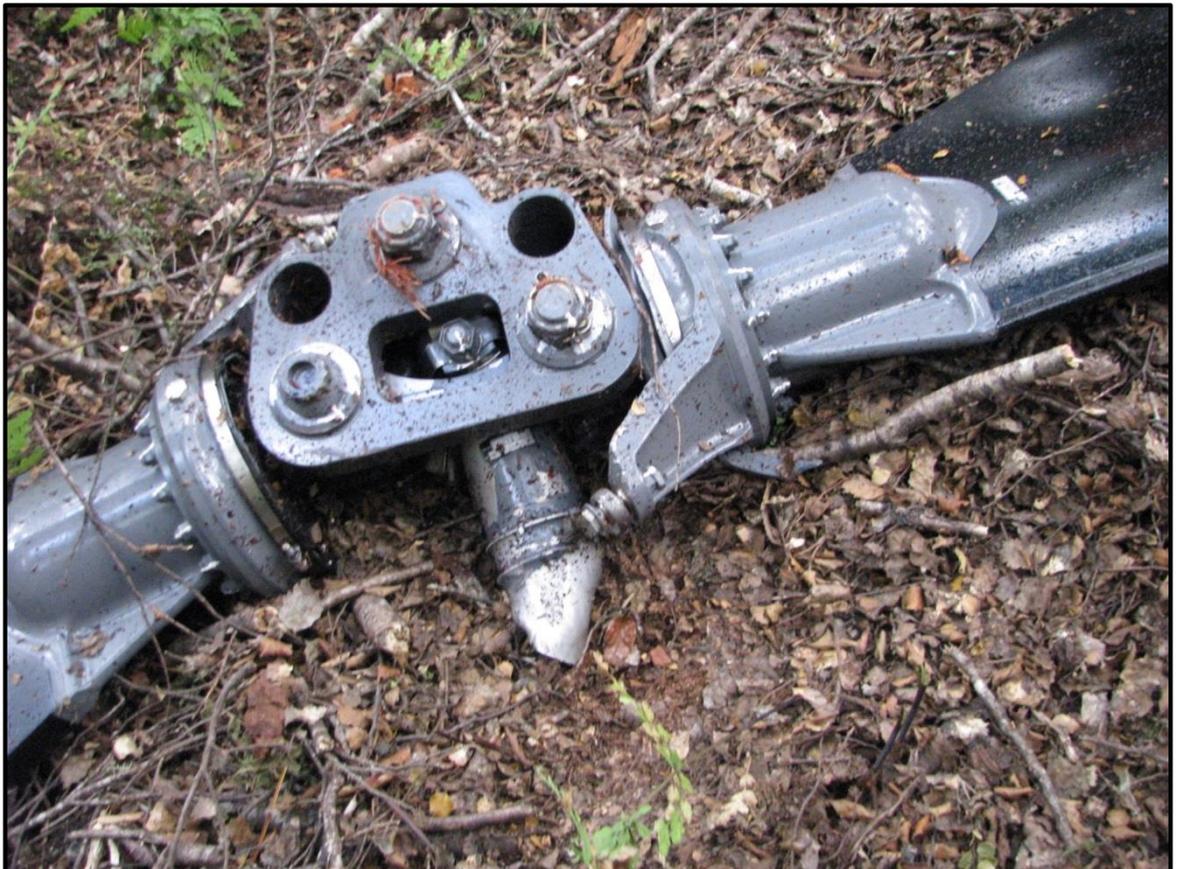
Figure 3
Main rotor head, showing severed drive shaft

- 4.1.2. The damage showed that a mast bump had preceded the in-flight break-up. A mast bump is usually a result of the blades having exceeded the allowable range of flapping. Robinson noted in its Safety Notice SN-11 that "severe in-flight mast bumping usually results in main rotor shaft separation and/or rotor blade contact with the fuselage" (Robinson Helicopter Company, 2010).
