Final Report AO-2013-006: Misaligned take-off at night  
Airbus A340, CC-CQF, Auckland Airport  
18 May 2013

Aviation inquiry A0-2013-006  
Misaligned take-off at night  
Airbus A340, CC-CQF  
Auckland Airport  
18 May 2013

Approved for publication: December 2015

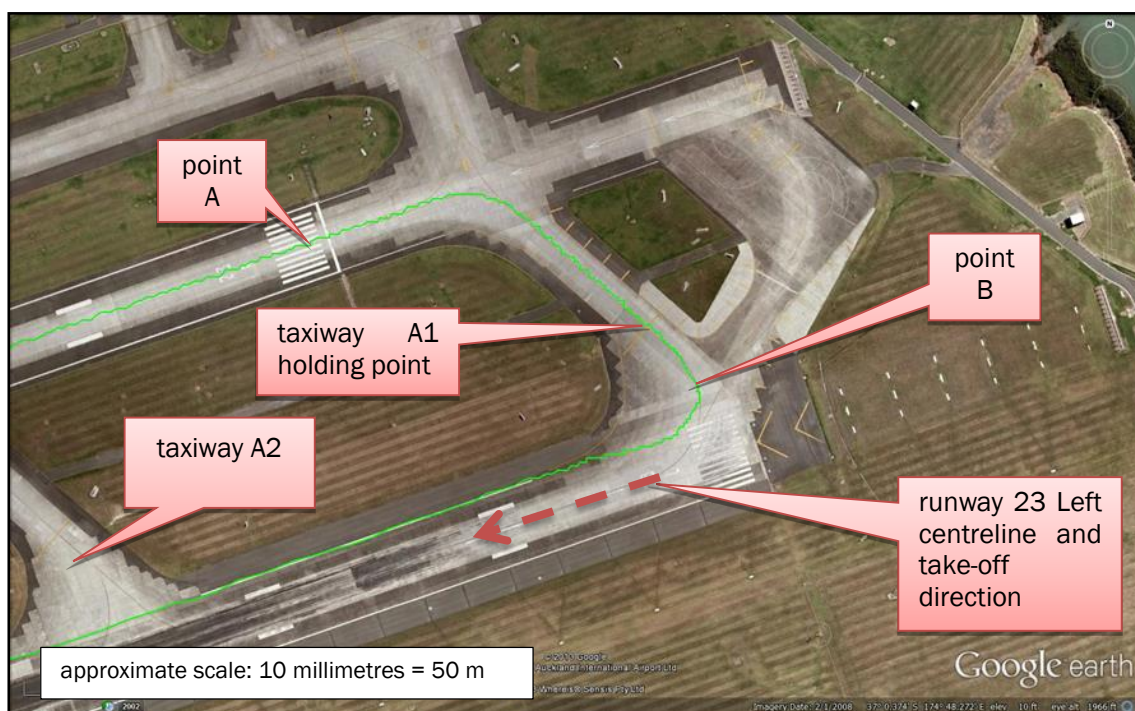
**Figure 1**  
**The aeroplane's taxi and take-off path**  
(The green line shows the aeroplane's track on the ground)

- 3.1.3. At 0610 the aeroplane was cleared to leave the terminal. While taxiing to the holding point<sup>7</sup> on taxiway A1 for runway 23 Left<sup>8</sup> (see Figure 1), the pilots conducted the before-take-off checks. The aeroplane's 'runway turn-off' and 'taxi' lights were on. All of the aerodrome lights were on.

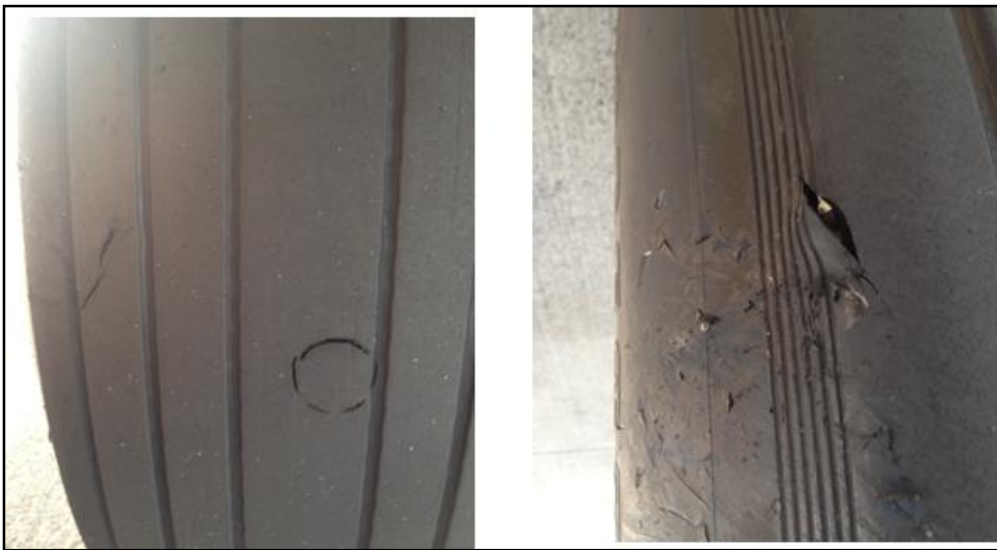
Figure 2  
Tyre damage

- 1.5. A routine runway inspection later that morning found that seven of the elevated runway edge lights were damaged and required replacement. The runway was closed for 20 minutes while the debris was removed. When the aeroplane was inspected after it arrived in Sydney, two of the tyres were found to be damaged and had to be replaced.

- 3.2.1. When the aeroplane arrived at Sydney Airport, the ground engineer noticed a cut in the right nose wheel tyre and advised the captain. Together they inspected the aeroplane and found another cut on the centre undercarriage right tyre. The replacement of these tyres delayed the return flight to Auckland by 39 minutes. Upon the captain's return to Auckland, the airport operator contacted him about the damaged edge lights. The captain explained that with no indication of damage until the visual inspection at Sydney, he had decided there was no need to report the incident to the tower. He subsequently filed an occurrence report with the CAA.
- 3.2.2. Photographs taken by the maintenance engineer in Sydney showed tyre damage that matched the shapes of the broken edge lights (see Figure 2).

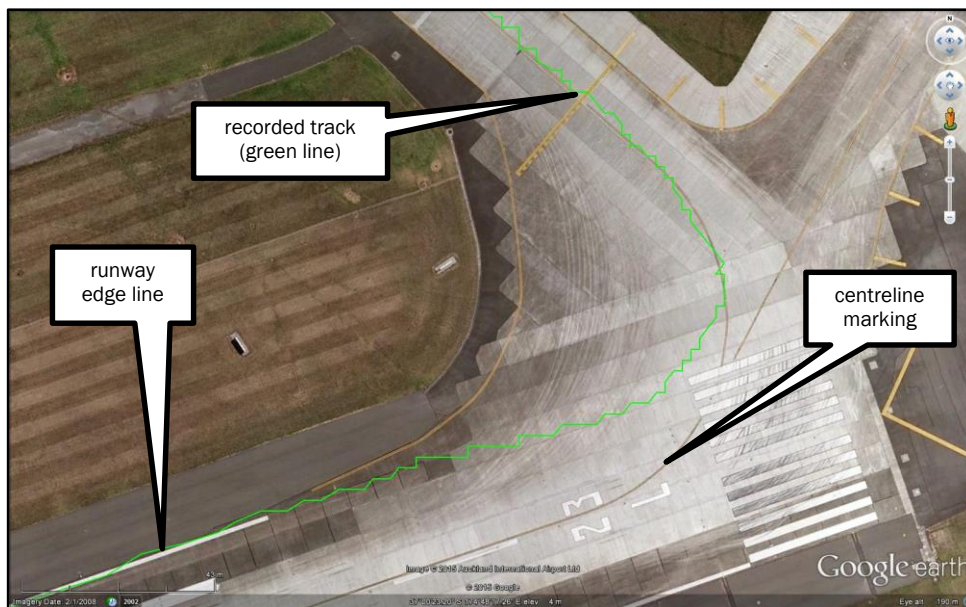
Figure 5  
Runway 23 Left entrance

- 3.4.1. Auckland Airport has one concrete runway in normal operation (see Figure 5 and Figure 6). It is 45 m wide with a 7 m strengthened shoulder on either side. The surface beyond the shoulder is protected from jet blast by a non-load-bearing asphalt surface for a further 7 m, giving a total sealed surface width of 73 m.
- 3.4.2. The taxiway and runway physical dimensions, markings and lighting installations on the aerodrome met the CAA design standards for an international airport that supported operations in conditions of very low visibility.

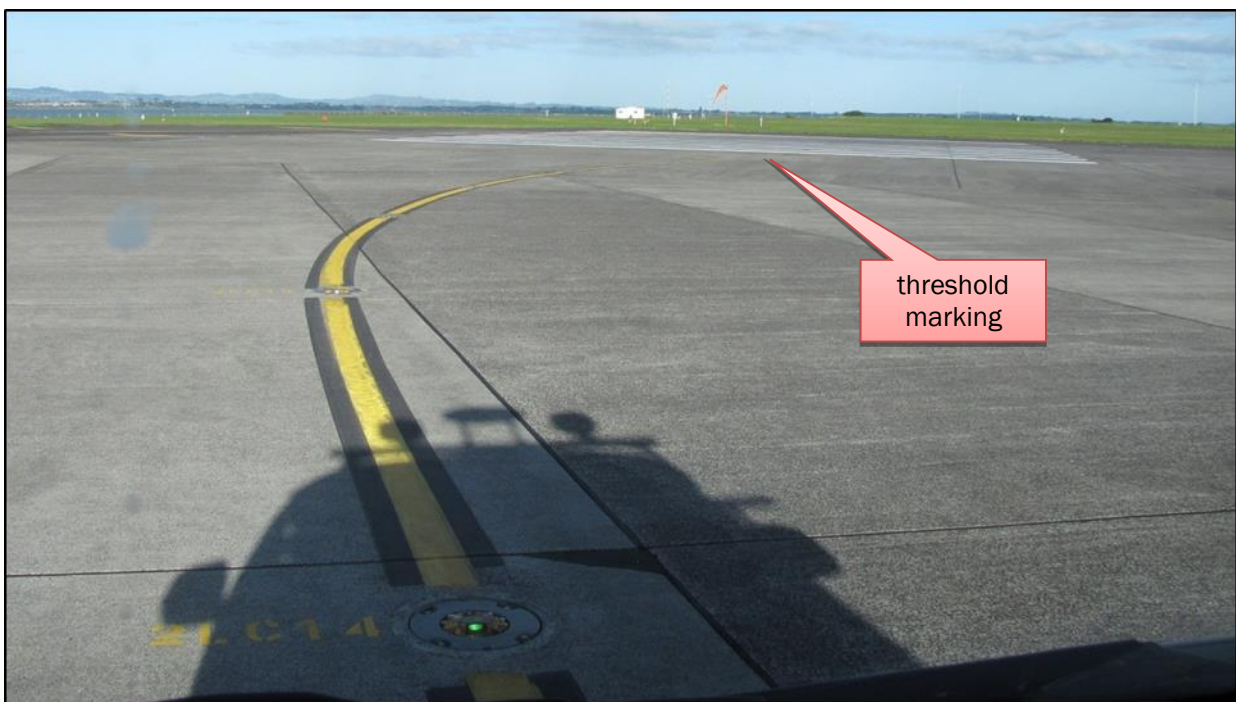
**Figure 7**  
Daylight view of taxiway A1 centreline lights and  
paint markings leading to runway 23 Left  
(taken from 1.5 m above surface)

- 4.2.3. Taxiway centreline lights are flush-mounted and green and have narrow light beams aligned with the taxiway centreline (Figure 7). On curved centrelines different fittings with wider beams are used. These are spaced more closely, with the centre of their beams toed in towards the centre of the curve radius, so that at least three lights are visible to a pilot as an aeroplane tracks around the curve.
- 4.2.4. Runway centreline lights are also flush mounted, but have white lights with narrowly focused beams aligned with the centre of the runway.
- 4.2.5. Runway edge lights are mounted on pedestals 300 millimetres above the runway surface, but where aeroplanes may roll over them they are flush-mounted. The elevated runway edge lights have narrow, high-intensity beams angled in towards the runway centre at three degrees from the edge line, and omnidirectional beams.

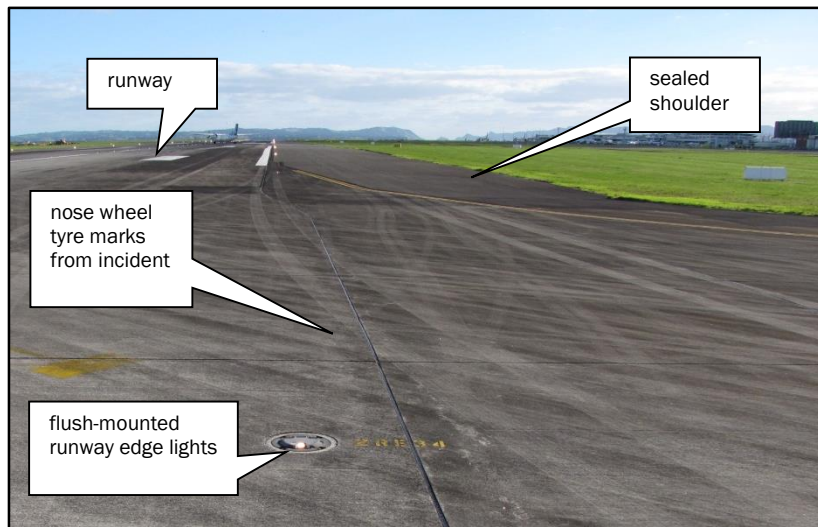
**Figure 8**  
Runway 23 Left's entrance from taxiway A1  
(at 1.5 m above the surface)

landing lights. When he looked out again, the brighter landing lights reflecting off the concrete runway may have diminished the visibility of the taxiway centreline lights, although the paint marking would have become more visible.

4.2.9. ICAO's guidance to best practice on the flight deck from the Manual on the Prevention of Runway Incursions (ICAO, 2007, pp. App B-2) recommends planning the timing and execution of checklists to have 'all eyes outside' during entry to the runway. The operator's standard operating procedures gave the captain the choice of switching on the landing lights personally or requesting the first officer to do so. Best practice in this case would have been for the captain to request the first officer to switch on the lights so that he could remain looking outside the aeroplane. The captain said that when he looked back outside to continue the turn onto the runway he presumed the 'line of very high intensity lights' were the centreline lights and aligned the aeroplane with them. The tight turn to align suggests that his mistake occurred after he had lost his previous lead-in cues.

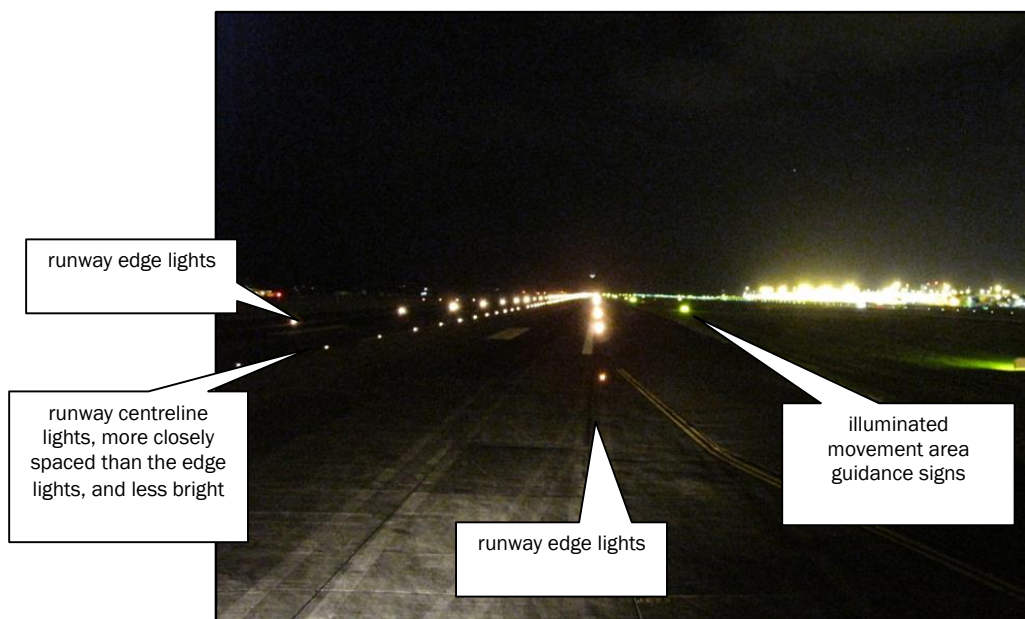
**Figure 9**  
Runway 23 Left view while aligned with the edge lights  
(at cockpit height, 5.0 m above the surface)

- 4.2.10. Once aligned, the runway lights should have appeared as three white lines converging at a single point in the distance. At a glance, it is possible to gain a visual impression that the runway edge lights are the centreline, but only if the line of illuminated movement area guidance signs are mistaken for the right-hand runway edge lights (see Figure 9). It was suggested that this type of illusion was present in the incident at Los Angeles International Airport (see paragraph 3.6.3 above).
