Final Report AO-2013-008: Boeing 737-300, ZK-NGI,
Loss of cabin pressure, near Raglan, Waikato, 30 August 2013

Aviation inquiry 13-008
Boeing 737-300, ZK-NGI
Loss of cabin pressure
near Raglan, Waikato
30 August 2013

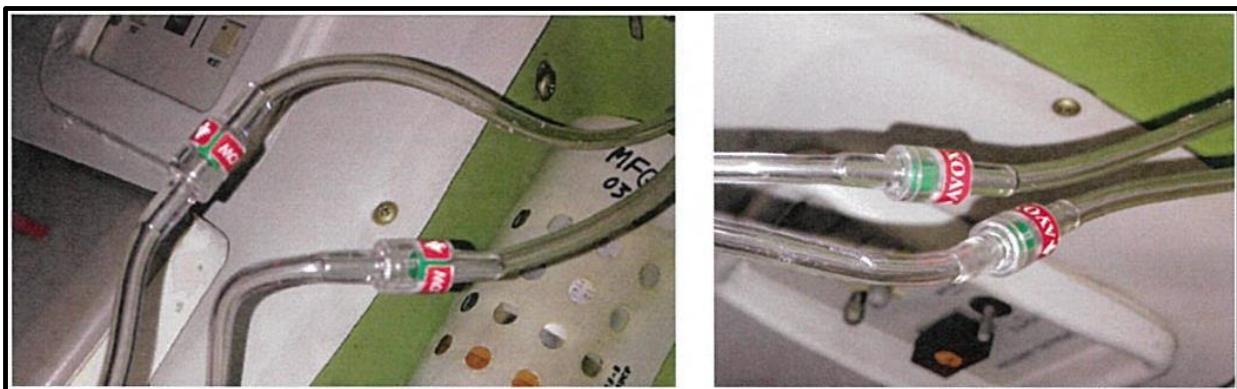
- 4.5.16. Later inspection showed that the oxygen generator at that position had not been activated. Therefore FA1 had not been supplied with oxygen. It was highly likely that she saw only the edge of the flow indicator, which may be slightly visible even when there is no flow (see Figure 4). The operator's training for cabin crew had not demonstrated how the indicator becomes fully visible when oxygen is flowing. The operator has since revised its cabin crew training to describe and demonstrate the oxygen system more accurately.

Figure 4
Oxygen tubing, showing no flow (left) and full flow (right)
(Picture from the operator)

- 4.5.17. Tests by the operator showed that improper packing of the oxygen mask was the likely reason for the generator at the front left door, where FA1 stood, failing to activate. Another test on a different Boeing 737 found some improperly packed passenger oxygen masks. Even though each row of seats had a spare mask, the improper packing or maintenance of equipment that is critical to life support is a potential safety issue on all aeroplane types. The operator reviewed the quality control of the maintenance of oxygen units across its fleets and deemed no further action was necessary. Therefore the Commission made no recommendation on this matter.²³
