Inquiry AO-2013-009: RNZAF Boeing 757, NZ7571, landing below published minima  
Pegasus Field, Antarctica, 7 October 2013

Aviation inquiry 13-009  
RNZAF Boeing 757, NZ7571  
landing below published minima  
Pegasus Field, Antarctica  
7 October 2013

Approved for publication: December 2014

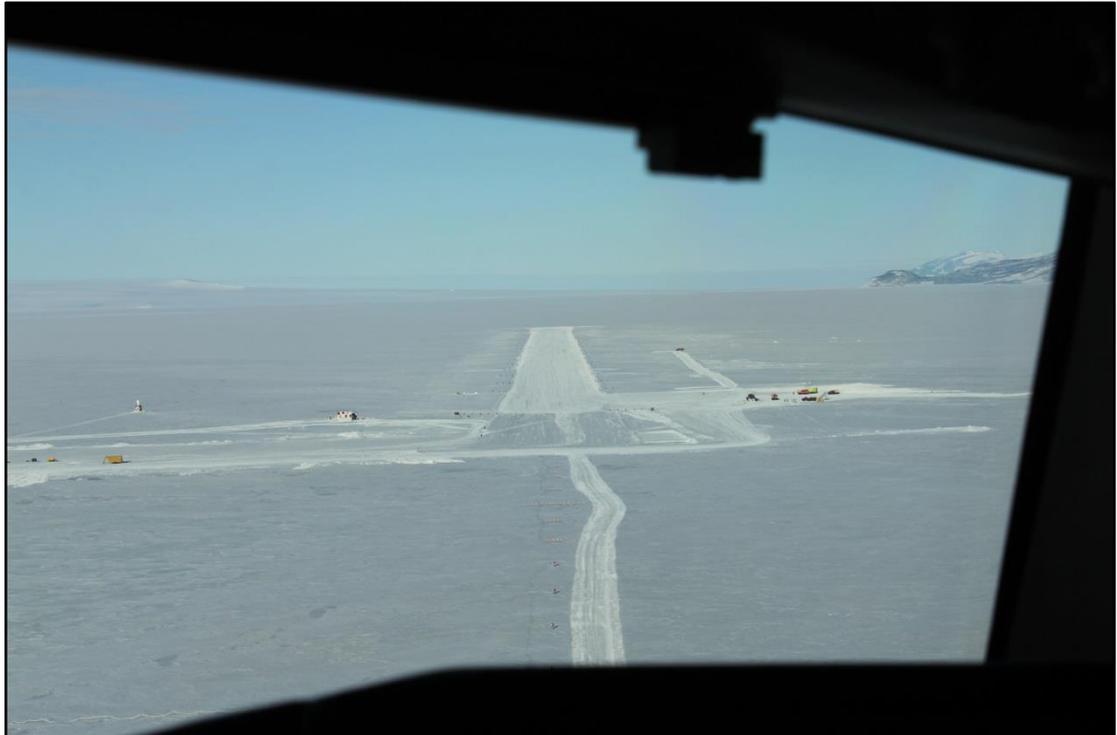
- 3.1.3. The captain under training, who was sitting behind the two pilot seats, took photographs of the area and the runway during the approach (see Figure 1). The crew was also able to validate the accuracy of the area navigation (RNAV) global positioning system (GPS) instrument approach for runway 33. The crew noted after landing that the runway centreline was offset to the right of the published inbound track information by about 15 metres (m).<sup>6</sup>

**Figure 1**  
**Approach to Pegasus Field runway 33, 3 October 2013**  
(Courtesy of the RNZAF)

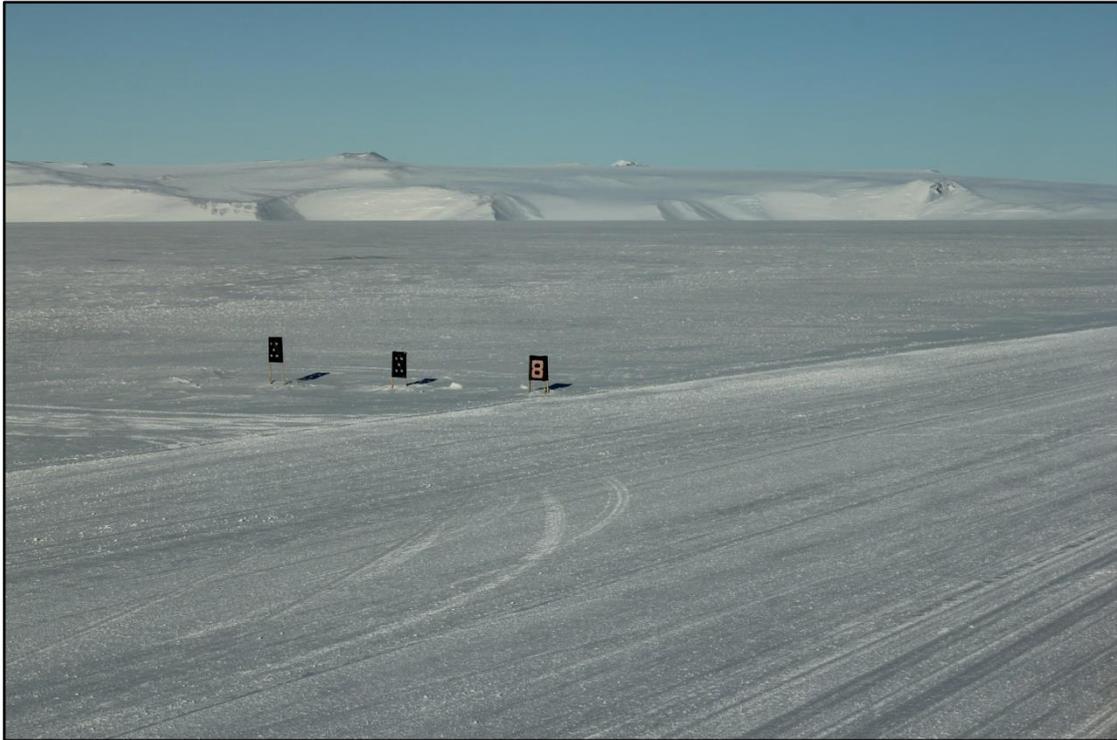
Figure 2  
Runway markings, 3 October 2013  
(Courtesy of the RNZAF)

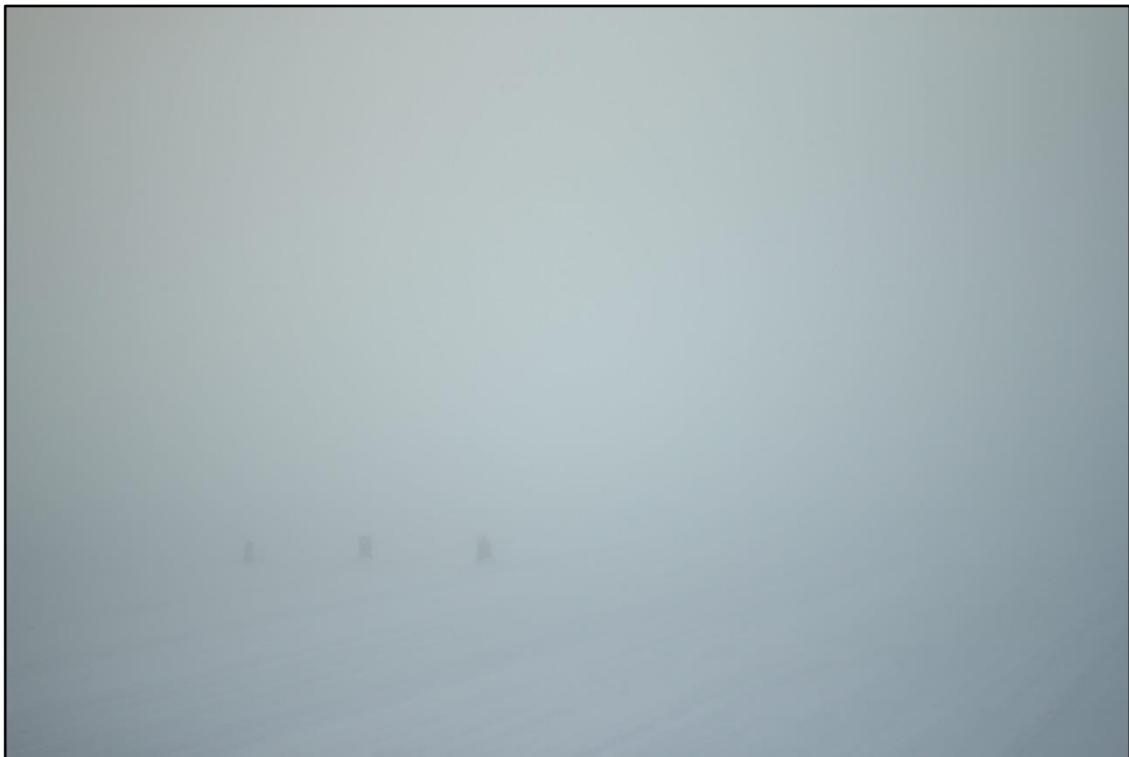
Figure 3  
Runway markings, 7 October 2013  
(Courtesy of the RNZAF)

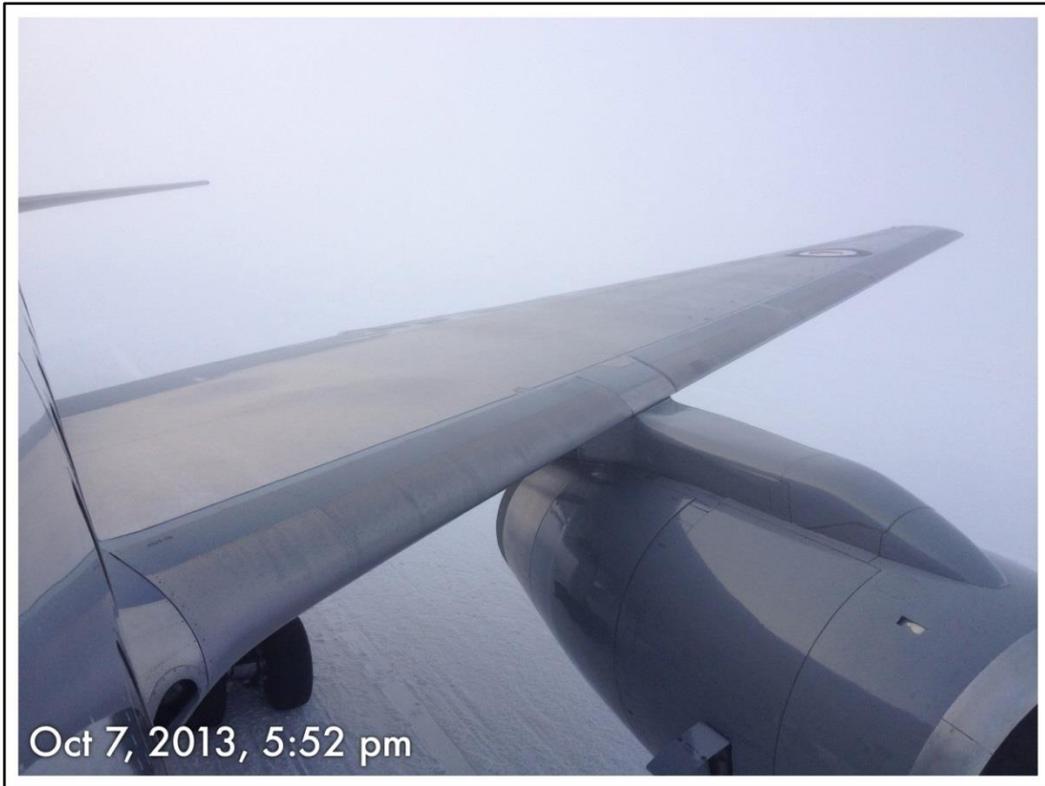
- 3.1.23. The aeroplane was brought to a halt with about 4,000 feet remaining. A “Follow Me” vehicle met the aeroplane as it was taxied back to the apron, guiding it to a parking spot. The fuel remaining on board after shutting down the engines was calculated to be about 3,000 kilograms, sufficient for one further approach if required. The fog started to clear about one and a half hours after the aeroplane had landed (see Figures 4 and 5).

Figure 4  
Visibility an hour after landing  
(Courtesy of the RNZAF)

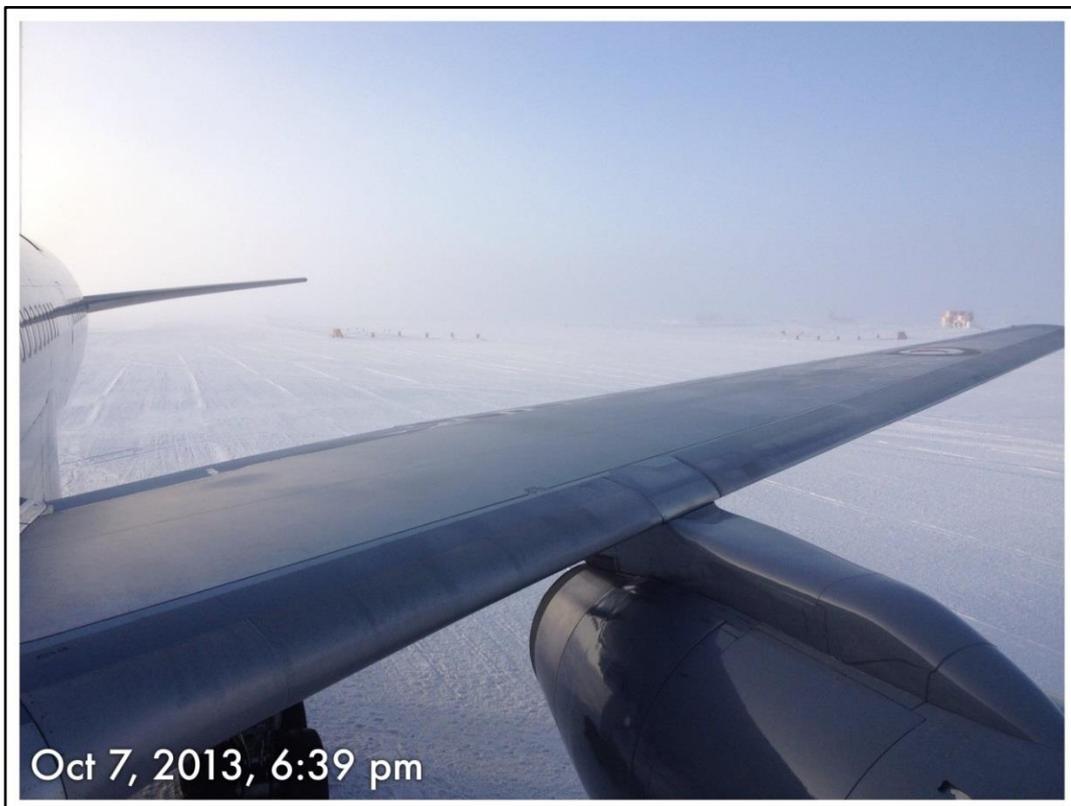
Figure 5  
Visibility one hour and 45 minutes after landing  
(Courtesy of the RNZAF)
