Final report AO-2013-010: Aérospatiale AS350B2 'Squirrel', ZK-IMJ,
collision with parked helicopter, near Mount Tyndall, Otago, 28 October 2013

Aviation inquiry AO-2013-010

Aérospatiale AS350B2 'Squirrel', ZK-IMJ,
collision with parked helicopter
near Mount Tyndall, Otago
28 October 2013

Approved for publication: June 2017

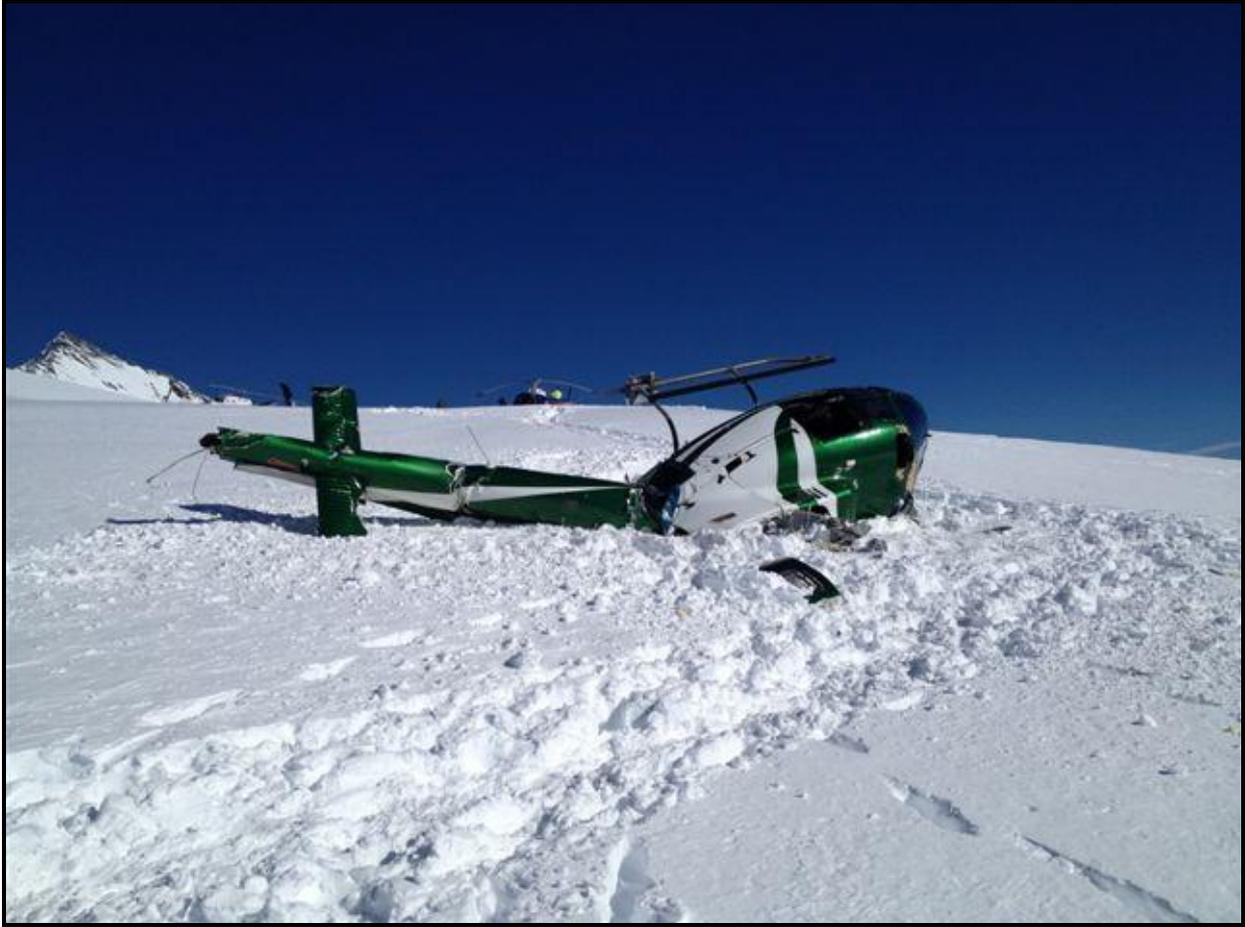
The accident scene, with ZK-IMJ in the foreground and ZK-HAE in the background

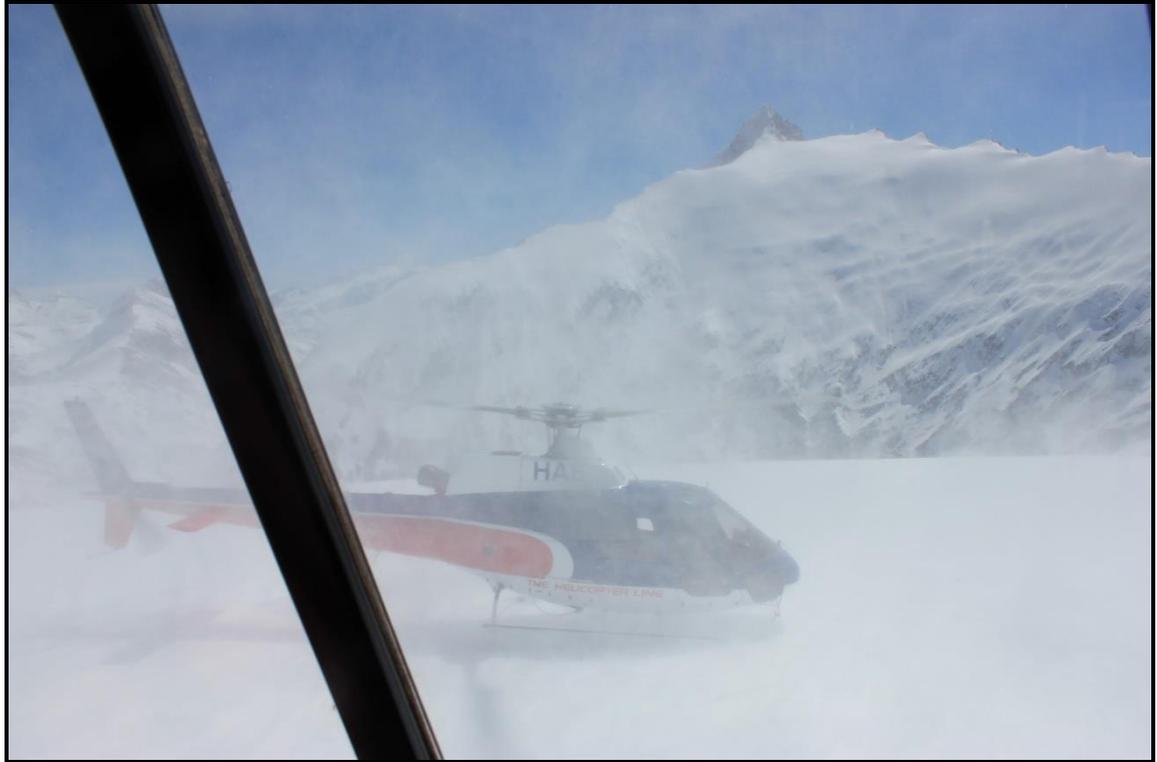
Figure 1
The parked helicopter as seen on the go-around from first approach

- 3.1.9. The helicopter continued to move towards the parked helicopter until its lower vertical stabiliser and tail rotor hit the main rotor blades of the parked helicopter. The tail rotor assembly and vertical fin separated from the helicopter and fell in front of and to the right of the parked helicopter.

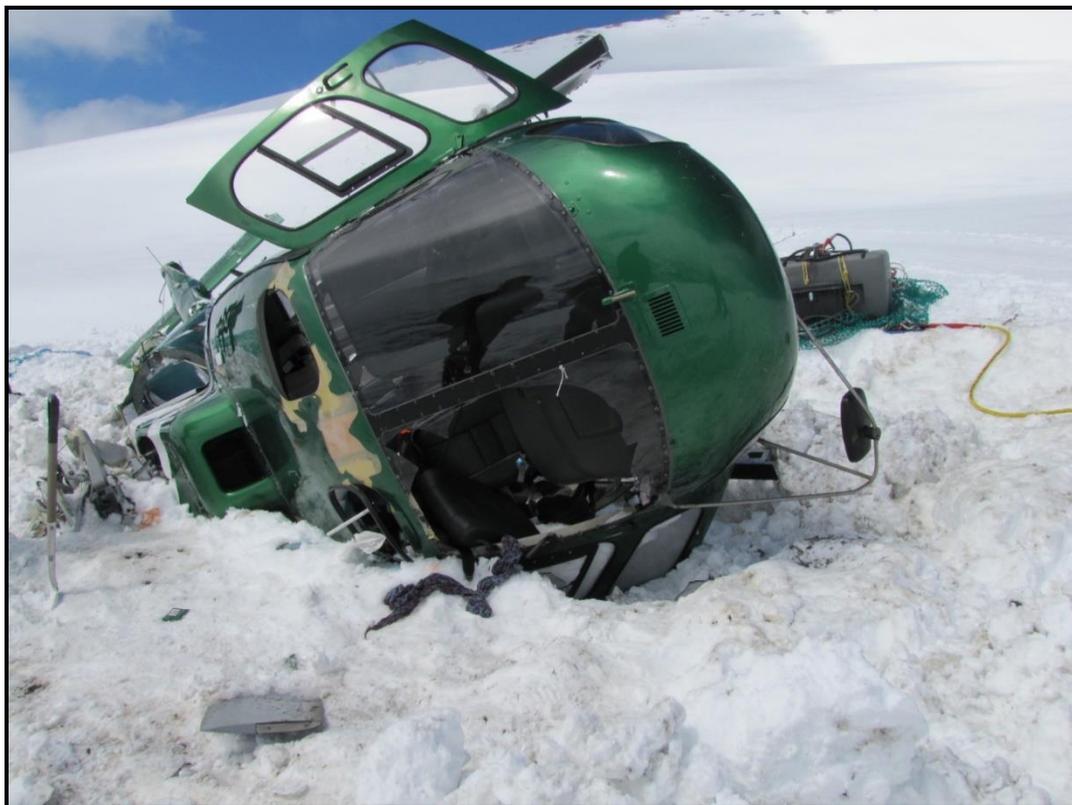
Figure 2
The helicopter after the accident (with de-fuelling kit alongside)

3.3.1. The helicopter came to rest on its right side (see Figure 2). The main rotor blades were attached but had shattered from striking the snow while under power. The tail assembly had fallen about 15 m in front of and to the right of the parked helicopter. The severed lower vertical stabiliser was located, but the removed section of tail rotor blade was not found. The front-left cabin door was detached in the ground impact.

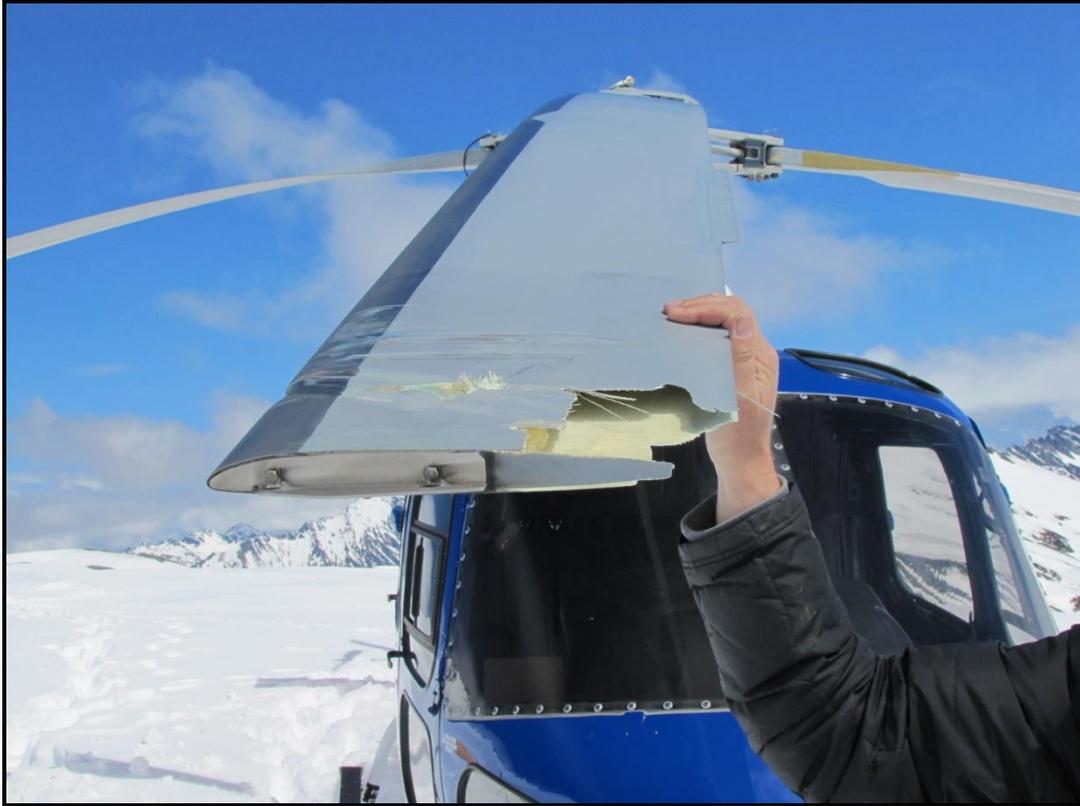
Figure 3
Typical damage to the main rotor blades of the parked helicopter

3.3.2. The visible damage to the parked helicopter was confined to the outermost half-metre of each of the three main rotor blades (see Figure 3). The main rotor head and main transmission were subjected to shock loading when the main rotor struck the airborne helicopter, and had to be replaced.

3.7.13. The visible damage to the parked helicopter was confined to the outermost half-metre of each main rotor blade. However, later examination determined that the main transmission and mast needed replacement.
