Final Report AO-2013-011: Runway excursion, British Aerospace Jetstream 32,
ZK-VAH, Auckland Airport, 2 November 2013

Aviation inquiry A0-2013-011

Runway excursion
British Aerospace Jetstream 32, ZK-VAH
Auckland Airport
2 November 2013

Approved for publication: February 2017

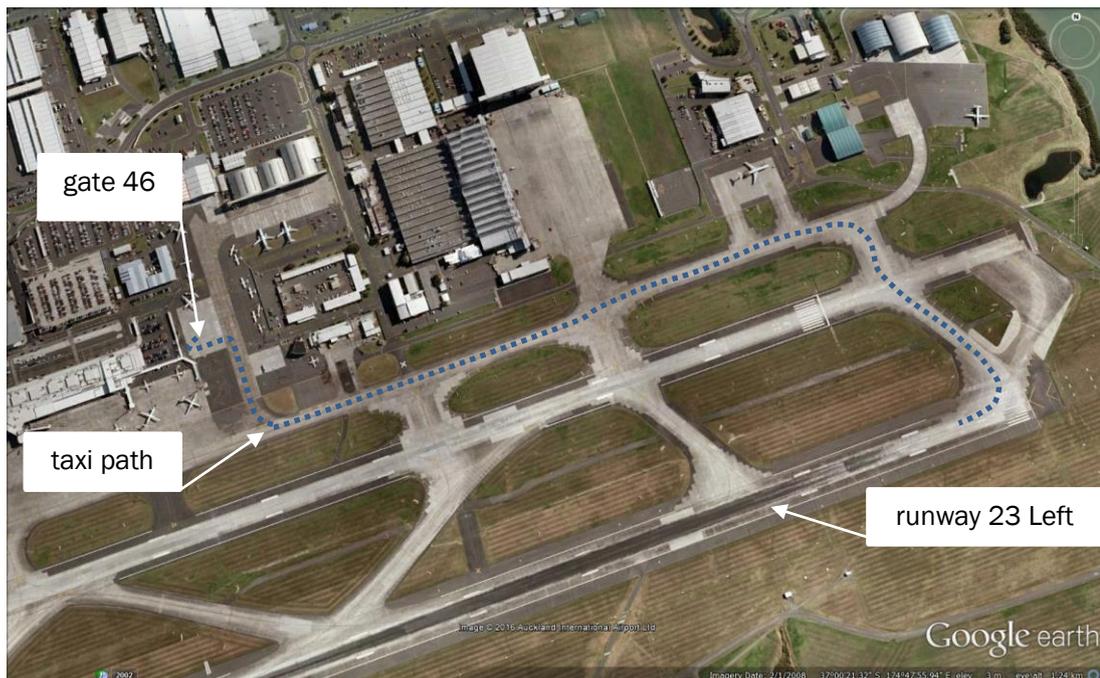
Figure 1
Taxi path to the runway

- 3.1.1. On Saturday 2 November 2013, a British Aerospace² Jetstream 32 ZK-VAH (the aeroplane) was being used for scheduled services to and from Auckland. At about midday a replacement crew arrived from Wellington to complete the remainder of the day's flying. The outgoing crew informed the replacement crew that there were no faults or concerns with the aeroplane.
- 3.1.2. At 1455, with 14 passengers on board, the engines were started for a flight to Taupo. A tight turn to the left through about 180° was required in order to leave the terminal parking area. The captain said a combination of full nose wheel steering, asymmetric power³ and asymmetric braking was required to turn the aeroplane. The aeroplane was then taxied to runway 23 Left (see Figure 1).

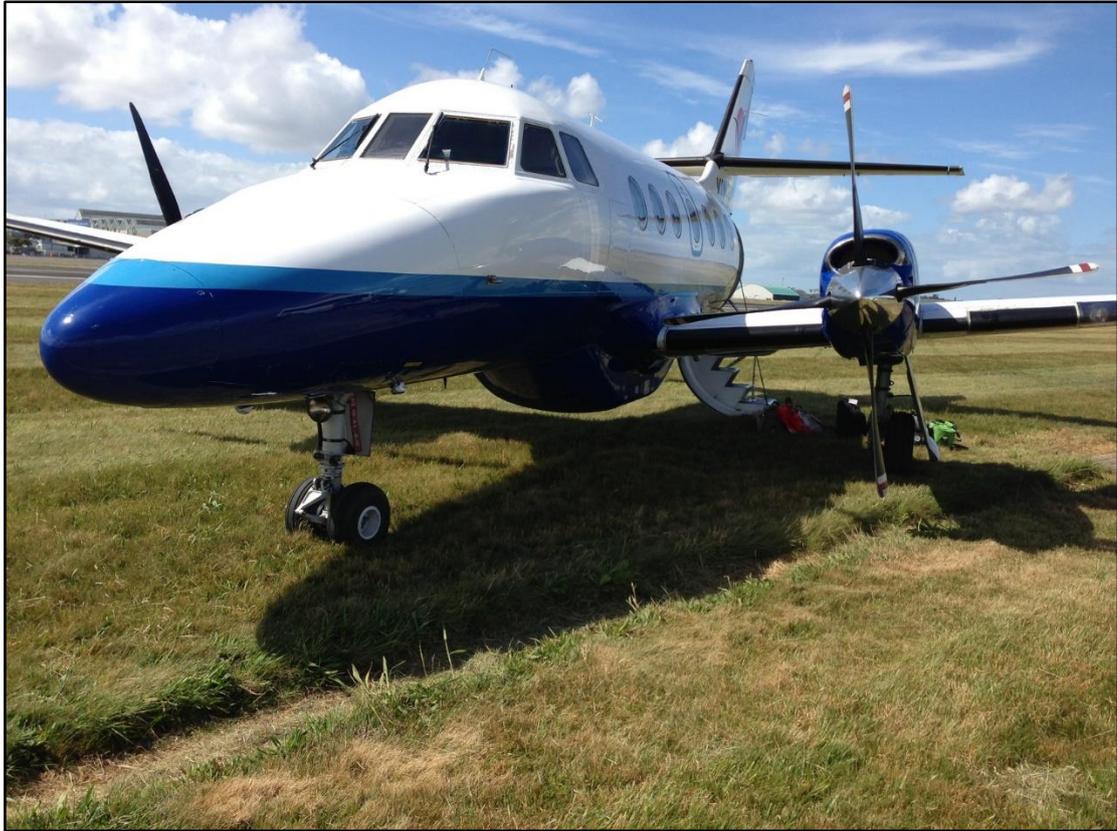
Figure 2
The aeroplane where it stopped

- 3.1.5. The captain called "stopping" as she closed both power levers. She then used a combination of nose wheel steering and asymmetric braking to try to keep the aeroplane on the runway. The first officer relayed the "stopping" call to the control tower during this time. The aeroplane came to a stop in the grass about 15 metres (m) from the runway (see Figure 2).

- 3.1.6. The engines were shut down and the passengers kept on board until emergency services arrived. No-one was injured and there was no damage to the aeroplane or ground installations as a result of the runway excursion.⁵ The aeroplane was later towed to a hangar to await the arrival of Commission investigators.

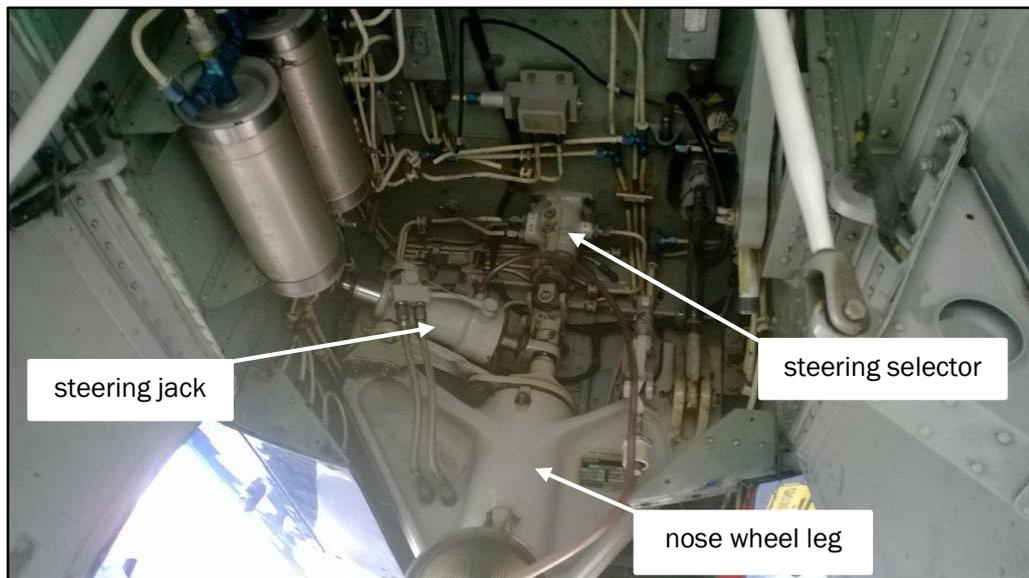
Figure 3
Steering components
(looking rearward)

- 3.5.5. A functional check and disassembly of the steering jack found no fault that may have contributed to the uncommanded left turn.
- 3.5.6. The overhaul facility that examined the steering selector identified two related faults during testing. Following “full counter-clockwise input to the selector, upon release the valve would stick and allow fluid to continually flow from [a] port”⁸; and “excessive internal valve leakage was observed”. The overhaul facility then disassembled the selector and found that the faults were caused by ‘spring boxes’ being out of adjustment. The spring boxes balanced the hydraulic pressure between the control pressure commanded by the pilot and the resultant steering forces from the nose wheel position.

- 3.5.7. The overhaul facility stated that because the steering selector locking tabs were still intact before disassembly, the misadjustment “must have been directly related to the springs”. These faults would direct hydraulic pressure to go to the left-turn side of the steering actuator. The overhaul facility further commented in its report that “the probable cause of the spring

boxes being out of adjustment is due to fatigue of the spring” and that from its experience this was “an isolated incident”.

- 4.6. The uncommanded turn to the left was determined to have been caused by a faulty steering selector. The steering selector had been installed on 20 July 2012 to replace another selector removed for scheduled overhaul.¹¹ At the time of the incident the selector had accrued 575.7 hours in service over a period of 16 months and 931 landings. The allowable service life was 10,000 landings or six years, whichever came first.

- 4.7. The examination of the steering selector after the incident traced the fault to incorrect spring tensions within the spring box of the steering selector, which affected the internal hydraulic pressure. This fault intermittently allowed uncontrolled hydraulic fluid to flow from the selector to the steering actuator, but only in the direction that turned the aeroplane to the left.
