Final report RO-2013-101: derailment of freight Train 345,
Mission Bush Branch line, 9 January 2013

Rail inquiry R0-2013-101
derailment of freight Train 345
Mission Bush Branch line
9 January 2013

Approved for publication: May 2017

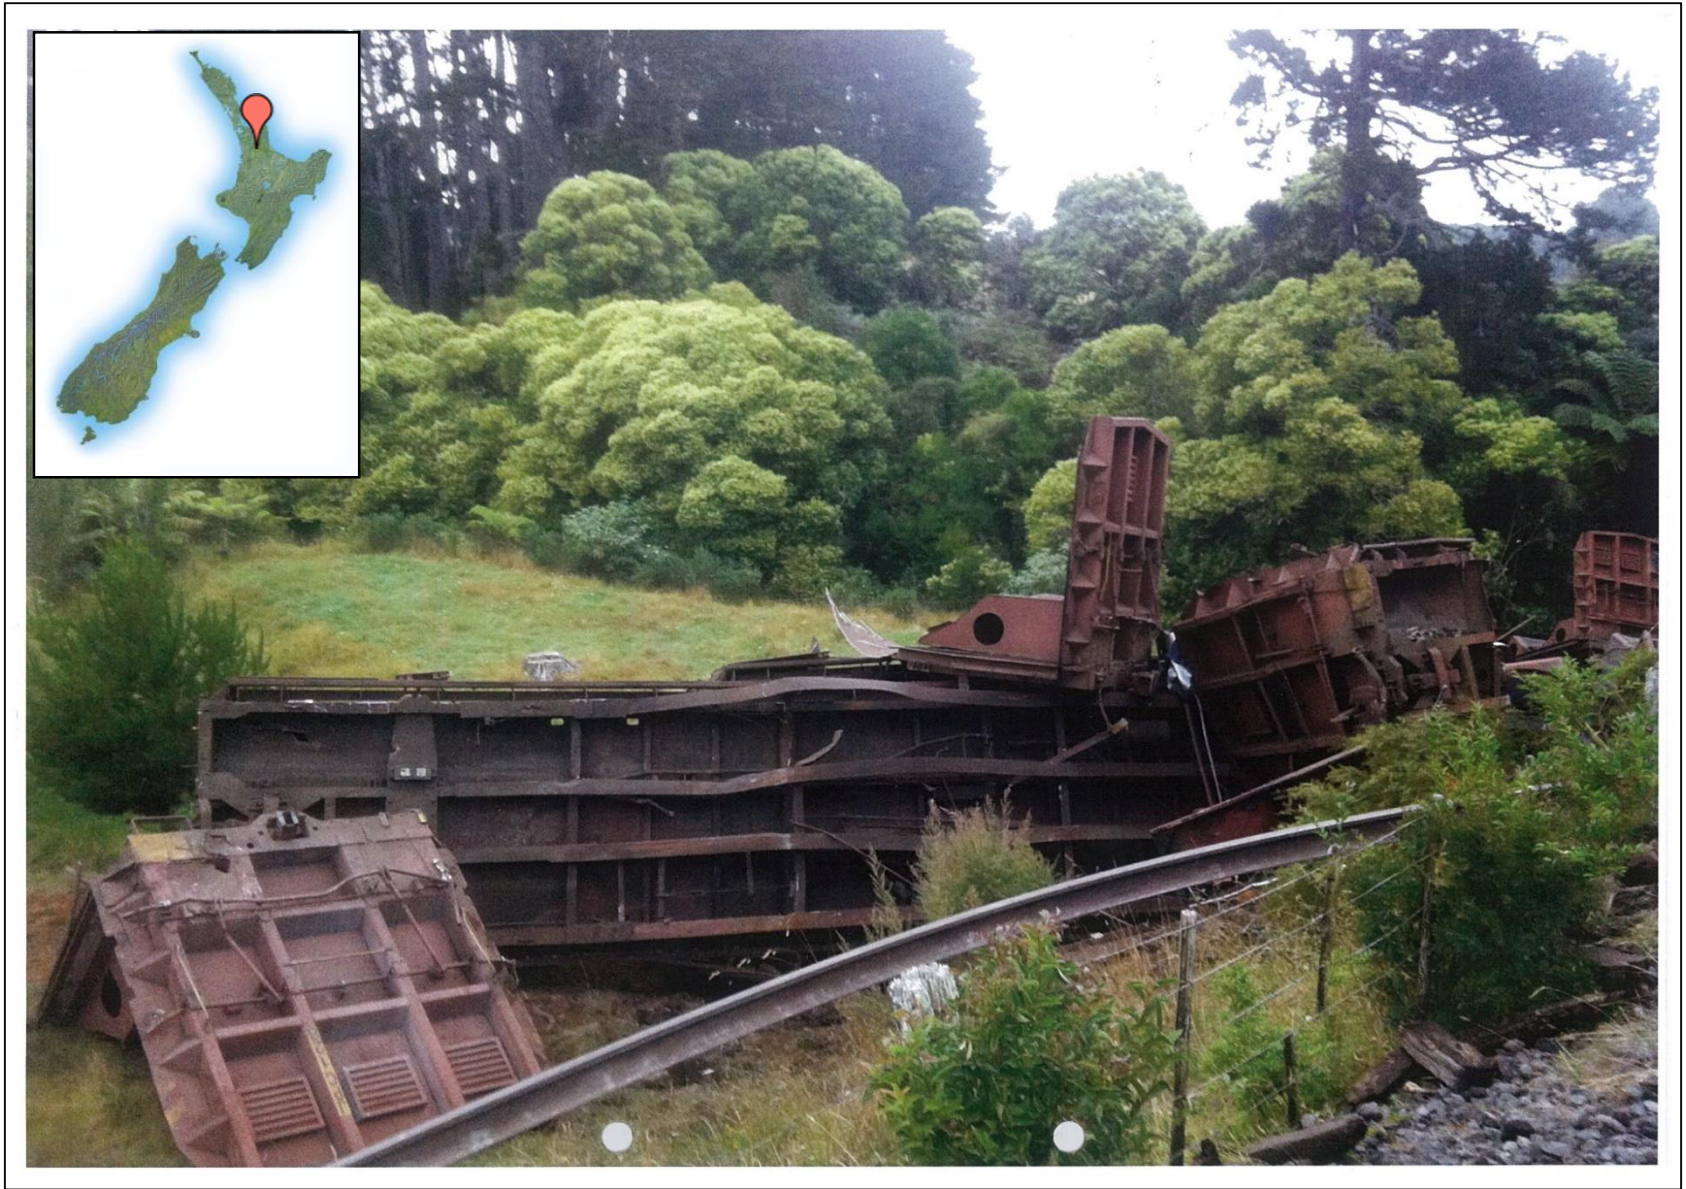
The derailment scene near Glenbrook

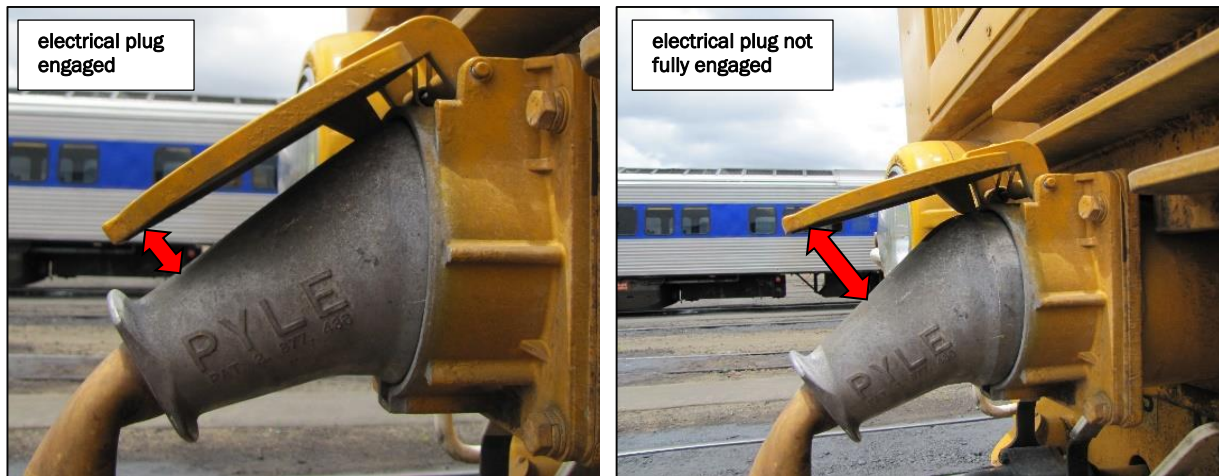
Figure 3
Examples of an engaged electrical plug, left, and a not fully engaged plug, right

- 3.2.3. At 1723 the Tranzlog⁴ event recorders on the locomotives detected an intermittent loss of connectivity in the electrical connection. The electrical plug on the second locomotive was later found not fully engaged (see Figure 3). This resulted in the two locomotives not working together during the journey to Mission Bush. Driver A was not aware of the issue.

4.3.5. The servicing staff and the train driver were qualified for their roles and all had experience in fitting and checking electrical connections between locomotives. KiwiRail reviewed its locomotive servicing procedures and used this derailment to highlight the need for train drivers to include visual examinations of electrical connections when dealing with any similar locomotive performance issues. Consequently, the Commission has not made any recommendations to KiwiRail to address this issue.

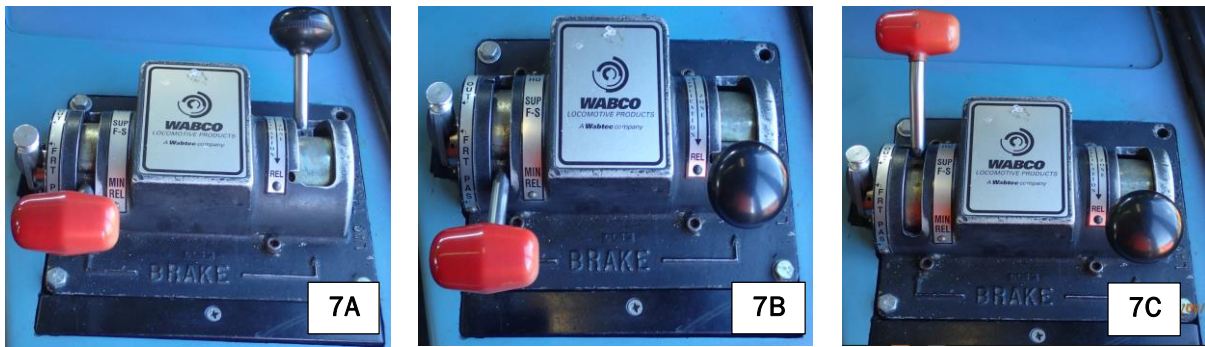
Figure 7
The different brake handle set-ups

- 3.3.4. Driver B was now in charge of the train, and he transferred control to the other end of the lead locomotive. He did not neutralise the two brake handles before he left the cab, leaving the handles in the positions shown in Figure 7A. The train would not move when driver B applied power to the train.
- 3.3.5. Driver B returned to the vacated cab and correctly neutralised the black handle for the locomotive brakes, but omitted to neutralise the red handle for the train brakes (see Figure 7B).
- 3.3.6. In order to transfer control to the other driving cab correctly, Driver B should have placed both handles to the positions as shown in Figure 7C.

- 3.3.7. The incorrect brake set-up meant that driver B had braking control on the three locomotives only, but no braking control on the 36 wagons. An intermediate brake test required to be conducted from the lead locomotive in compliance with KiwiRail's rules was not carried out. The intermediate test would have identified that there was no braking control on the wagons.

- 4.4.3. KiwiRail investigated several options before choosing the Tranzlog event recorder system to provide an interlock capability to prevent a similar incident. The Tranzlog system was chosen to perform this interlock because the positions of the brake handles were already being monitored by the system. This option was successfully tested during 2014/2015 and rolled out on all the DL-class locomotives. In view of this work, the Commission has not made a recommendation to KiwiRail to address this issue.
- 4.4.4. Additionally, KiwiRail has committed to providing a similar Tranzlog-based interlock capability on all its other mainline diesel locomotives. This work will supplement the existing manual interlock and was underway at the time of the compilation of this report.

- 6.6. On 12 August 2016 KiwiRail advised that all operational DL-class locomotives had had the Tranzlog upgrades completed. A small number of non-operational locomotives that were currently having asbestos removed at its workshop facility in the Hutt Valley near Wellington would have the Tranzlogs upgraded when the repairs were completed.

- 6.8. On 5 October 2016 KiwiRail advised that it was reviewing the Tranzlog upgrade designed to detect an incorrect brake set-up on the DL-class locomotives with a view to installing the upgrade in its remaining single-cab diesel locomotive fleet.

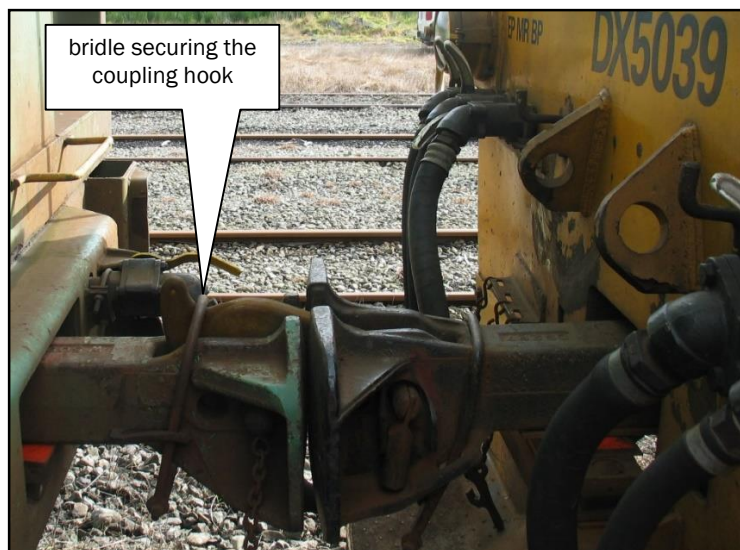
Figure 8
Coupling hook and bridle security arrangements on a standard coupler mechanism

- 3.4.1. At 0437:02 driver B accelerated the train away from the level crossing. At 0440 the speed of the train reached 63 km/h on a descending gradient. The driver applied the train's brakes to slow the train for an upcoming 40 km/h temporary speed restriction without success. Driver B made several applications of the locomotives' brakes, but the speed of the train increased to 76 km/h over the speed-restricted section of track.
- 3.4.2. At 0440:45 the Tranzlog recorded a sudden drop in air pressure in the train's brakes. The wagons had surged forward on the descending gradient, causing the coupling hook to lift up and the brake hoses to separate between the sixth and seventh wagons (see Figure 8).

- 3.4.3. The bridle and coupling hook were later found to be intact on the separated sixth and seventh wagons. It could not be established whether the bridle had been correctly secured between the two wagons before the train left Mission Bush or whether it had lifted off while the train was travelling between Mission Bush and the location of the derailment. It was normal practice for the train examiner to check that all bridles were in place before a train departed.

- 4.1.4. The separation between the sixth and seventh wagons and was very likely caused by an incomplete coupling connection that had gone undetected during the terminal brake test undertaken at Mission Bush before the train departed. The incomplete coupling allowed the hook to spring up when the couplings suddenly compressed as the train descended the gradient from Glenbrook.
